Your Inspection Report

281 A Glory Road
Bancroft, ON K0L 1C0

INSPECTION DATE:
Wednesday, June 18, 2025

RE: Report No. 2340
281 A Glory Road
Bancroft, ON
K0L 1C0

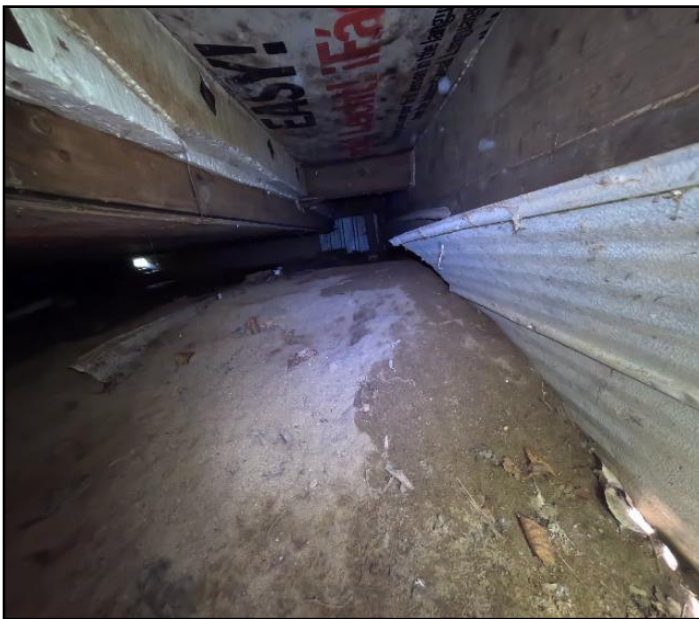
42. Crawlspace

5. Condition: • [Typical minor settlement](#)

The way in which this cottage has been structured in terms of the footings and foundations is a common way that cottages were supported many years ago. O.B.C. requirements by today's standards for structures would normally be, a footing extending to a depth that is below the frost line on to native soil (undisturbed soil), or bedrock where the footing would be pinned. A couple of common issues with these piers are frost heave and then thawing. That cycle sets in motion a pattern in which over the years the piers or columns on the surface of the ground are heaving up then settling back down. Of course, the blocks never go back exactly as they started. Each year's movement can be almost undetectable but over time the yearly movement becomes exacerbated until you have the settled blocks and leaning columns. That can cause twisting, rotating beams, hinging column/pier connections and a host of other possible issues all from the piers or posts moving. The second problem is simple erosion of the soil around the deck block. I don't see erosion being a big problem in this setting. Left alone and unrepaired the piers or posts will slowly move and become unstable. However, getting under the cottage yearly to inspect for movement and repairing the same by lifting and leveling will help keep big repairs at bay.

Task: Inspect annually
