Inspection Report

Property Address:
910 Walnut Falls Cir
Mansfield TX 76063

PROPERTY INSPECTION REPORT FORM

Michael Sullivan	11/7/2023
<i>Name of Client</i>	<i>Date of Inspection</i>
910 Walnut Falls Cir, Mansfield, TX 76063	
<i>Address of Inspected Property</i>	
Ernest Johnson	20120
<i>Name of Inspector</i>	<i>TREC License #</i>
<i>Name of Sponsor (if applicable)</i>	<i>TREC License #</i>

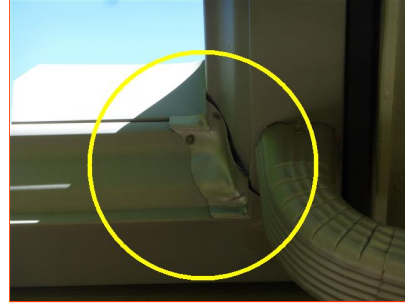
B. Item 2(Picture)

(2) The gutter appears to leak at seam on front of home. Recommend cleaning and apply gutter sealant or epoxy.

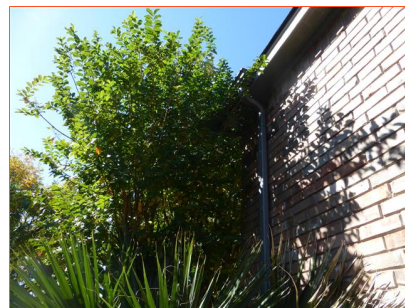
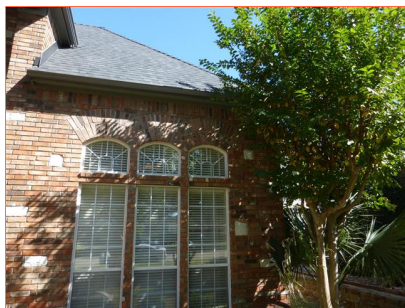
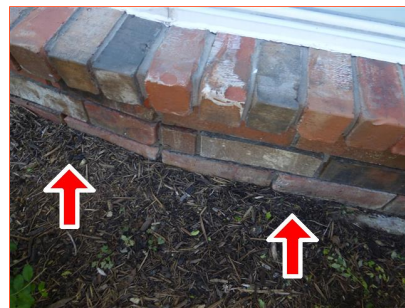
(4) Trees / Shrubs and excessive grade were observed at front, rear, and exterior sides of home. Too much foliage and excessive grade can potentially allow the entry of unwanted insects to enter and create more problems or cause water to enter the structure.

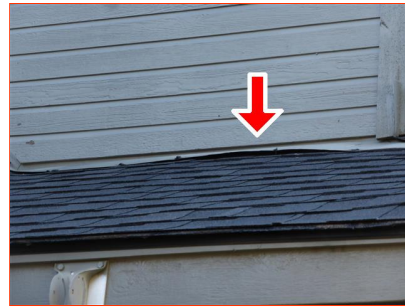
C. Item 2(Picture)

(2) Flashing located at left side of roof observed pulling up exposing nails. Recommend a qualified contractor inspect and repair.

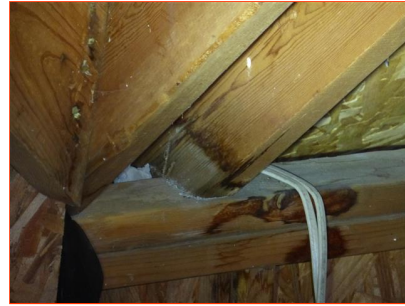
D. Item 2(Picture)

(2) Evidence of moisture stains were observed within the attic. Due to lack of heavy rain during the inspection we are unable to determine if conditions noted are older conditions or if current conditions still exist. We recommend inquiring with seller of any past issues or repairs.

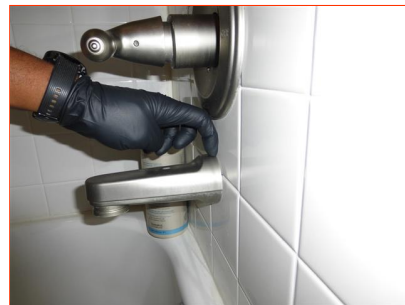
E. Item 4(Picture)

- (3) Sections of wall tiles located inside enclosures of "all" showers in the home were observed in need of caulking improvements in wall corners, edges, escutcheon's, fixtures, drains, and junctions. Caulking improvements are needed to prevent water intrusion behind walls. The exposed areas noted can lead to chronic moisture intrusion and makes wall conditions behind tiles unknown. We recommend repair or improvements using a qualified contractor as needed.

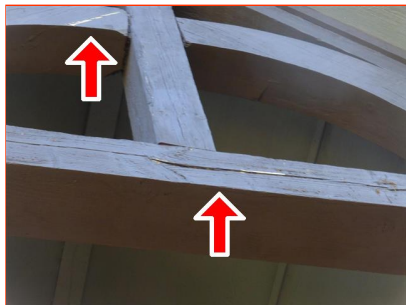
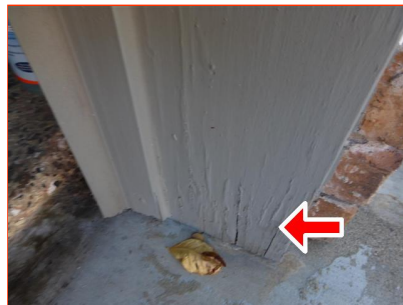
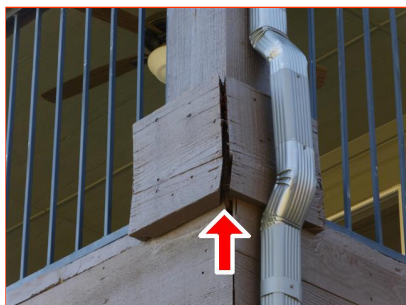
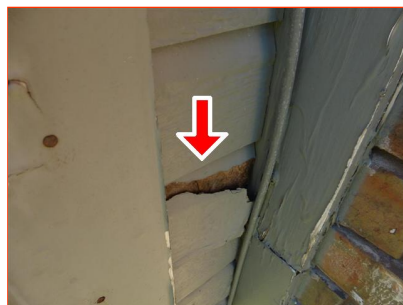
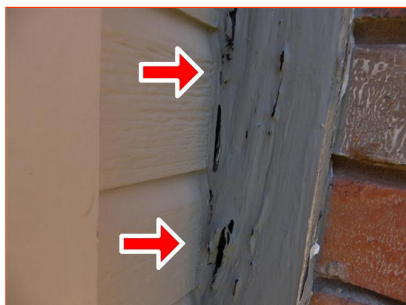
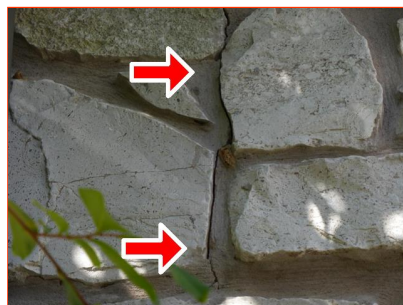
- (4) Interior / exterior walls were inspected and as the home has aged signs of stress, wear, deterioration, and foundation settlement have formed at interior / exterior walls and trim (**See additional emailed**

photos). These visible signs are common in most previously occupied homes and are typically cosmetic. Wear at exterior fascia, trim, and siding boards were also visible along with signs of settlement at bricks and mortar. Repair methods can vary from simple caulking or painting to a more complex repair and may require a professional contractor for their improvements.

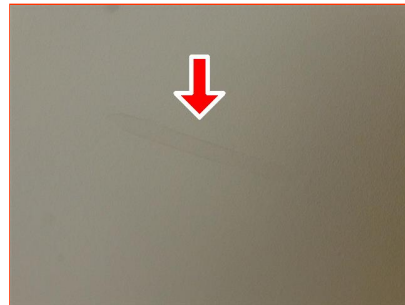
F. Item 4(Picture)

(4) We observed evidence of moisture stains at living room ceiling. It's important to note that the HVAC units are located within the attic above noted evidence. We recommend inquiring with seller of any past issues or repairs or a qualified contractor to further inspect and evaluate.

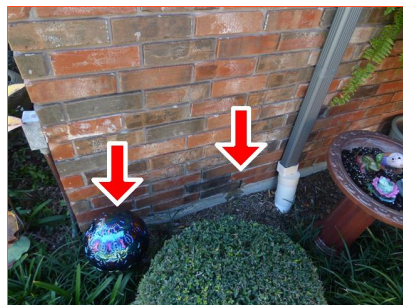
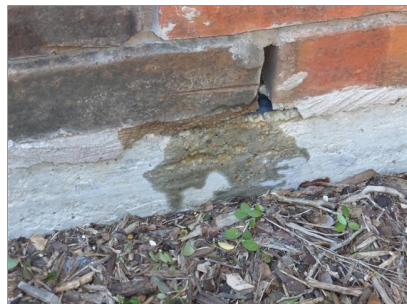
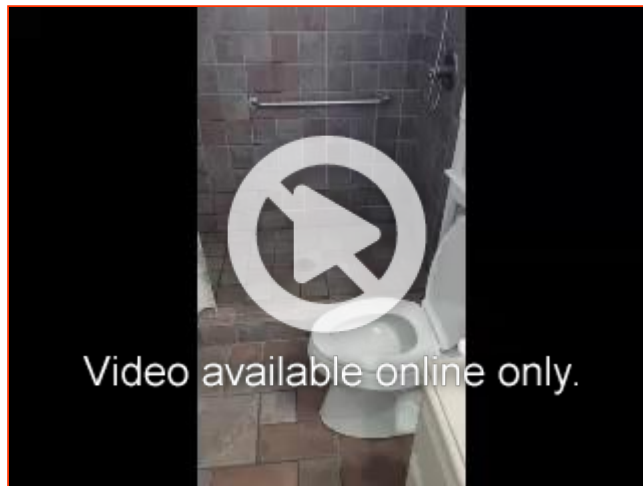
(5) During shower pan test inside guest bath 1 water was seen leaking from exterior slab. We recommend a qualified contractor further inspect, evaluate, and repair prior to close.

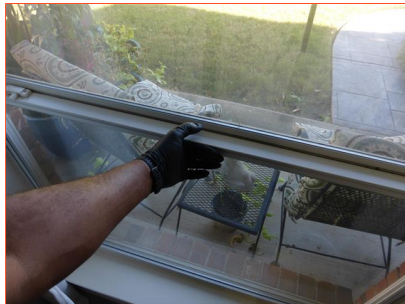
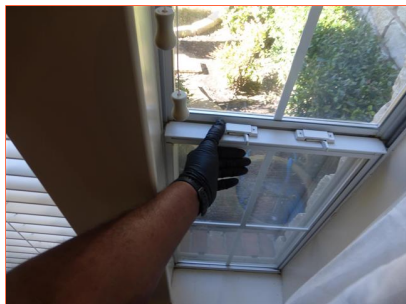
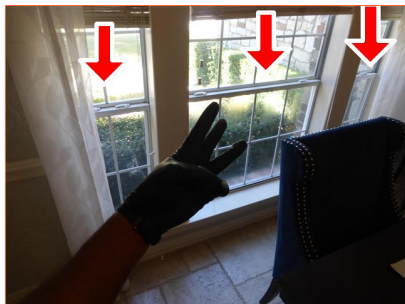
- (5) Multiple windows throughout the home were found closed stiff and could not be opened using normal force.

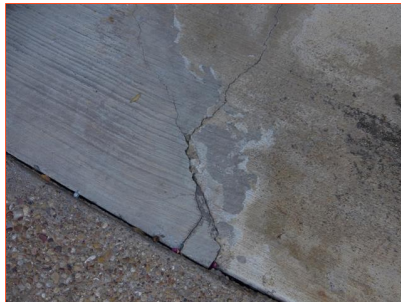
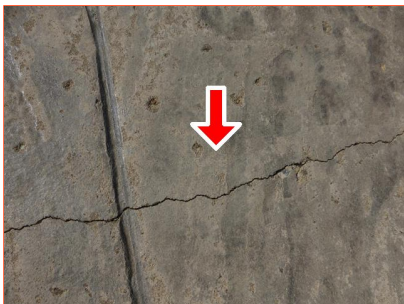
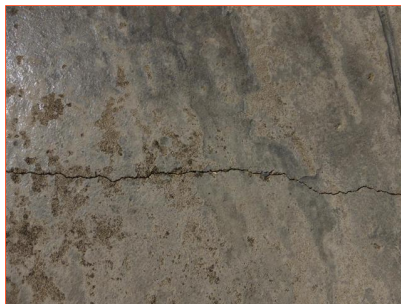
(2) Cracking was observed at sections of front porch and rear pool deck and patio. Sealing cracks with appropriate material may help to prevent further separation. This type of cracking is typically associated to the curing process or human error.

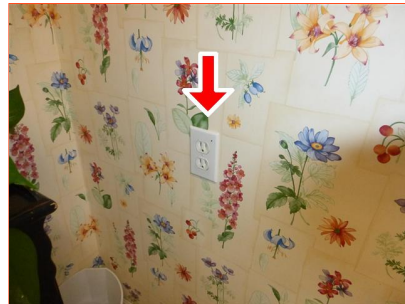
B. Item 4(Picture)

(7) Electrical outlet near laundry room sink was found **not** GFCI (Ground Fault Circuit Interrupter) protected. GFCI outlets at kitchens, baths, garages, exterior, and outlets near water sources are recommended for added protection.

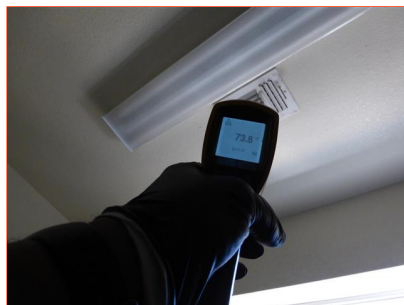
C. Item 2(Picture)

(1) Register readings were taken at each register to determine proper heating and cooling. Air register temperatures inside study room and master bath closet were found with more than 10 degree increase in temperature over other air registers. This is considered an imbalance in the ventilation system and we recommend a qualified HVAC technician inspect and evaluate.

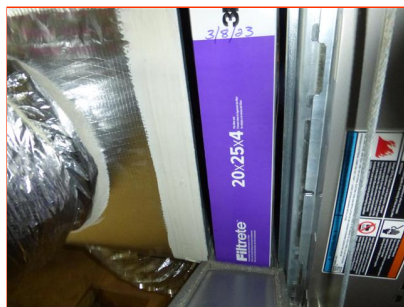
C. Item 4(Picture)

(2) Disposable air filters were found dirty. Failure to change filters regularly could result in poor health as well as high electric bills and future repairs.

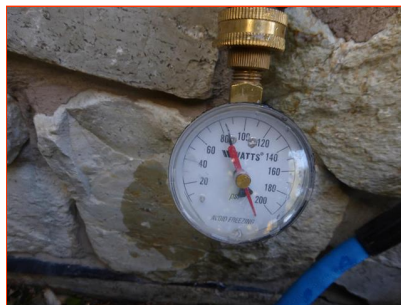
A. Item 1(Picture)

- (1) Secondary water shutoff valve could not be located during the inspection. Secondary valves are typically located at front shrubs, garage, or inside laundry rooms and should always remain visible.
- (2) Water pressure tested at hose bib read 84 psi. The State requires water pressure at properties to be a minimum of 40 psi and maximum of 80 psi. Water pressure too high can cause damage to plumbing fixtures or blow gaskets and seals. In order to reduce or regulate the water pressure in the home a pressure reducing valve (PRV) would have to be installed. Recommend a licensed plumber inspect and evaluate.

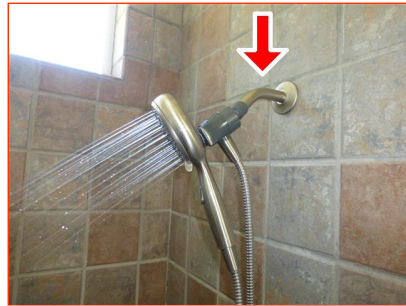
A. Item 3(Picture)

(4) Shower head pipes below were found loose at wall.

B: Left pipe inside master bath

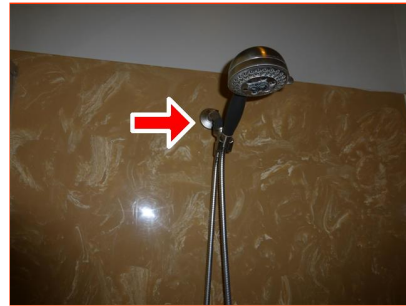
A. Item 4(Picture)

C: Shower head pipe inside Jack & Jill bath

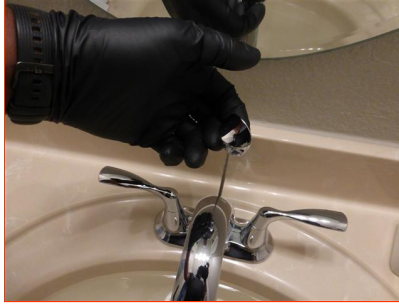
B. Item 1(Picture)

(1) Plunger rod was observed detached from pivot rod beneath left sink at Jack & Jill bath.

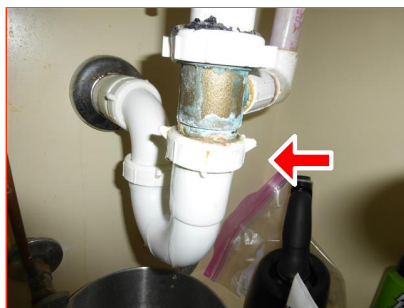
B. Item 3(Picture)

(3) Leaks were observed at identified drain locations below. Recommend a licensed plumber inspect and repair.

A: Right sink drain connection at master bath

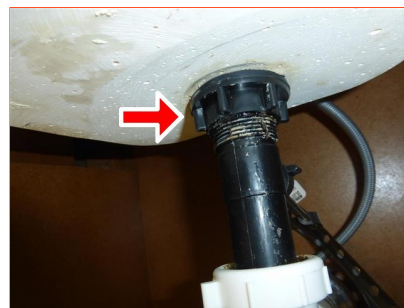
B. Item 4(Picture)

B: Left sink drain connection inside Jack & Jill bath

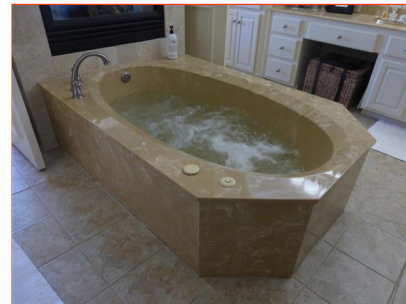
D. Item 2(Picture)

Jet tub located at master bath was observed functioning at the time of the inspection. Quick access to the motor was not observed and therefore we were not able to inspect the motor and suction lines for leaks.

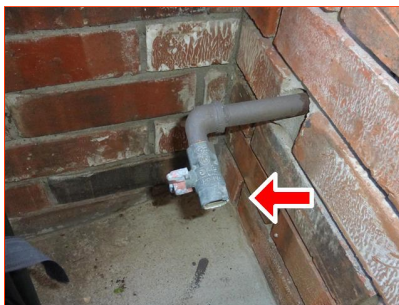
E. Item 1(Picture)

(2) Gas supply line connection at rear patio was found not in use and lacking a cap.

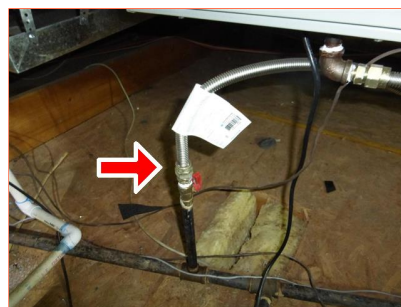
E. Item 3(Picture)

(3) We did not observe dirt legs installed at one of the water heaters and one of the furnace unit gas supply lines. Recommend a licensed plumber inspect and repair as needed.

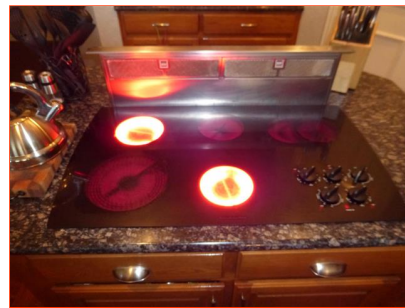
D. Item 2(Picture)

(2) Two cooktop heating elements were observed brighter than other elements which may indicate halogen cookers or possible malfunction.

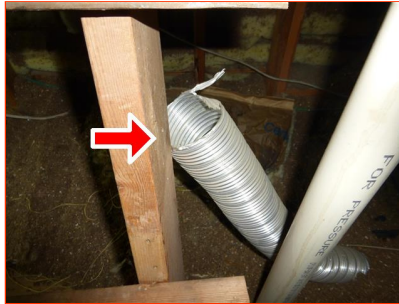
F. Item 1(Picture)

(2) Mechanical exhaust vents appeared to terminate within the attic. Vents terminating within the attic could cause moisture within attic space.

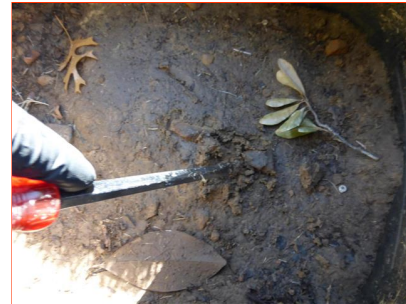
A. Item 2(Picture)

(3) Handle at sprinkler backflow valve near street was observed covered with earth and worn or rusted off.

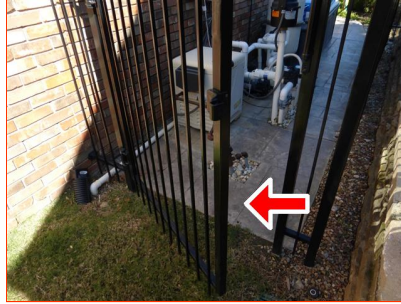
B. Item 1(Picture)

(3) Pool gates should be self closing, self latching, and should swing away from pool area. Right side gate at this property was observed not self closing.

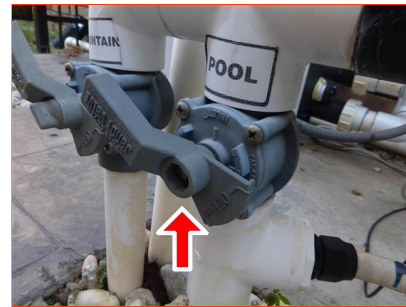
B. Item 3(Picture)

(4) Two Jandy valves were found lacking twist locks at the handles.

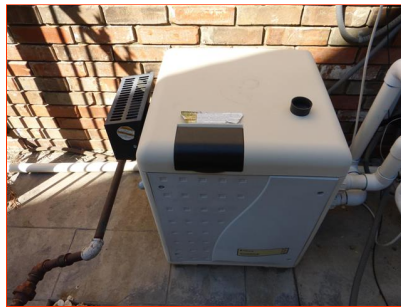
B. Item 4(Picture)

(5) We were made aware the pool heater was not functioning. Therefore we did not attempt to turn on and operate pool heater during the inspection.

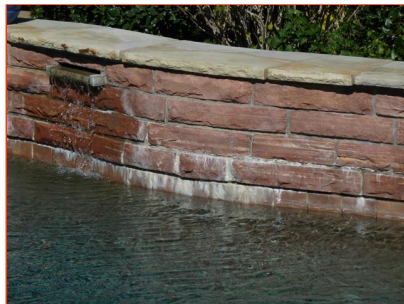
B. Item 5(Picture)

(6) Calcium was seen forming at sections bricks and walls inside pool.

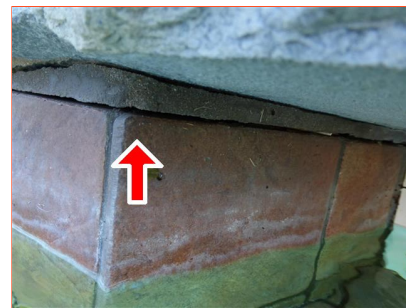
B. Item 10(Picture)

(10) During inspection inside skimmer basket we noticed cracks inside basket wall. We are unable to determine if cracks are superficial or if they penetrate through the basket material. We recommend a pool specialist inspect and evaluate.

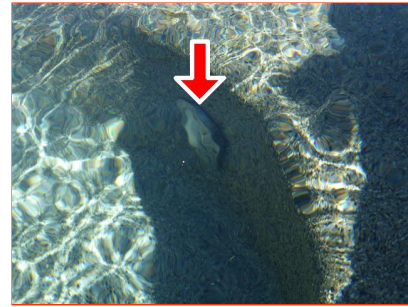
B. Item 14(Picture)

(11) Spa light was observed not functioning during the inspection. Recommend a qualified pool specialist inspect and repair.
