# INSPECTION REPORT

For the Property at:  
**22 RAGLAN STREET NORTH**  
CAMPBELLFORD, ON K0L 1L0

RE: Report No. 5158  
22 Raglan Street North  
Campbellford, ON  
K0L 1L0

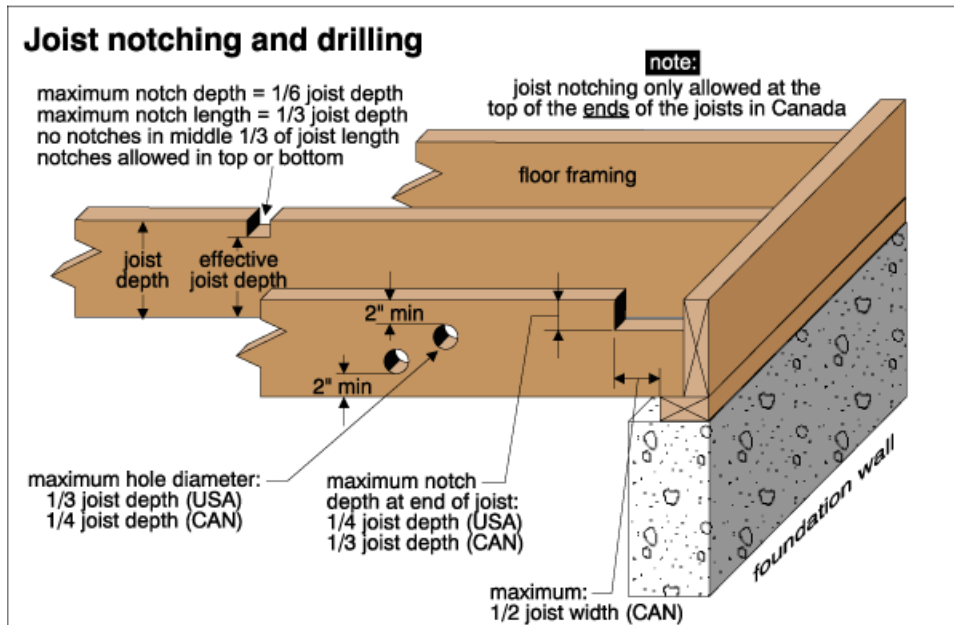
**6. Condition:** • Notches or holes  
**Implication(s):** Weakened structure  
**Location:** Crawlspace  
**Task:** Monitor  
**Time:** Ongoing
