AmeriSpec Inspection Services of Peterborough
1318 Cartier Boulevard
Peterborough ON, K9H 6S1
Phone #: 705-761-5439

Inspection Number: 156040 Inspector: Reg Deck
Inspection Date: 11/13/2024
Inspection Address: 4272 Highway 7
Norwood, ON K0L 2V0
Listing Agents: Catherine Hanrahan & Ben VanVeen Real Estate Company: Century 21 United Realty

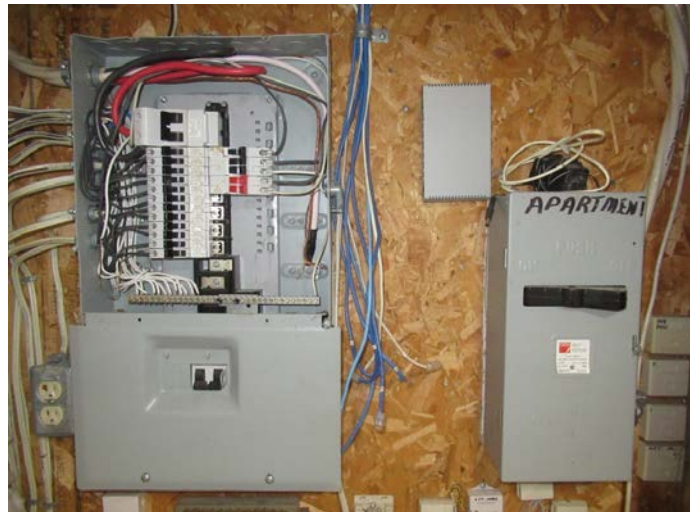
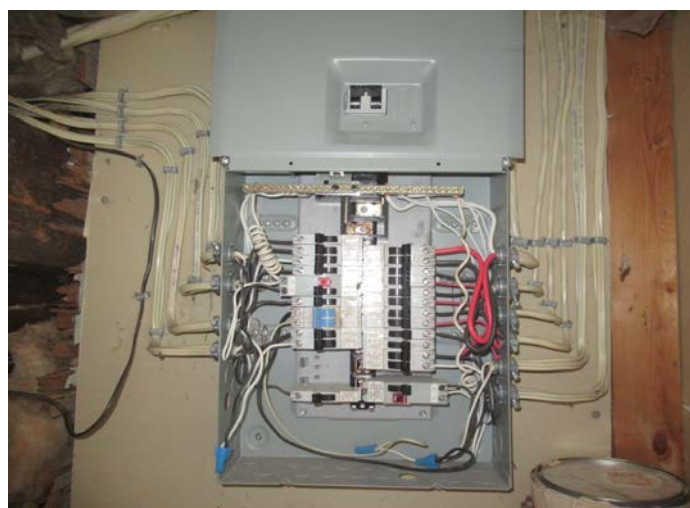
Step #	Component	Comment
2505.	System Configuration	The capacity of the main electrical service to the main floor is approximately 125 amps; the capacity of the main electrical service to the upper level apartment is approximately 100 amps. 120/240-volt system noted. The main service wires enter the home overhead.
2510.	Main Electrical Panels	Serviceable. The main distribution panels are located at the main floor, rear left and at the left side of the upper level apartment. Manufacturer: FEDERAL PIONEER/STAB-LOK. Main disconnects noted. Overload protection of the main electrical service wires is provided by breakers. The main conductor is copper. The system appears to be properly grounded. Circuit(s) available for future expansion/additional circuitry requirements. Panel directories are incomplete/not fully labeled. Recommend labelling for convenience and safety.

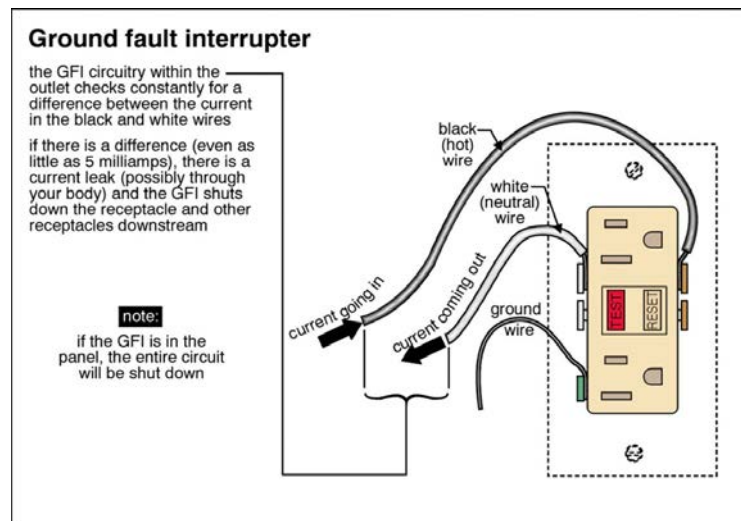
2530. GFI/GFCI

Ground Fault Circuit Interrupters (GFCIs) are special electrical devices that shut the power off to a circuit when as little as 0.005 amps of electricity is leaking from the electrical system. GFCIs/GFIs may be incorporated into circuit breakers or outlets. In order to enhance safety, GFCIs/GFIs should ideally be installed on all outdoor outlets and interior outlets where electricity may be in close proximity to water.
