# 14504 Laurinburg Dr

## Austin, Texas 78717

| Type | Home Inspection Report -<br>14504 Laurinburg Dr |

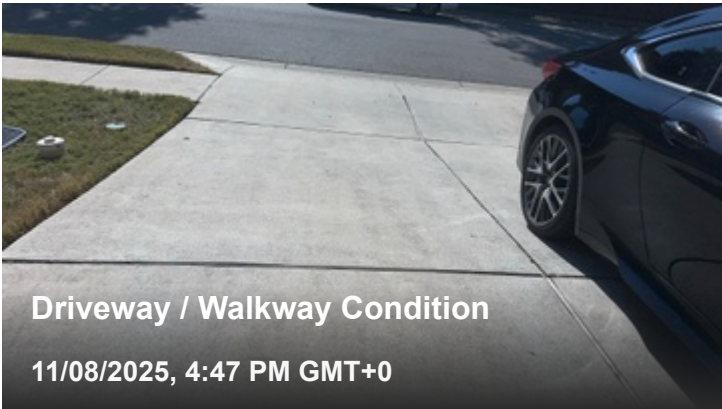
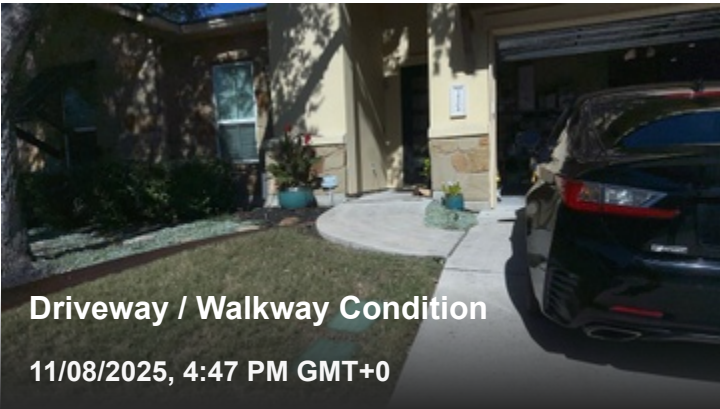
### Missing / Deteriorated Expansion Joint Materials

Expansion joint materials are missing / deteriorated. Recommend repairs or replacing by a qualified professional.

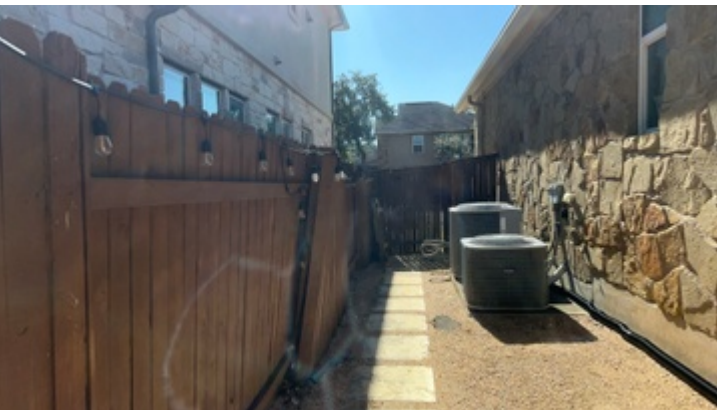
The fence is leaning. Recommend repairs or replacing by a qualified professional.

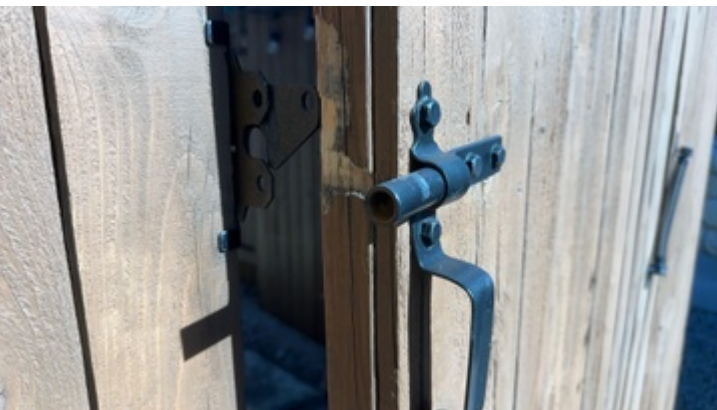
Damaged Gate

The gate is sticking. Recommend repairs or replacing by a qualified professional.

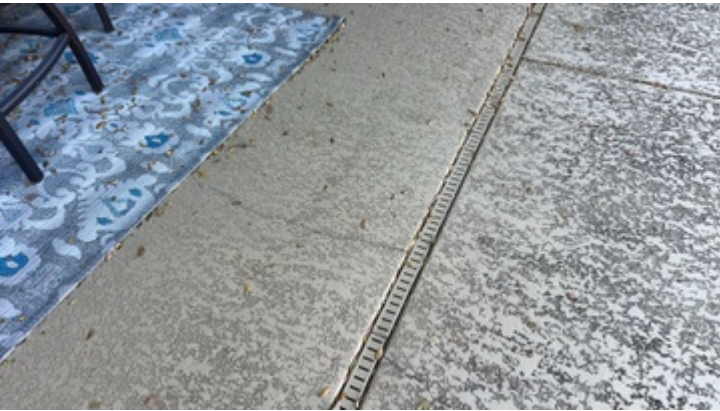
Minor Cracks in Patio / Porch

There are minor cosmetic cracks on the patio / porch. Recommend repairs or replacing by a qualified professional.

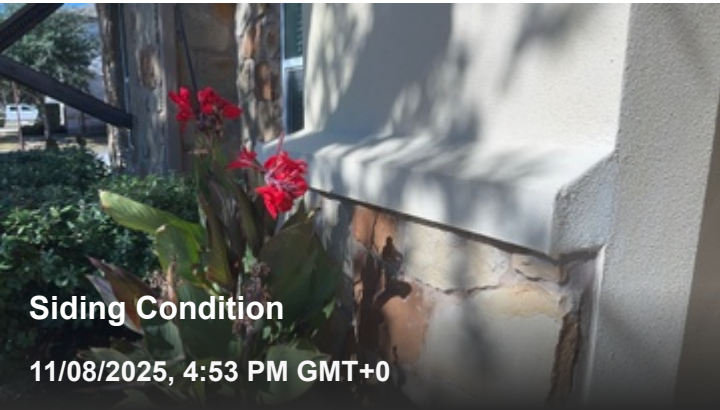
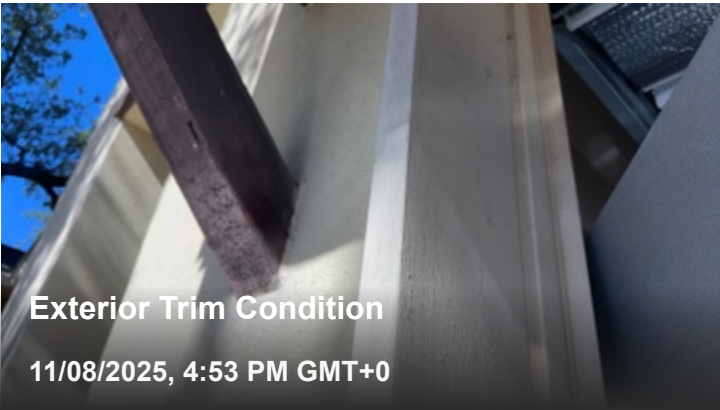
Cracked Mortar

There is cracked mortar on one or more areas of the roof. Recommend repairs or replacing by a qualified professional.

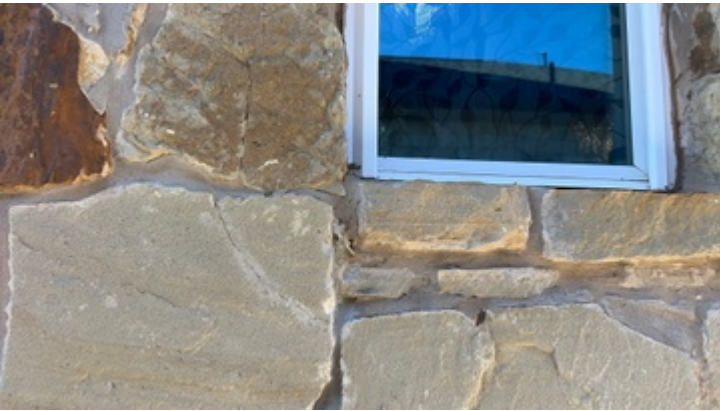
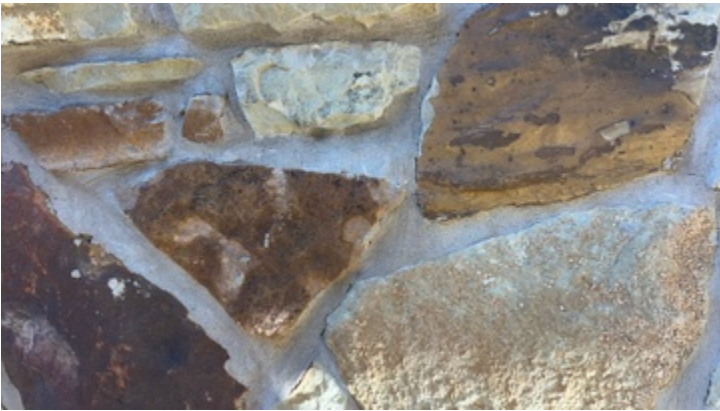
The exterior trim needs to be touched up. Recommend repairs or replacing by a qualified professional.

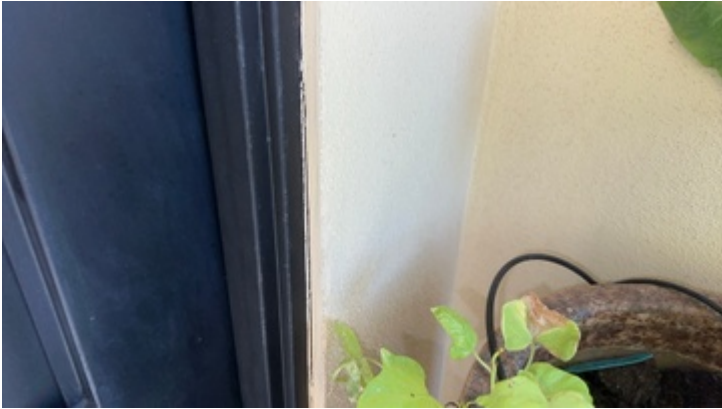
Cracked / Damaged Stucco

The exterior stucco is showing signs of cracking or damage. Recommend repairs or replacing by a qualified professional.

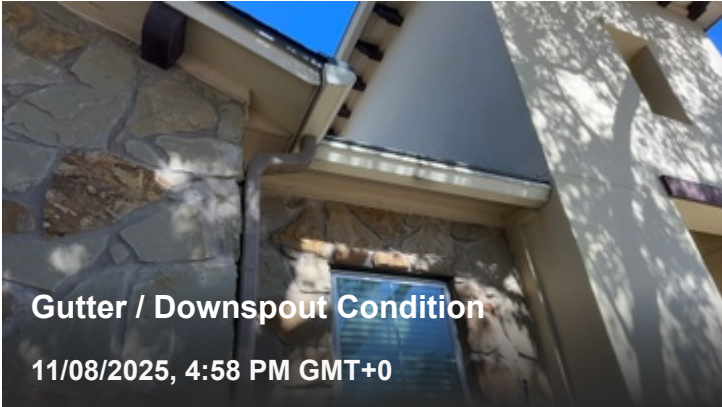
## Missing Downspout Splash Blocks

There are no splash blocks for the downspouts. Recommend repairs or replacing by a qualified professional.

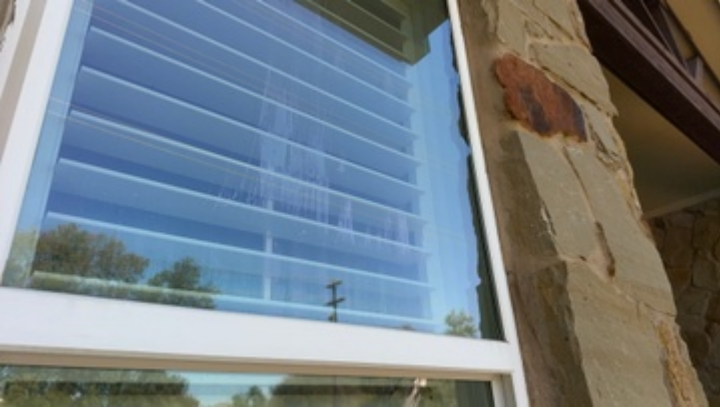
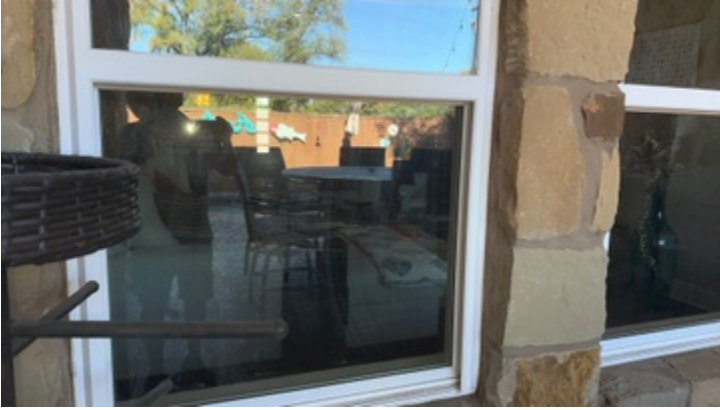
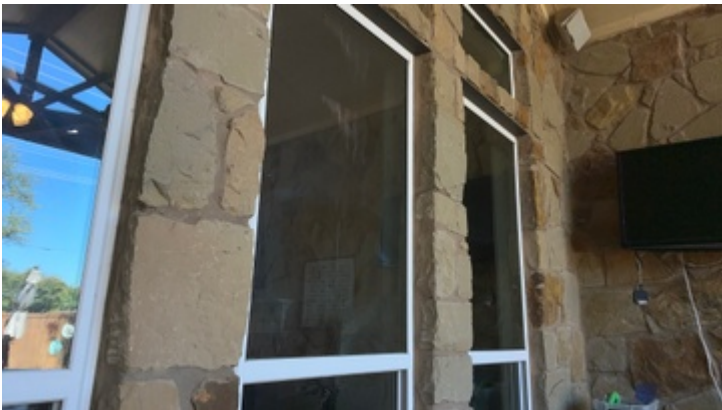
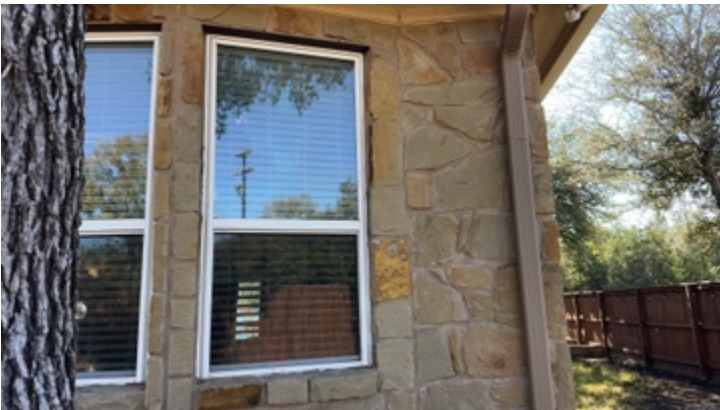
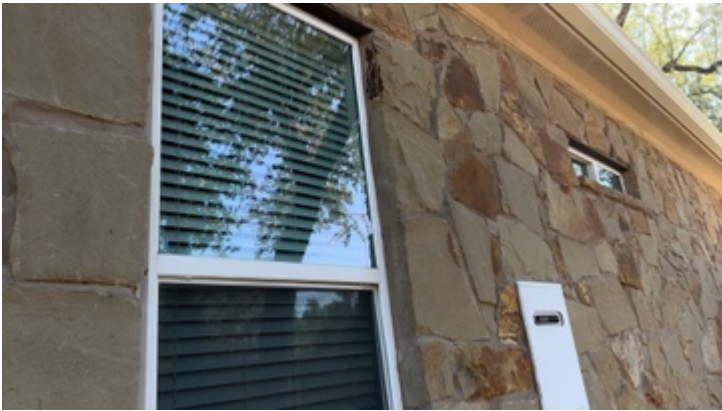
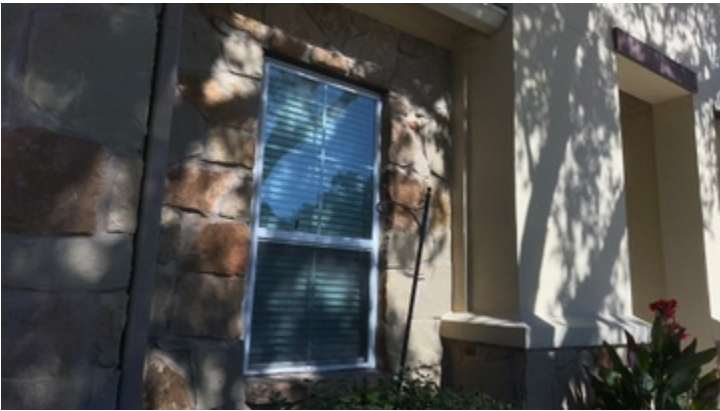
Deteriorated / Failed Window Seal

One or more windows have condensation between the window panes. Recommend repairs or replacing by a qualified professional.

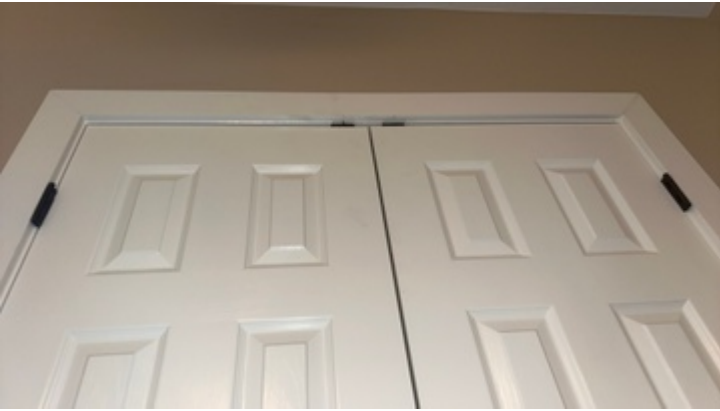
**Door Does Not Latch**

The door does not latch properly. Recommend repairs or replacing by a qualified professional.

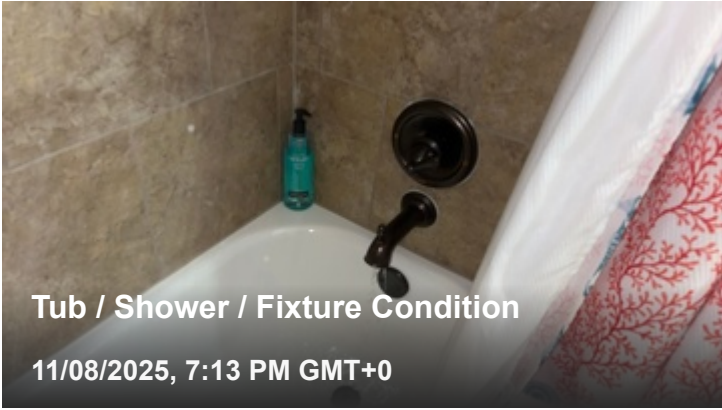
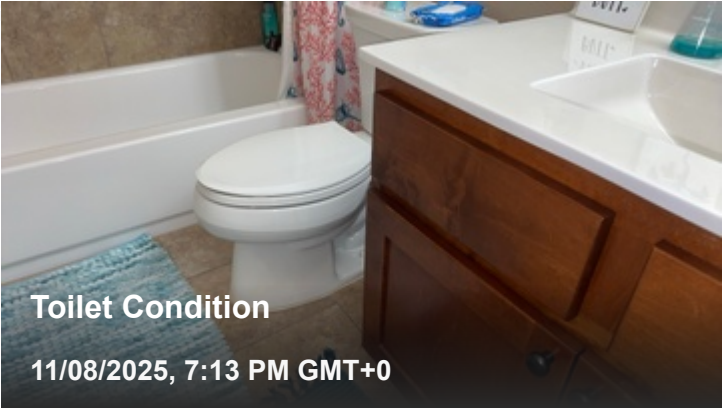
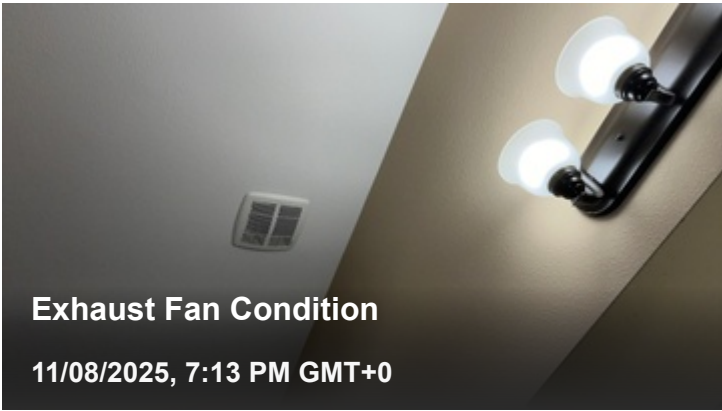
**Repair deficiency**

**Inoperable Shower Diverter Valve**

The shower diverter valve is not working correctly. Recommend repairs or replacing by a qualified professional.

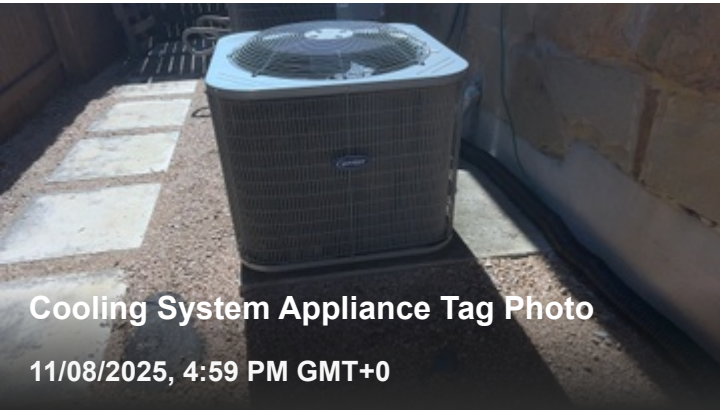
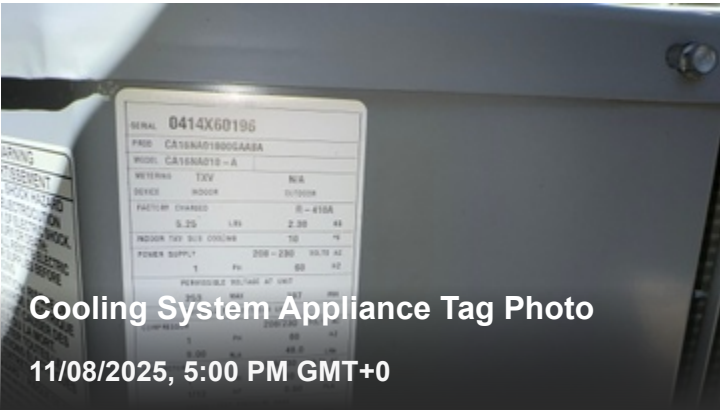
Missing or Damaged HVAC Line Insulation

The refrigerant line insulation is missing or damaged. Recommend repairs or replacing by a qualified professional.

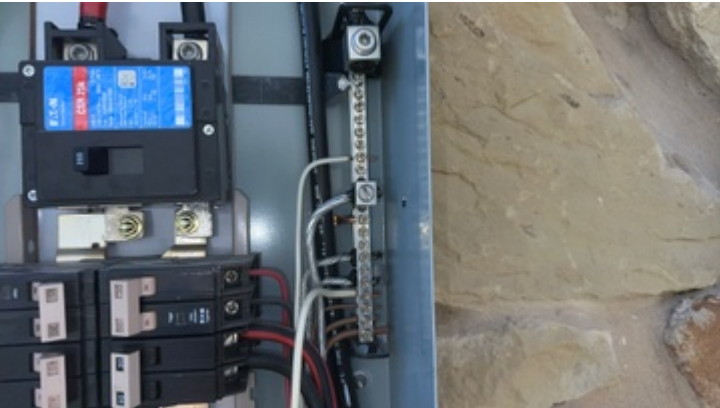
### Bond screw missing

Safety deficiency

The bond screw on the neutral bus bar was missing at the main panel Recommend repairs or replacing by a qualified professional.

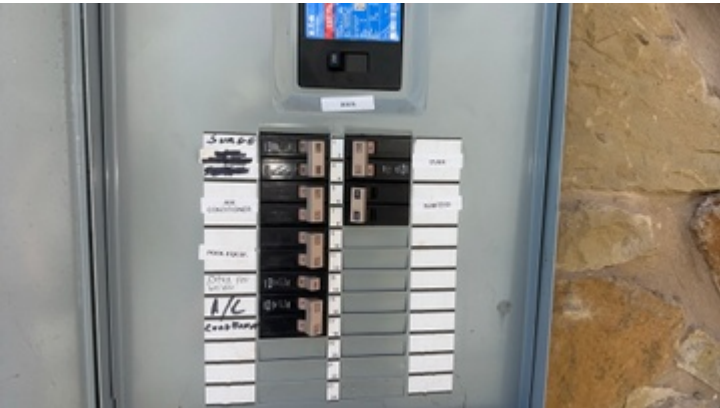
### Missing Surge Protection

Repair deficiency

There is no whole-house surge protection installed. Recommend monitoring this, and further evaluation by a qualified professional.

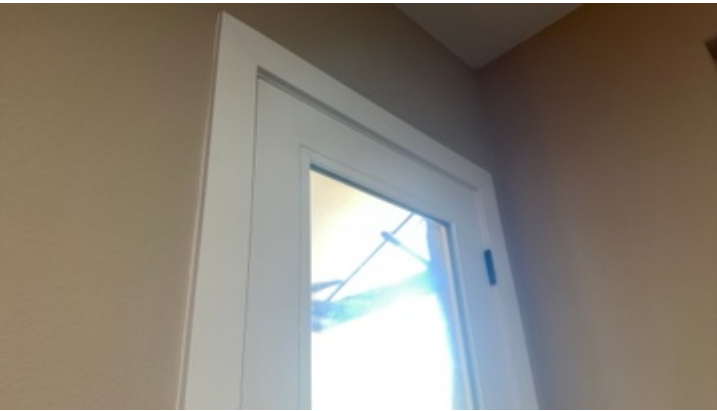
**Safety deficiency**

There is not proper pool alarm devices on exterior doors leading to the pool area Recommend repairs or replacing by a qualified professional.
