# Property Inspection Report

19880 Silverwood Drive, Lake Elsinore, CALIFORNIA 92530

Date of Inspection: 9/25/2026 Time: 01:00PM

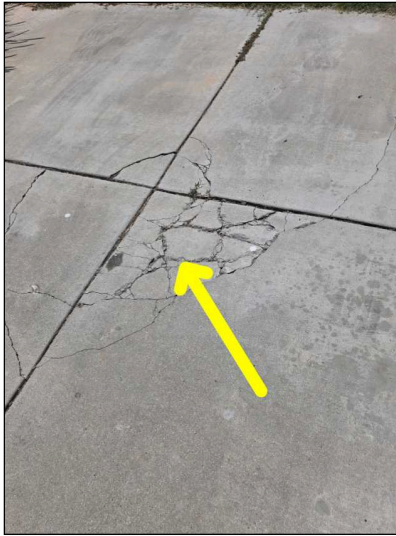
| Page 33 Item: 6 | Driveway/Walkway/Patio Condition | 6.1. Cracks and damage observed. Repair and / or monitor for expansion and development of trip hazards. |

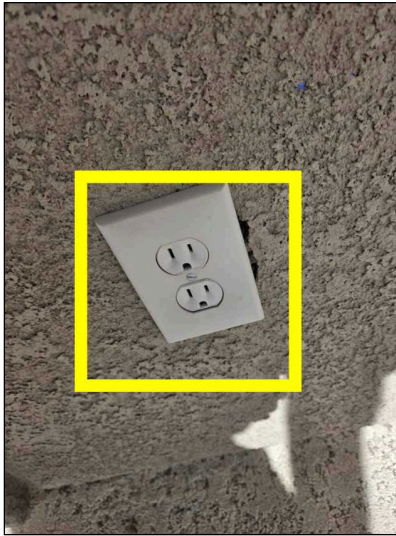
| Page 35 Item: 11 | Grounds Electrical | 11.1. One or more exterior outlet receptacles/light switches must be protected and in a waterproof cover. |

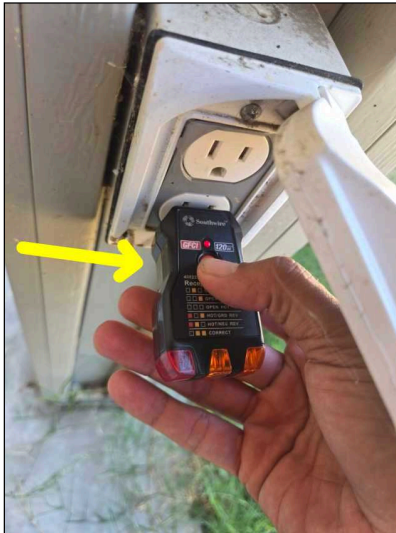
Page 35 Item: 12 GFCI

12.1. Some exterior outdoor **GFCI** outlet receptacles did not respond when tested with electrical outlet tester. Specifically the patio cover one. pose a potential safety shock hazard. Seek a licensed electrical contractor for further evaluation and repairs.

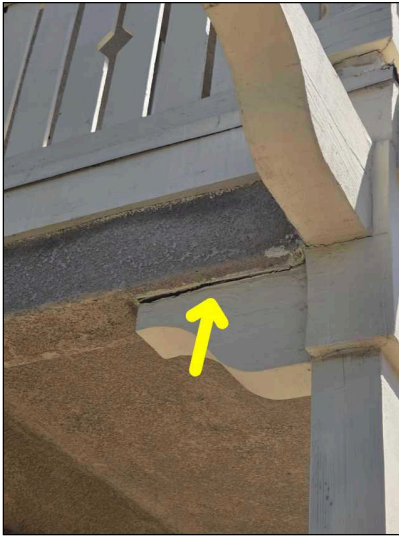
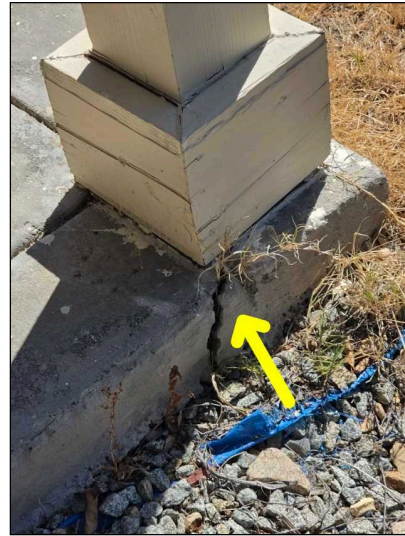
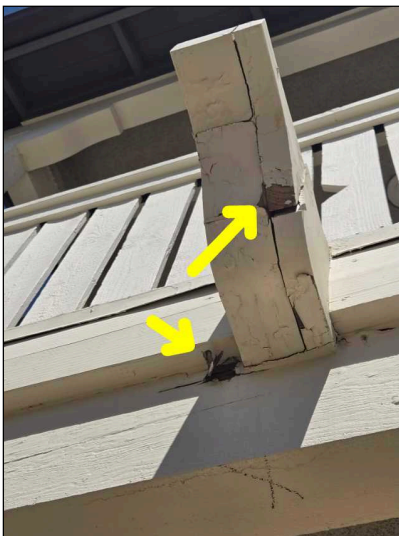
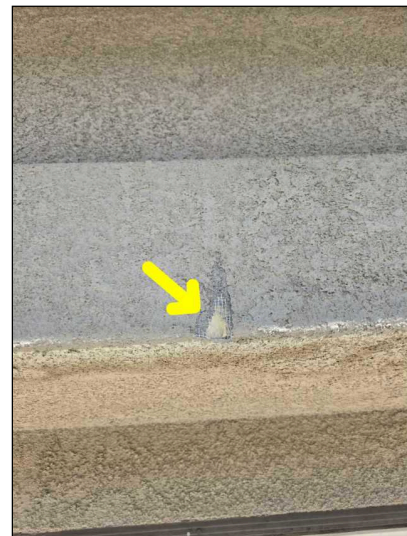
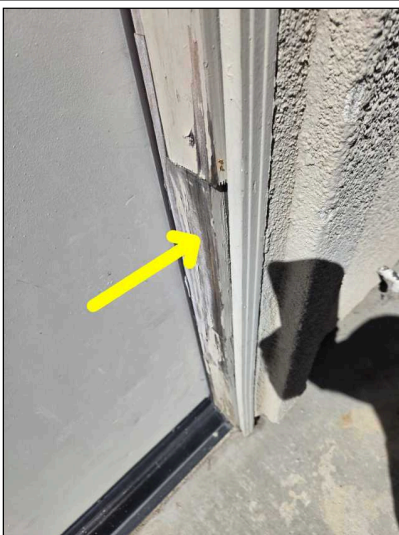
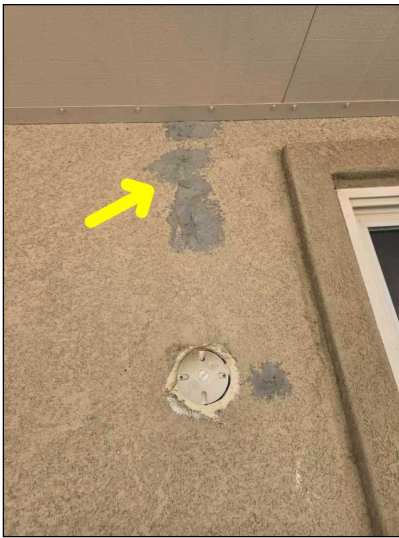
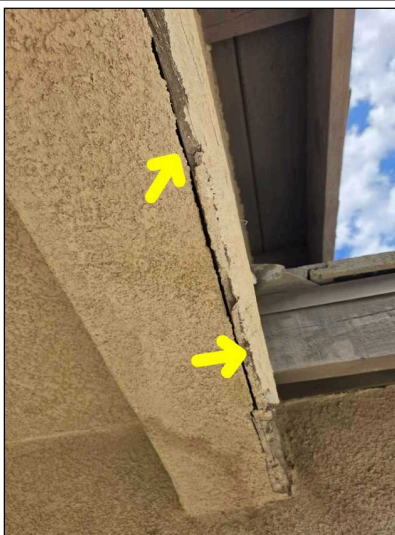
| Page 39 Item: 1 | Siding Condition | 1.2. Observed multiple cosmetic based defects at the exterior area. See photos. Recommend correction as needed |

Separation

Paint needed

Deterioration

Stucco needed

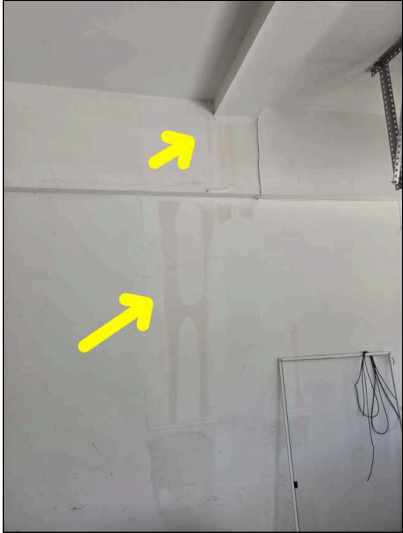
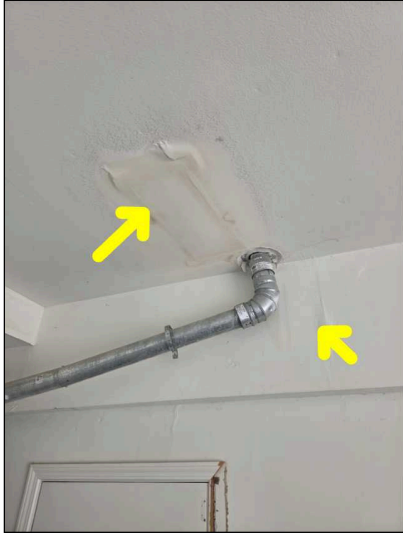
| Garage | | |
|---|---|---|
| Page 42 Item: 1 | Common Observations | 1.2. Observed staining in the garage area. Unable to determine cause however there is a water source above. Recommend further evaluation as needed. |

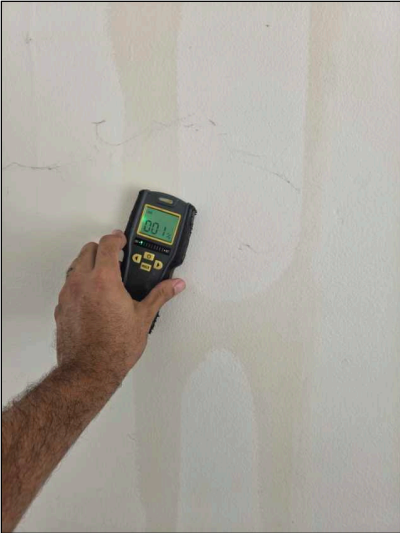
| Garage | | |
|---|---|---|
| <div><div>A photograph showing a hand holding a digital moisture meter against a white wall. The meter's screen displays '00.1'.</div><div>No active moisture</div></div> | | |

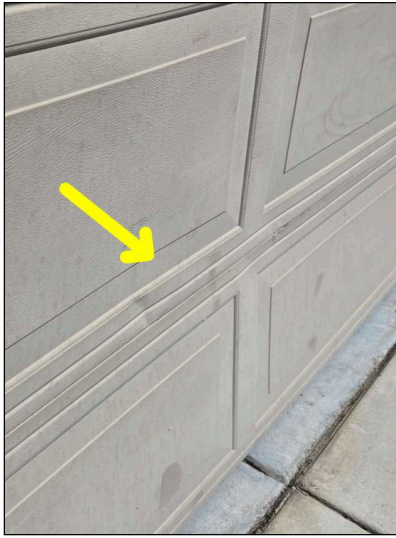
| Garage | | |
|---|---|---|
| Page 45 Item: 2 | Garage Door Condition | 2.2. The front garage door is damaged. Observed the garage door Dented. Conditions are susceptible to further damage and failure. Seek a qualified license garage door contractor for further evaluations and repairs. |

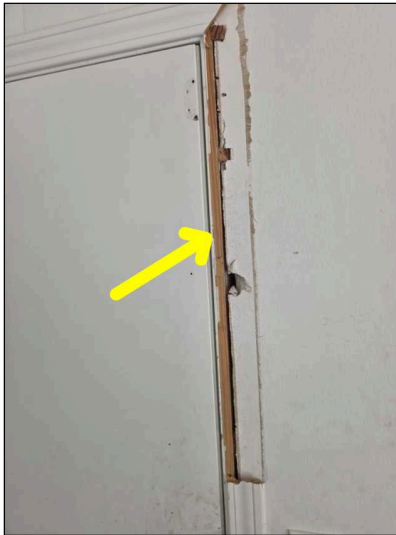
| Page 46 Item: 4 | Exterior Door | 4.1. Trim damage observed. Recommend correction |

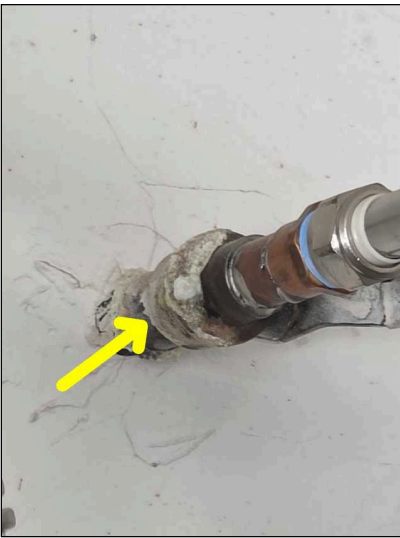
| Page 52 Item: 8 | Plumbing | 8.1. There are signs of oxidation and corrosion located at the cold copper water pipe installed onto the gas water heater. This is susceptible to water leaking. Seek a licensed plumbing contractor for further evaluation and repairs. |

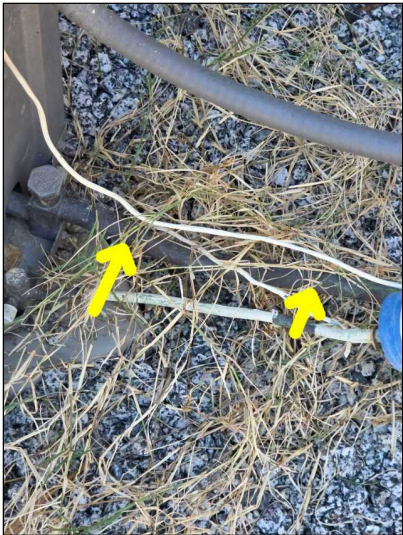
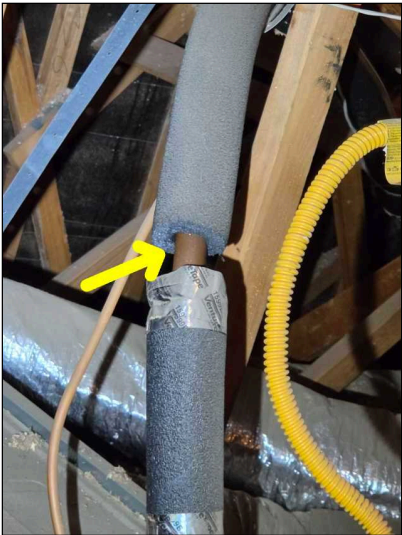
| Page 58 Item: 8 | Refrigerant Lines | 8.1. Missing insulation in areas around refrigerant line. Seek a licensed HVAC contractor for further evaluations and repairs. |

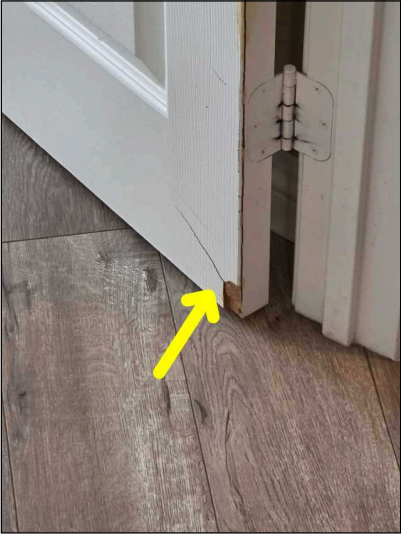
| Page 74 Item: 6 | Doors | 6.1. Damage observed. Recommend correction |

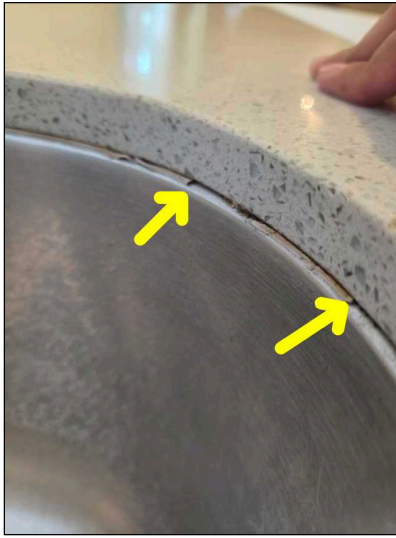
Page 87 Item: 4    Sinks    4.2. Caulking and sealants recommended around the sink perimeter and at all seam joints to prevent moisture intrusion.

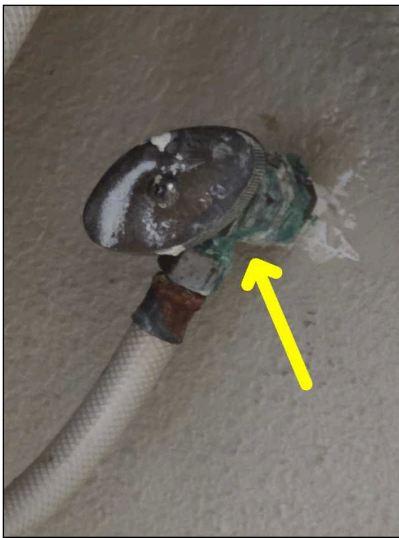
Page 88 Item: 5

5.1. Observed signs of oxidation at one or more plumbing fixtures underneath the sink area. This is indicative of a previous leak that has sealed itself. Recommend replacing these valves to prevent future leaks using a licensed plumber.

5.2. Active leaking noted at the water line just below the faucet below the sink areas. Advise further evaluation and repair by a licensed plumber or qualified professional.

leak

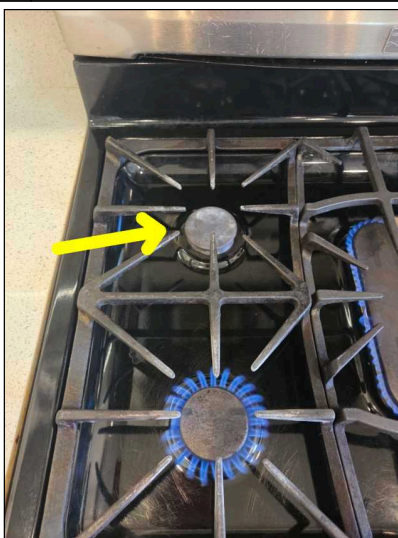
Cook top  
condition

7.1. 1 oven burner did not fully ignite during time of inspection. Refer to the sellers to advise and seek further evaluations and repairs by a licensed appliance contractor.

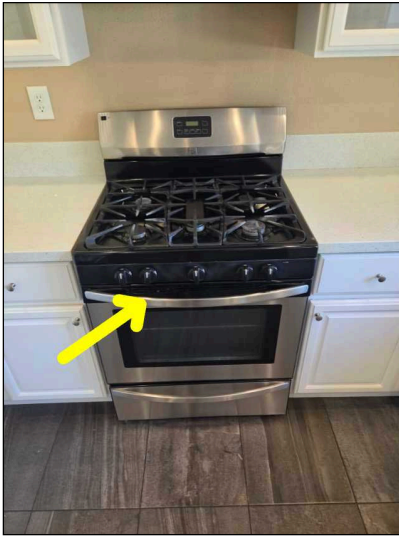
Page 90 Item: 8

8.2. CAUTION: The oven/range is not equipped with an anti-tip device, which prevents the range from tipping, or its contents from spilling, should a child attempt to climb on it or its open door. This is a recommended safety feature that should be installed, and particularly if small children occupy or visit the residence.

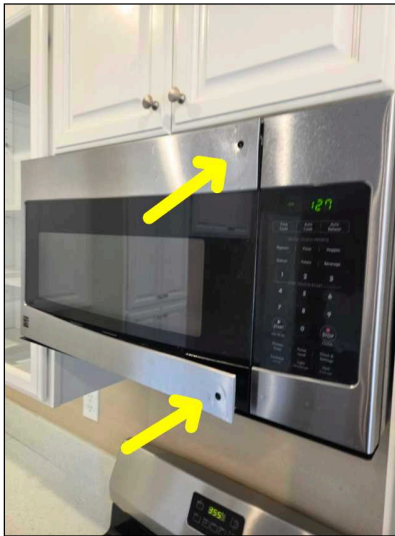
Page 90 Item: 9    Microwave

9.1. Observed damage to the outside of the microwave.  
Correction or repair recommended.

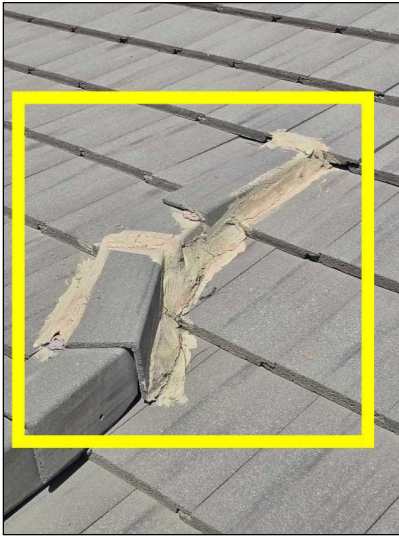
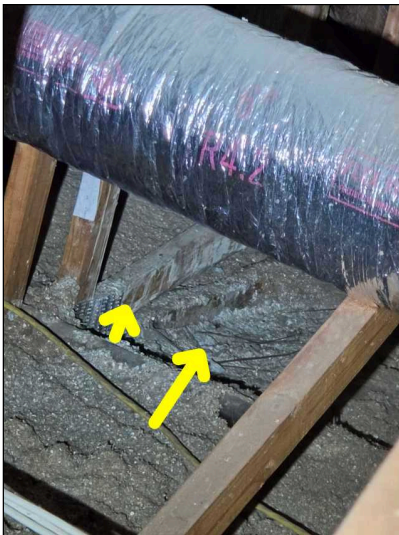
Page 95 Item: 3    Structure

3.1. There is an area on the roof where the various level transition appears to have been previously repaired. From inside the attic space there has been visual moisture intrusion and daylight shining through. Recommend further evaluation by a licensed roofing contractor

Evidence of moisture intrusion

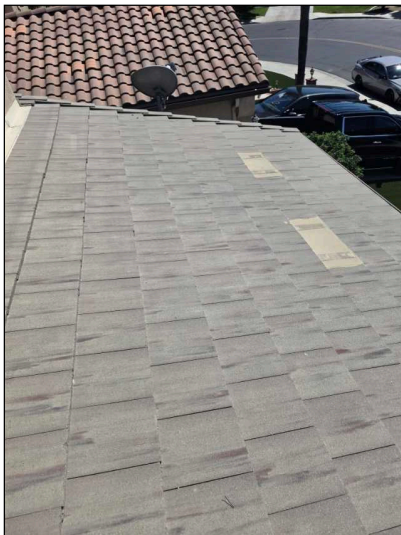
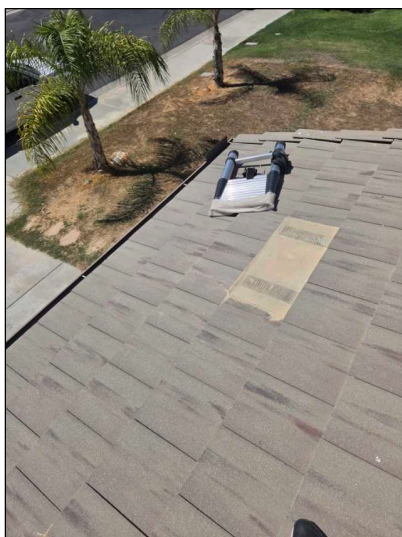
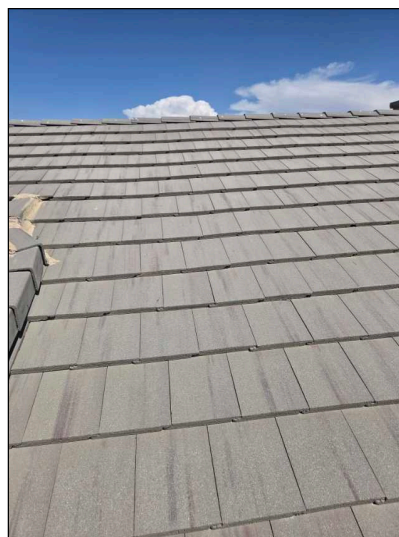
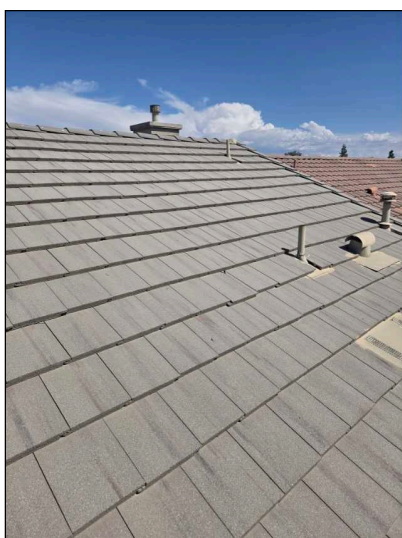
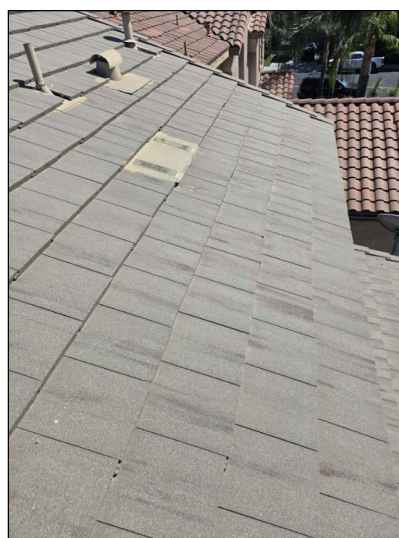
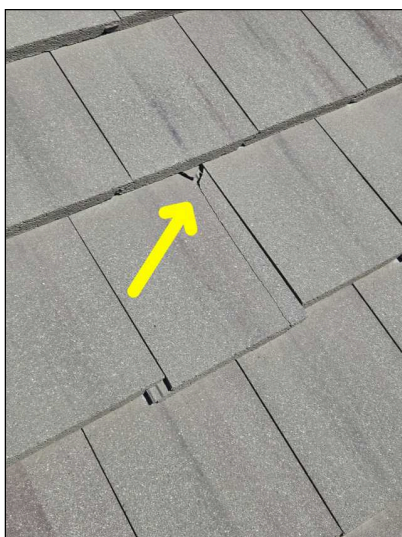
1.2. 1 cracked and slipped tiles observed on the roof system. Recommend correction by a licensed roofing contractor

Slipped

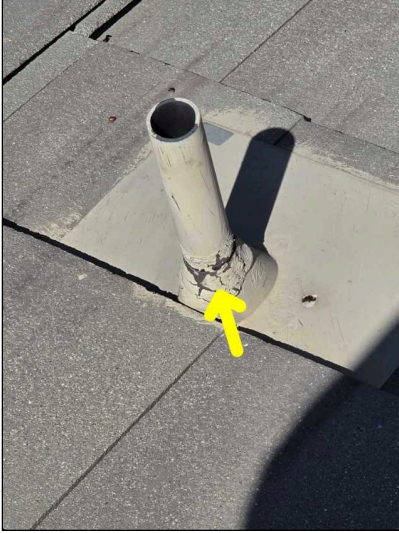
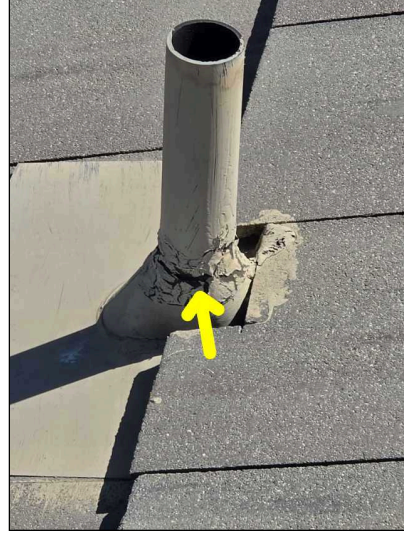
2.1. Recommend re-sealing all through the roof vents, flashings, and roof projections as a part of routine maintenance. Cracking around plumbing vents observed.

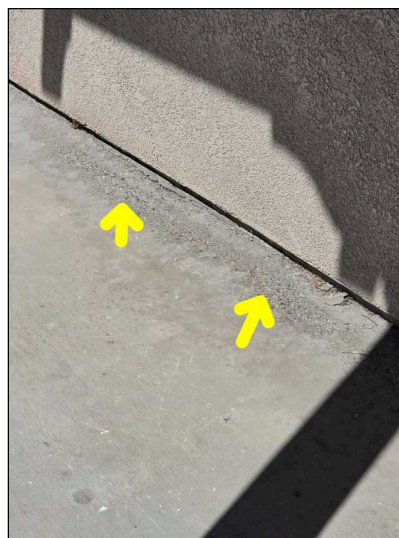
Minor deterioration

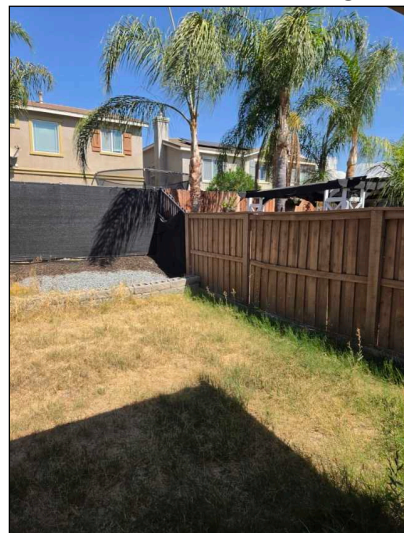
Potential for ponding water

7.3. Drainage on this property is solely dependant on soil-percolation and hard surfaces, and there are no area drains. Such conditions are not ideal, and water may pond at various points during prolonged rains. Therefore, you may wish to have a specialist evaluate, but we did not see any evidence of moisture contaminating the living space.

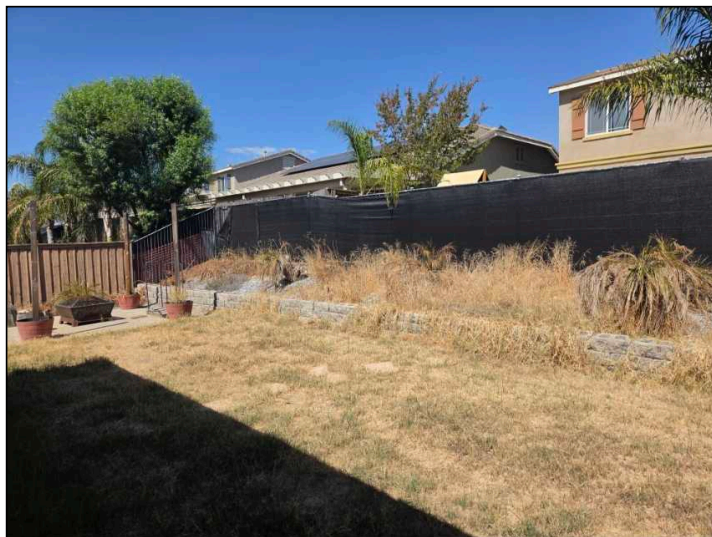
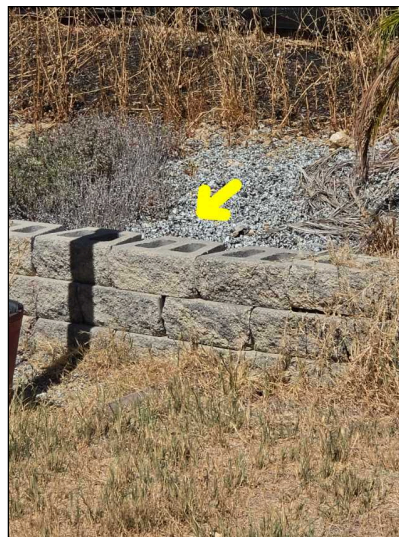
No cap pieces

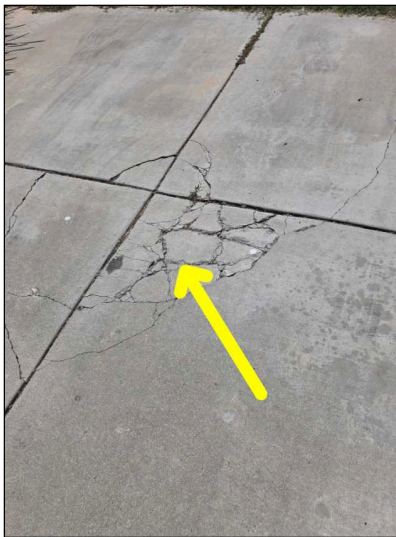
6.1. Cracks and damage observed. Repair and / or monitor for expansion and development of trip hazards.

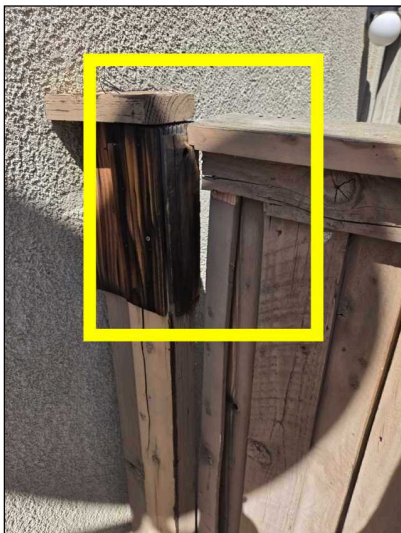
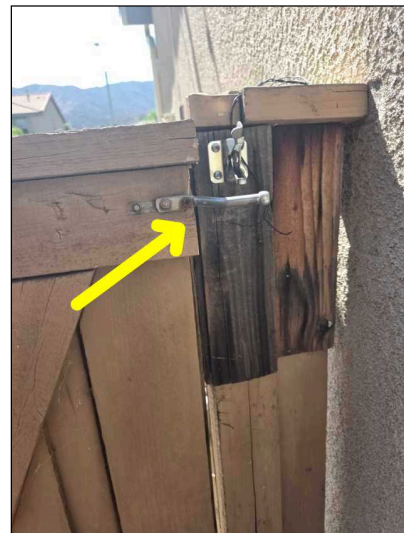
8.1. Damaged gate observed. Not fully functional. Recommend repair or replacement.

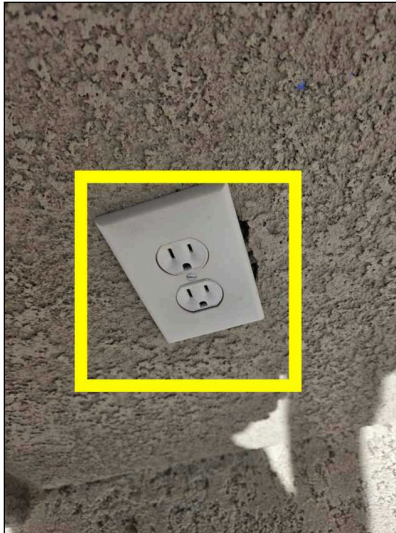
11.1. One or more exterior outlet receptacles/light switches must be protected and in a waterproof cover.

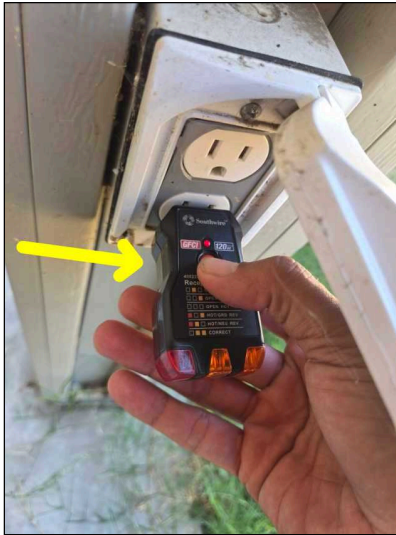
12.1. Some exterior outdoor **GFCI** outlet receptacles did not respond when tested with electrical outlet tester. Specifically the patio cover one. pose a potential safety shock hazard. Seek a licensed electrical contractor for further evaluation and repairs.

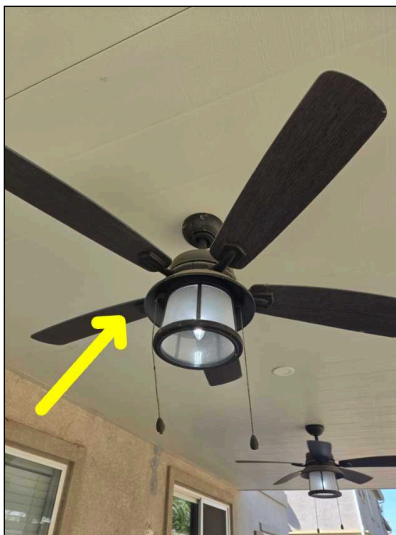
14.2. One ceiling fan was not functional. Recommend correction by a licensed contractor

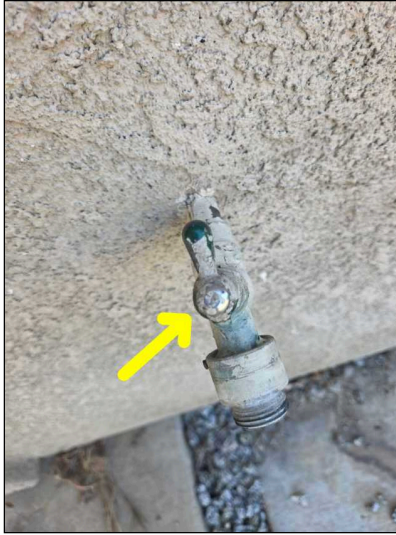
Broken faucet handle. Recommend correction

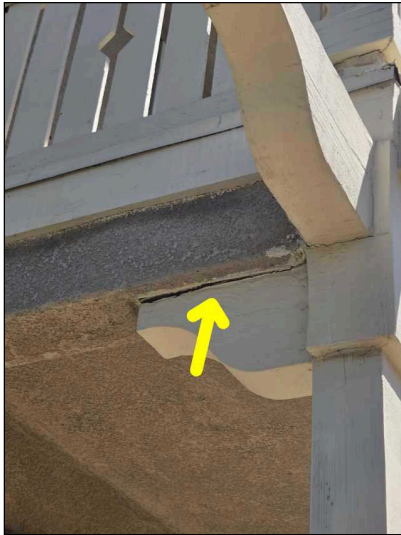
1.2. Observed multiple cosmetic based defects at the exterior area. See photos. Recommend correction as needed

Separation

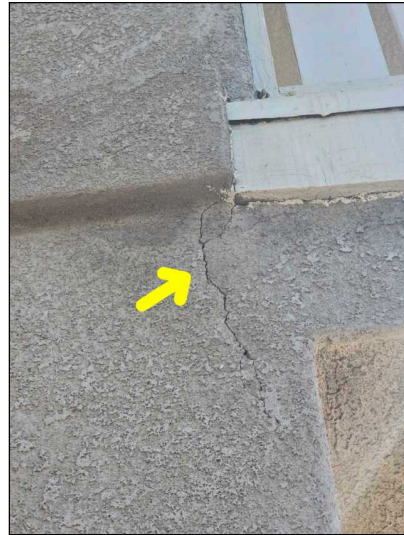
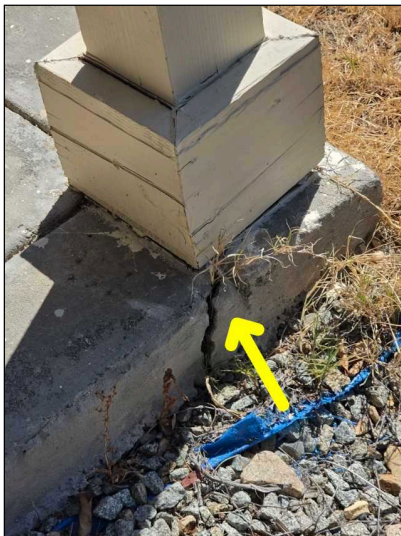
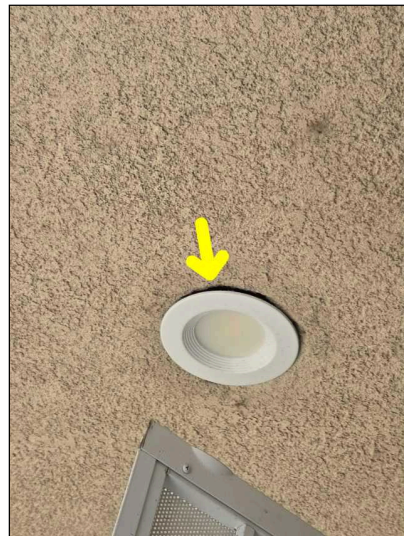
Minor gapping

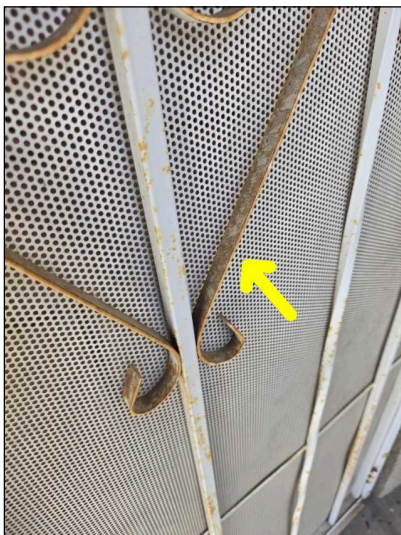
Rust

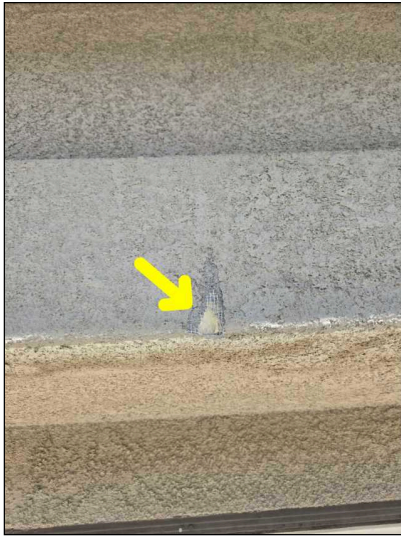
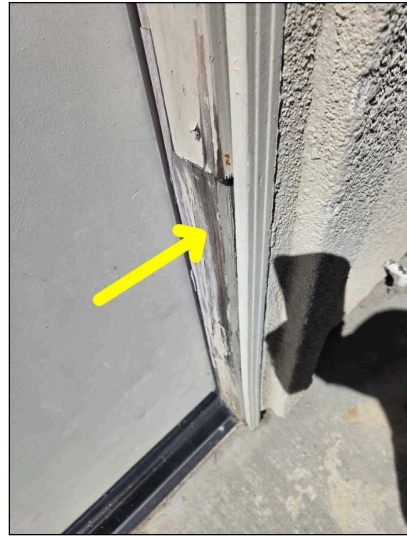
Paint needed

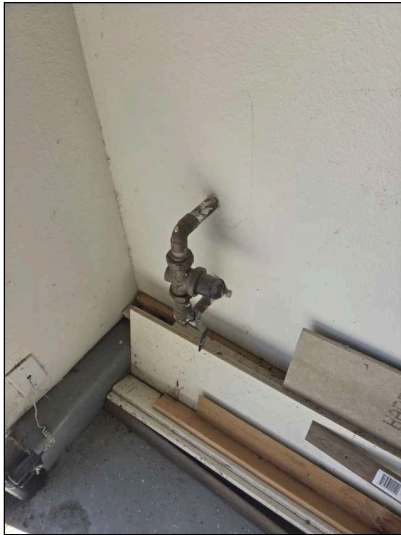
Weird vibration noise at water meter and secondary

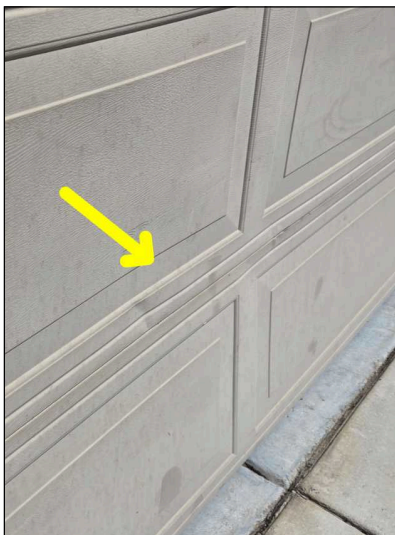
2.2. The front garage door is damaged. Observed the garage door Dented. Conditions are susceptible to further damage and failure. Seek a qualified license garage door contractor for further evaluations and repairs.

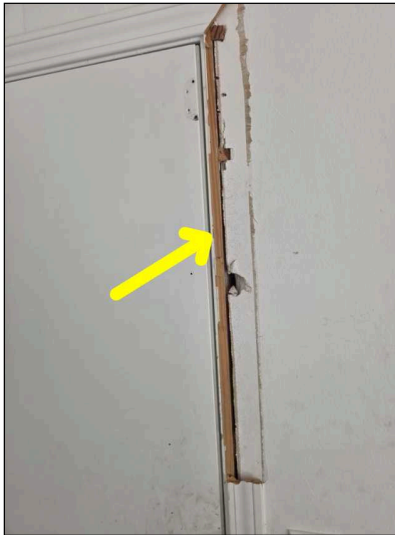
4.1. Trim damage observed. Recommend correction

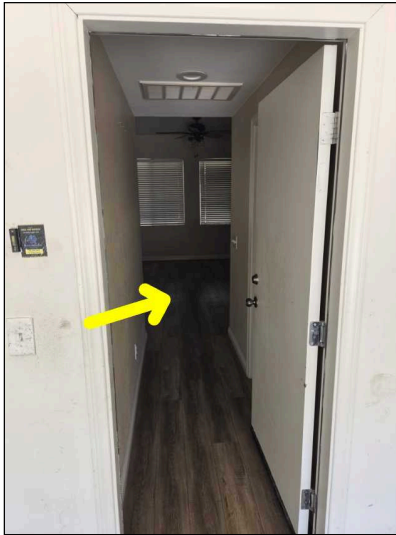
5.1. The house entry door is not fully self-closing and is required to be, to maintain the necessary firewall separation between a garage and living quarters, and will need to be serviced. Recommend replacement of proper hinge to spring closed

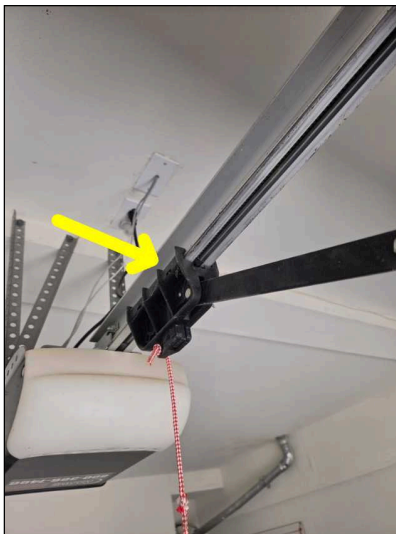
8.1. Vibration/noise observed at chain drive. Lubrication is more than likely the solution.  
Recommend correction

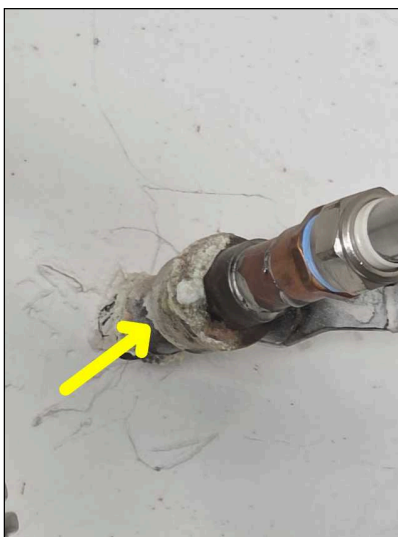
8.1. There are signs of oxidation and corrosion located at the cold copper water pipe installed onto the gas water heater. This is susceptible to water leaking. Seek a licensed plumbing contractor for further evaluation and repairs.

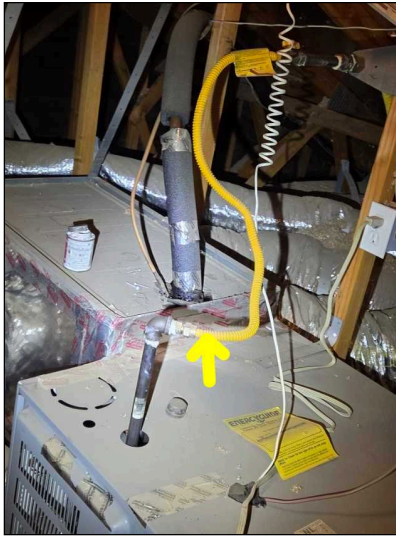
4.2. The furnaces are not equipped with a sediment trap drip leg. This may not have been required when the furnace was installed but current standards require a drip leg at the gas connection. Seek licensed plumbing contractor for repairs.

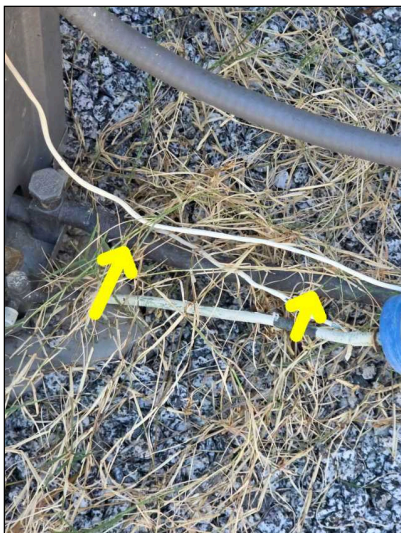
8.1. Missing insulation in areas around refrigerant line. Seek a licensed HVAC contractor for further evaluations and repairs.

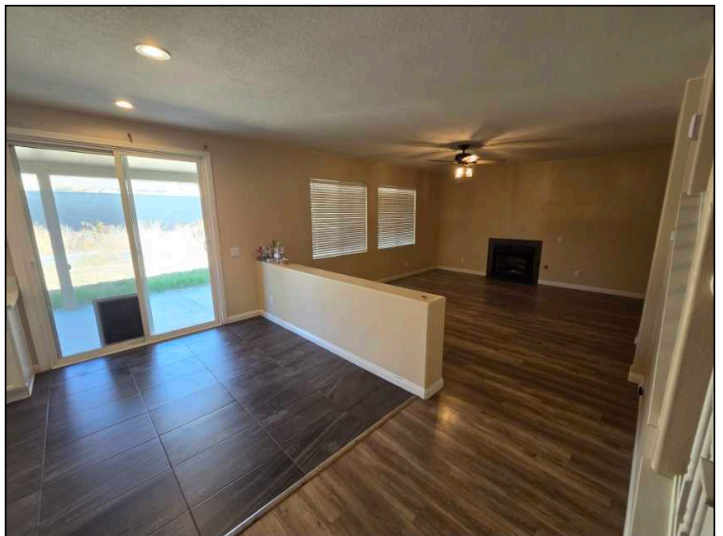
Recommend cleaning

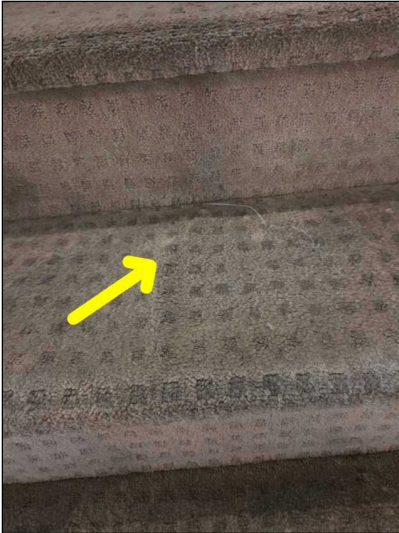
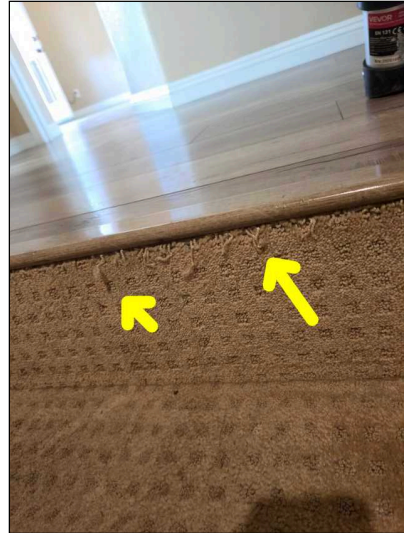
7.1. Carpet on stairs approaching end of life. Recommend correction and cleaning

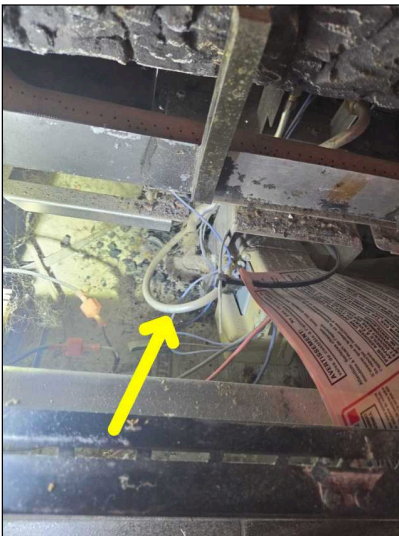
9.3. Hearth should extend 16 inches. Only 12 observed. Be advised

9.4. Missing glass doors on the fireplace. Recommend correction

9.5. The fireplace did not function with the switch or components within. This does not mean they are broken however it takes a particular professional to get up and running. Recommend correction

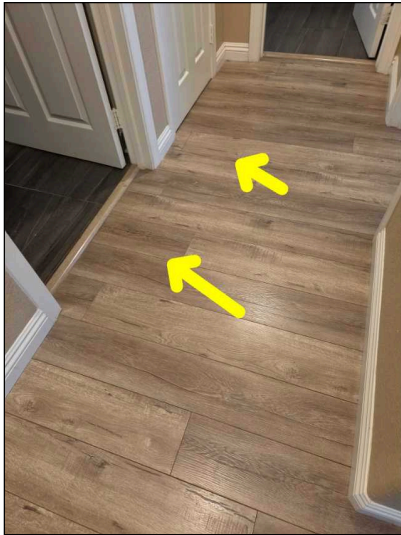
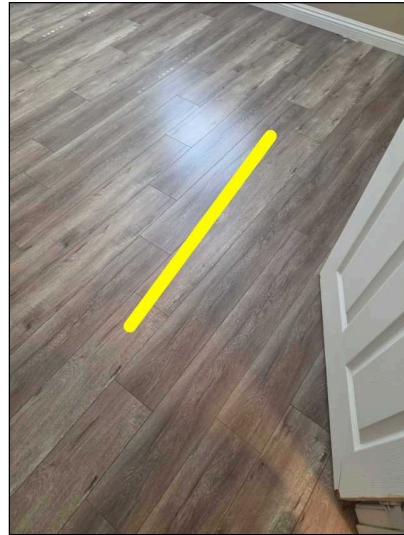
2.2. Unlevel area observed in 1 of the rooms and hallway area. Unable to determine cause. Monitor or correct as needed.

Unlevel

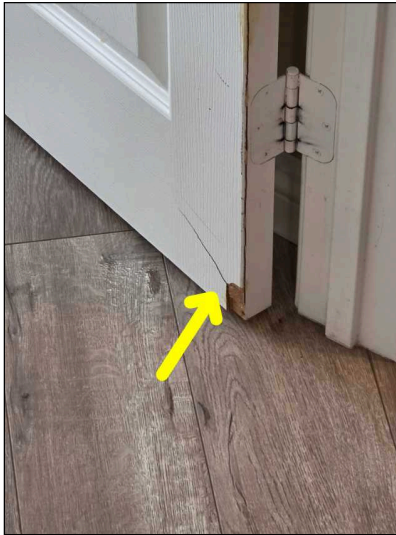
6.1. Damage observed. Recommend correction

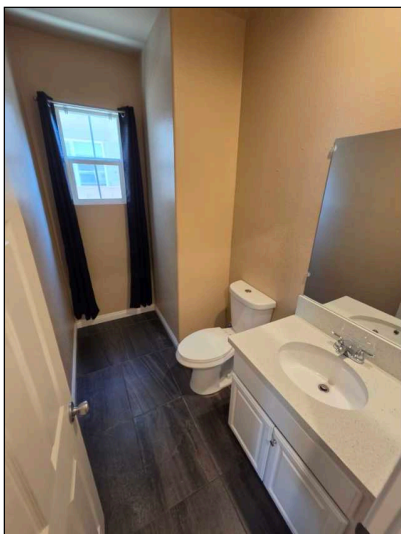
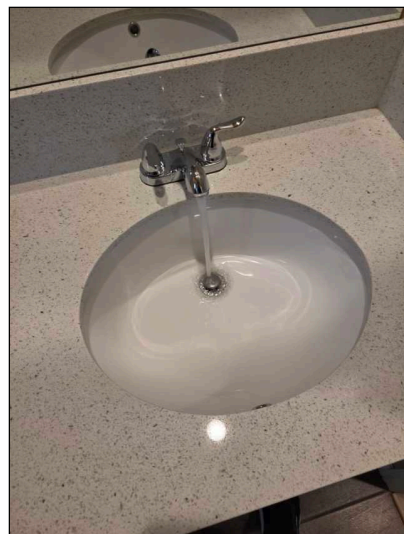
1.2. Minor cosmetic related items observed. See photos with arrows. Recommend correction

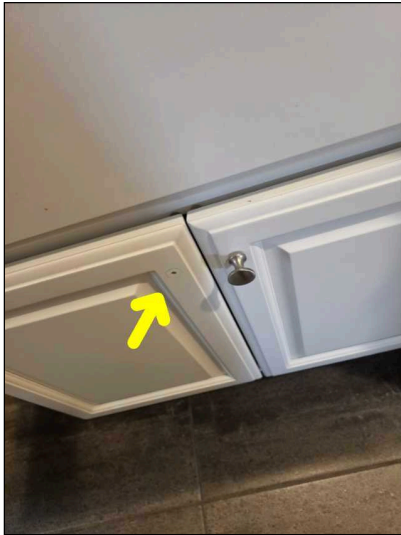
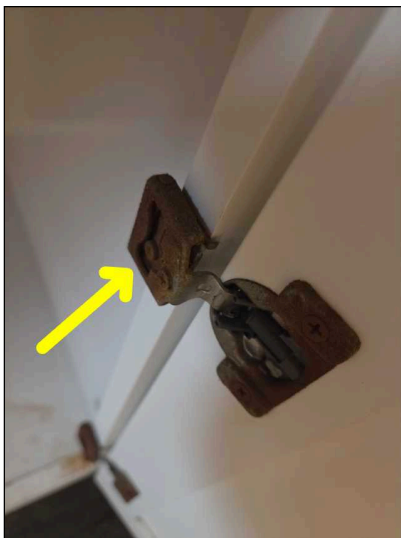
Rust

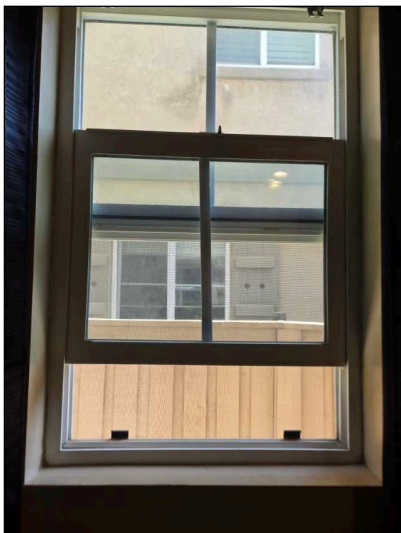
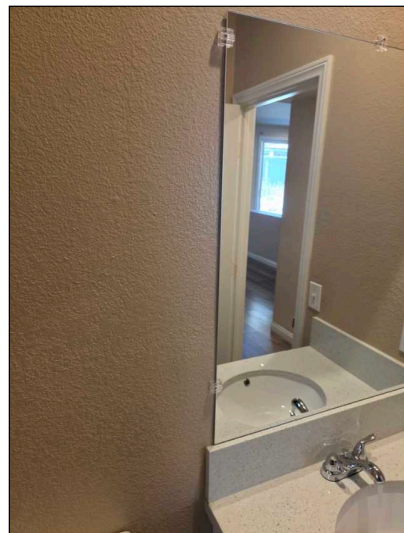
Plumbing knock

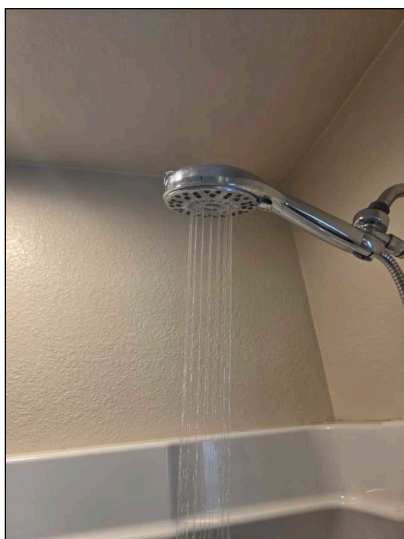
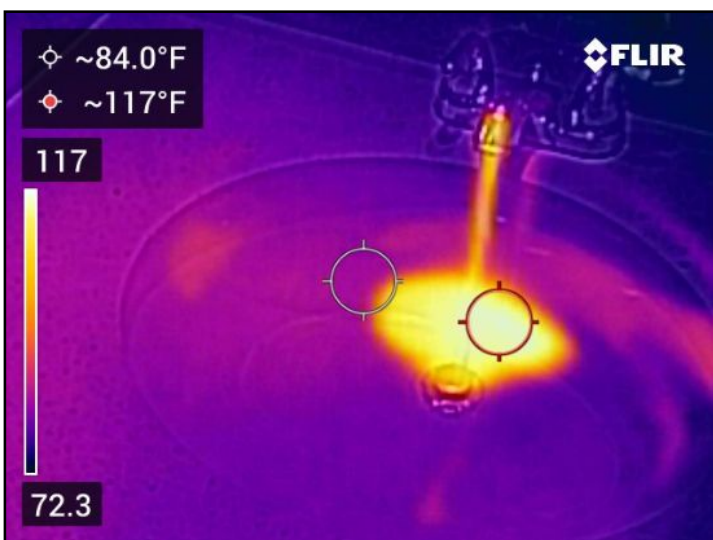
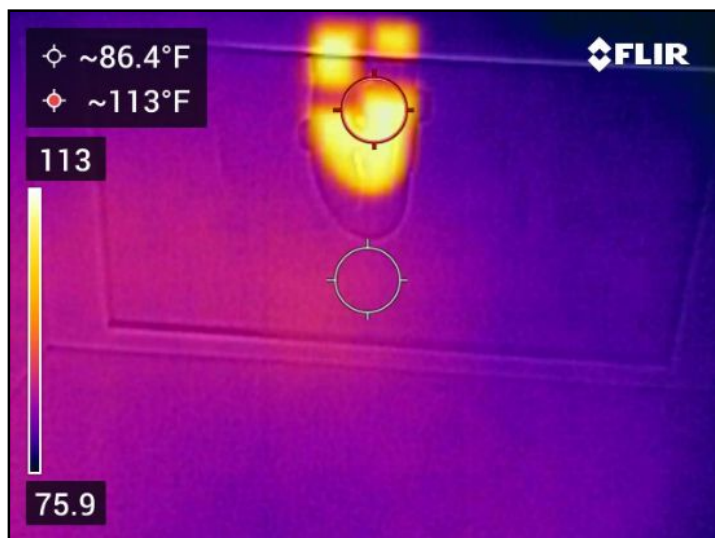
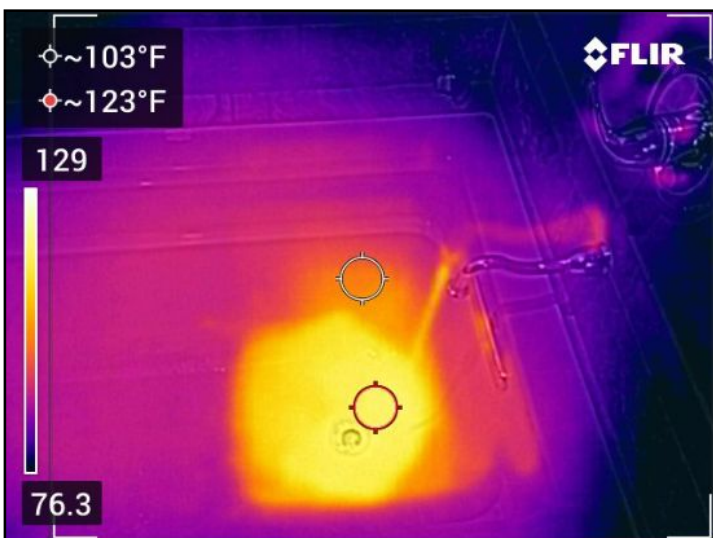
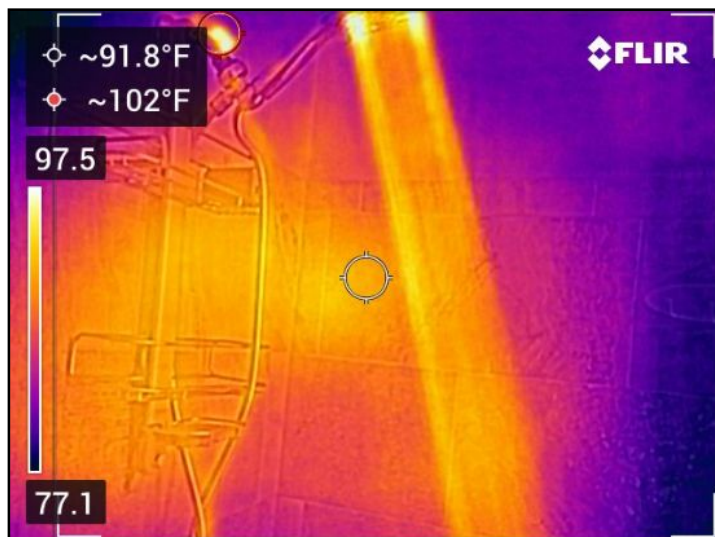
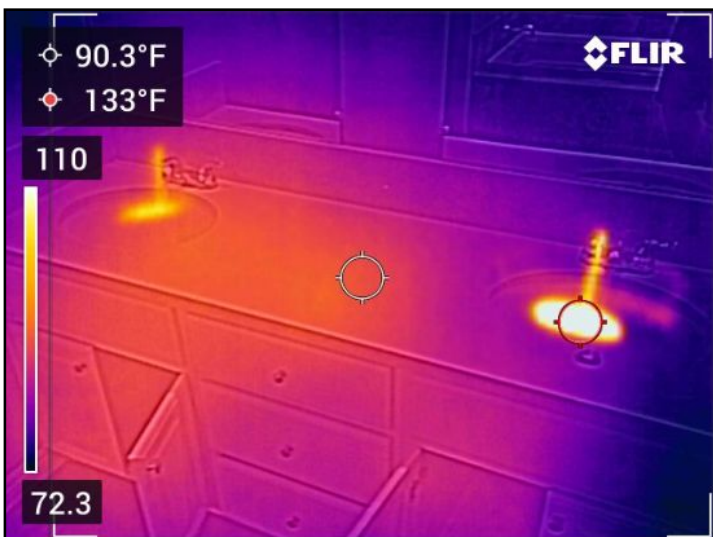
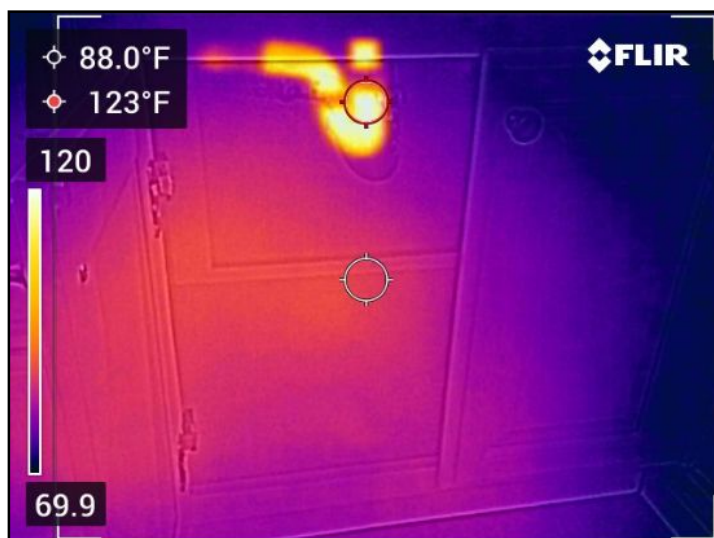
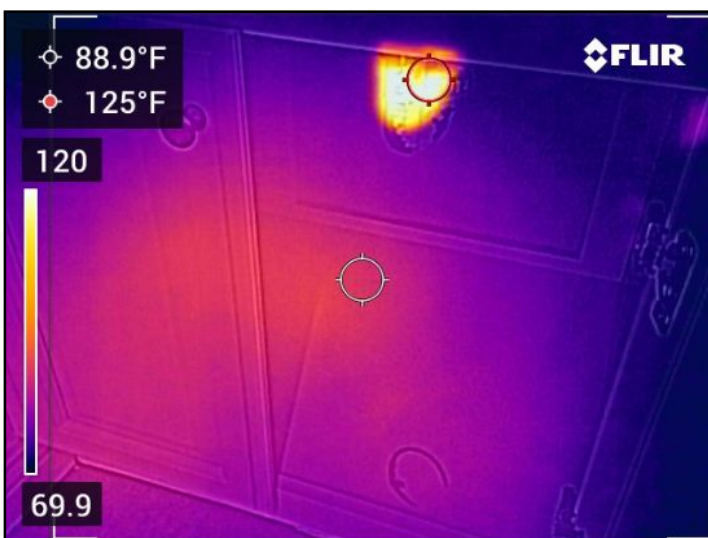
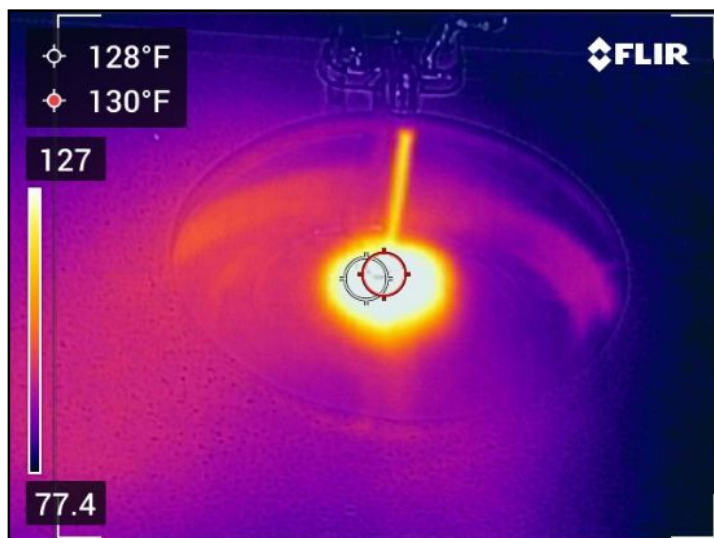
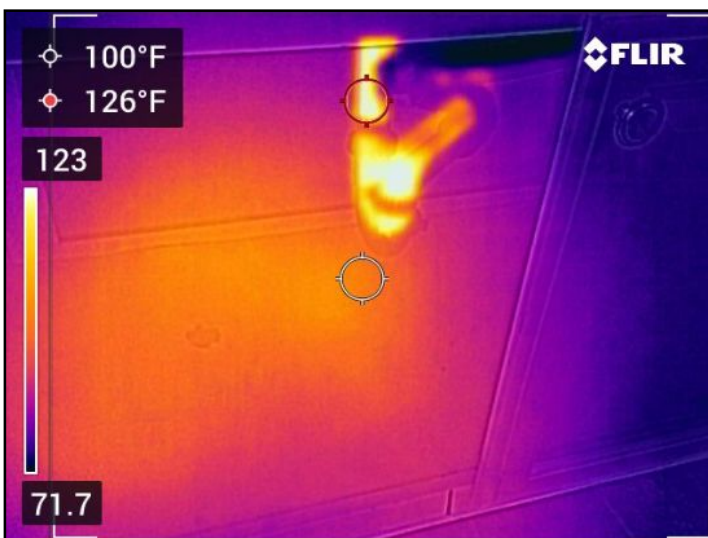
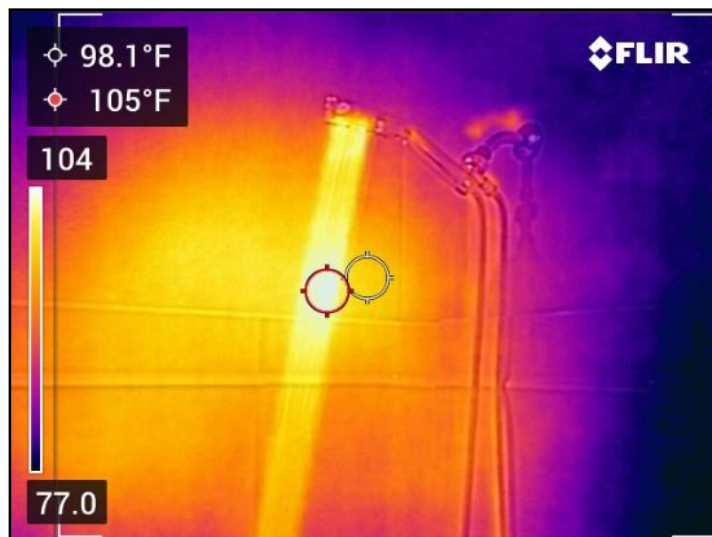
Improperly installed

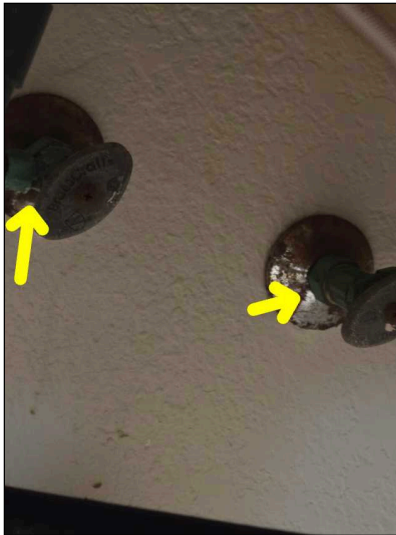
3.2. Supply lines show signs of corrosion in various locations under the sinks and toilets. This is susceptible to water leaks and moisture intrusion. Refer to a licensed plumbing contractor for repairs.

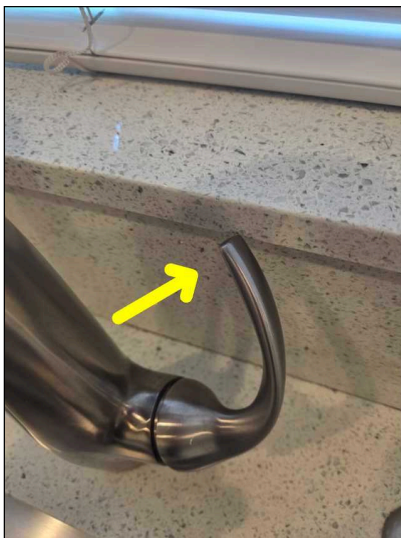
Touches counter

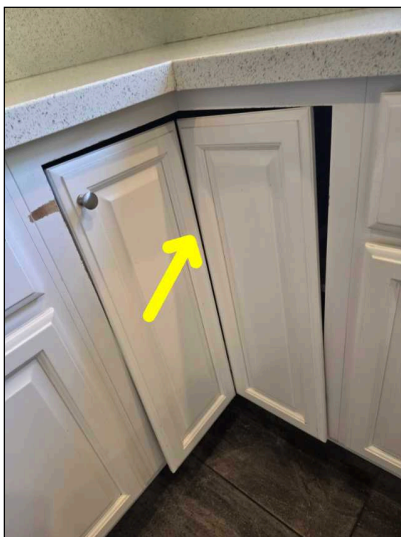
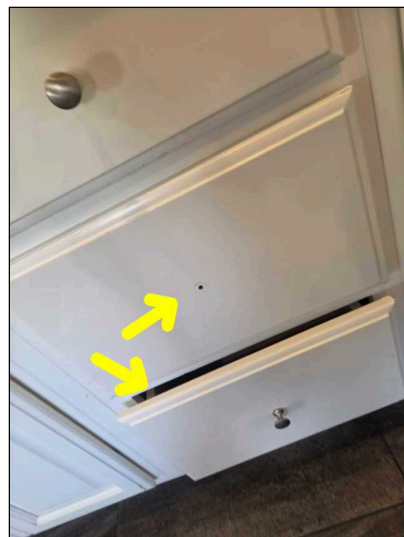
3.1. Service needed in multiple places.
