# Property Inspection Report

19880 Silverwood Drive, Lake Elsinore, CALIFORNIA 92530

Date of Inspection: 9/25/2026 Time: 01:00PM

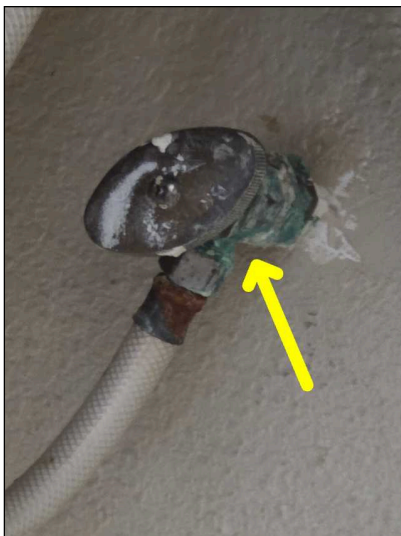
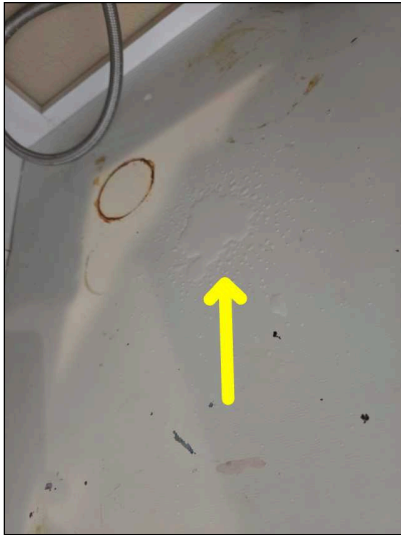
5.2. Active leaking noted at the water line just below the faucet below the sink areas. Advise further evaluation and repair by a licensed plumber or qualified professional.

leak

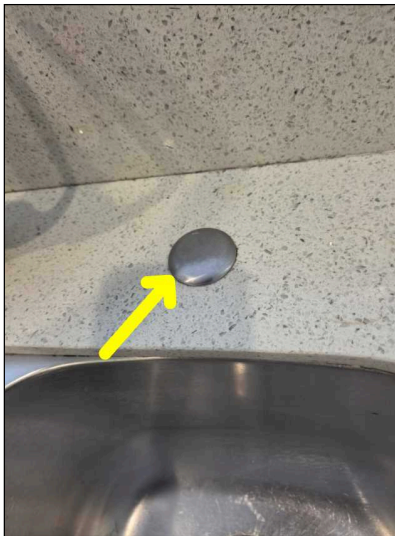
6.2. Missing **air gap** overflow observed at the dishwasher drain line. Air gap overflow devices help prevent outgoing water from re-entering the dishwasher. Recommend correcting and advise repair by a licensed professional. Look into high loop options

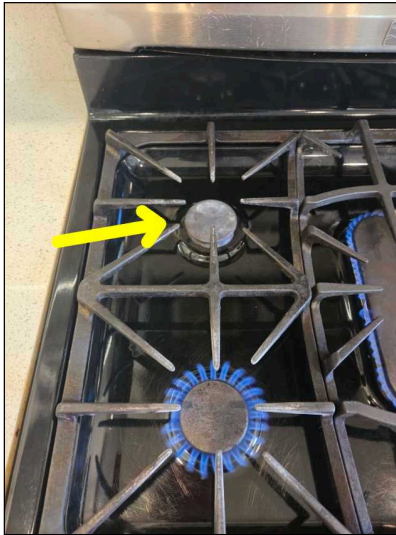
7.1. 1 oven burner did not fully ignite during time of inspection. Refer to the sellers to advise and seek further evaluations and repairs by a licensed appliance contractor.

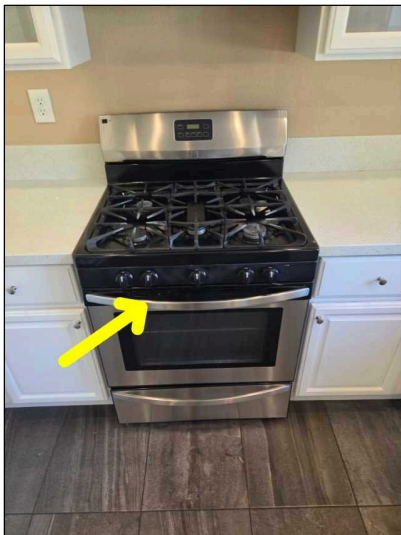
8.2. CAUTION: The oven/range is not equipped with an anti-tip device, which prevents the range from tipping, or its contents from spilling, should a child attempt to climb on it or its open door. This is a recommended safety feature that should be installed, and particularly if small children occupy or visit the residence.

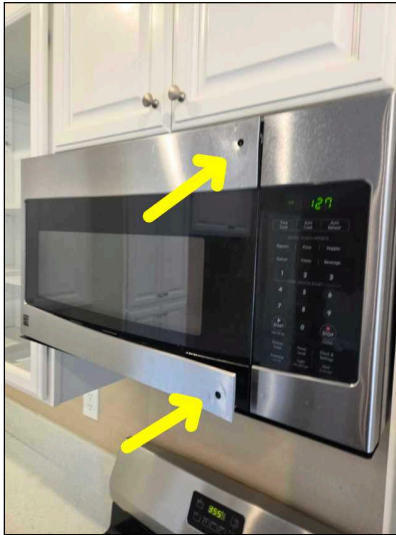
9.1. Observed damage to the outside of the microwave. Correction or repair recommended.

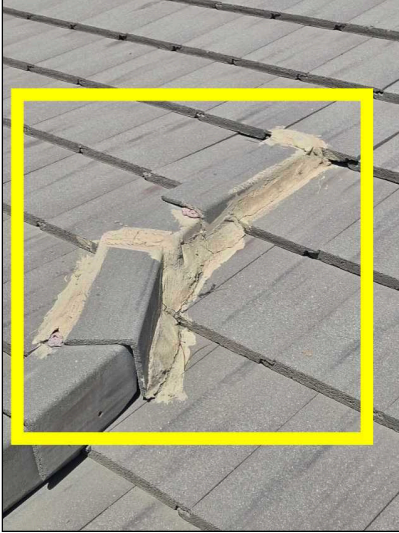
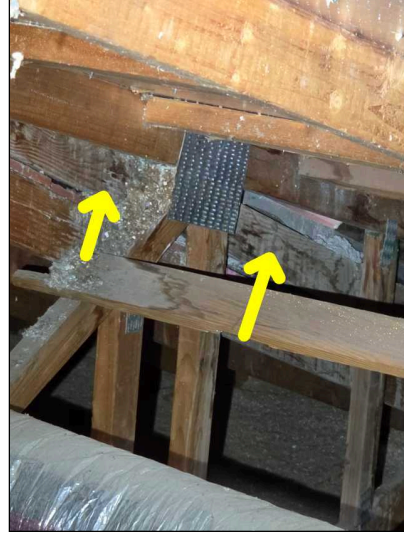
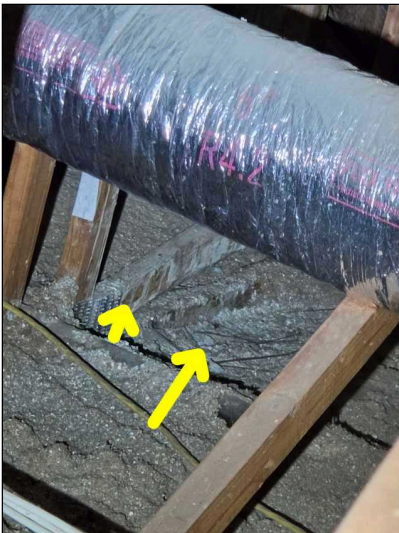
3.1. There is an area on the roof where the various level transition appears to have been previously repaired. From inside the attic space there has been visual moisture intrusion and daylight shining through. Recommend further evaluation by a licensed roofing contractor

Evidence of moisture intrusion

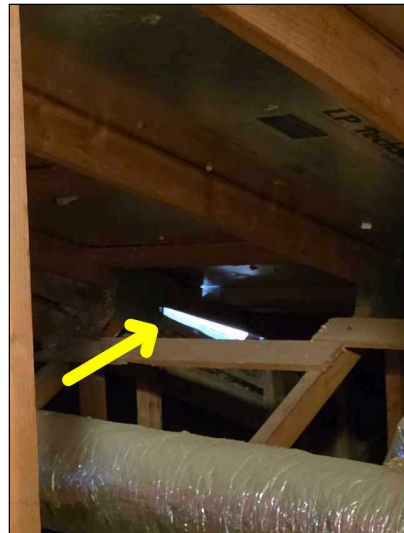
Open area
