# INSPECTION REPORT

**335 DOURO THIRD LINE**  
DOURO-DUMMER, ON K0L 2H0

Inspection Date: Tuesday, July 14, 2026

RE: Report No. 5801  
335 Douro Third Line  
Douro-Dummer, ON  
K0L 2H0

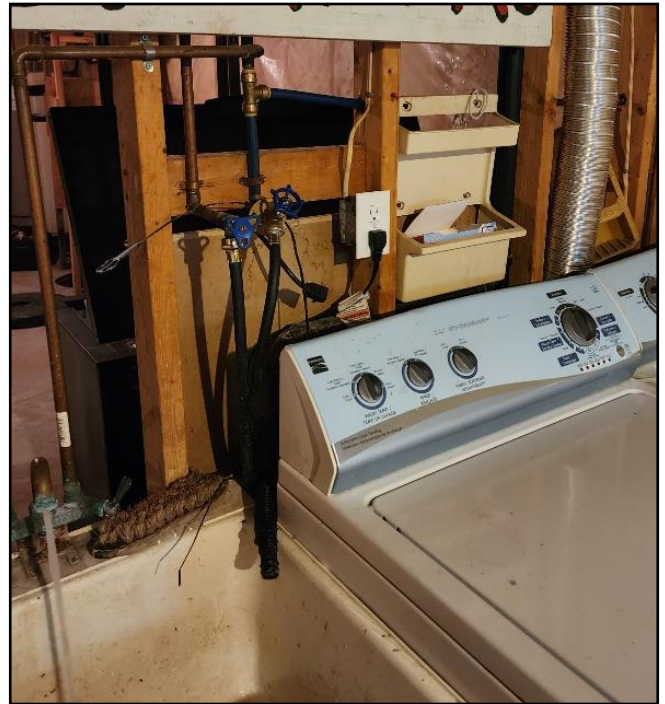
8.

#### **5. Condition:** • No GFCI/GFI (Ground Fault Circuit Interrupter)

Although not a deficiency in a home of this age safety may be improved by upgrading these receptacles

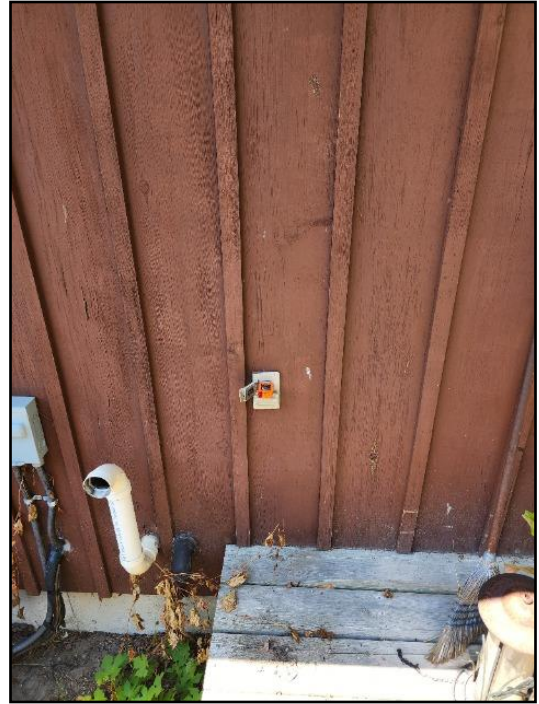
10.

**6. Condition:** • Test faulty on GFCI/GFI (Ground Fault Circuit Interrupter)

**Implication(s):** Safety hazard

**Task:** Replace
