## HOME INSPECTION REPORT (TREC REI 7-6)

101 Monarch Lane  
Austin, TX 78737

# PROPERTY INSPECTION REPORT FORM

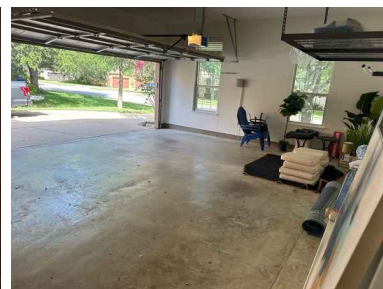
Front right corner measurement not taken due to the slope of the garage

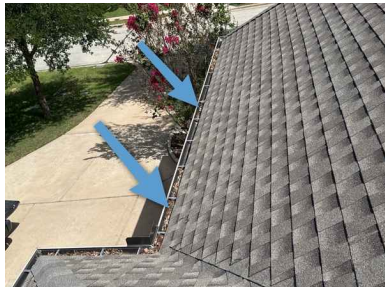
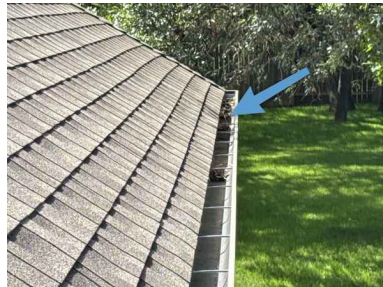
Gutters were filled with debris/foilage at multiple locations. These gutters should be cleaned to allow for proper drainage.

Recommendation: Contact a qualified professional.

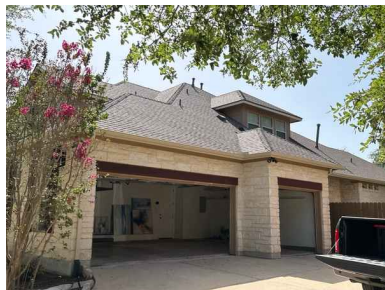
Unable to walk the roof covering materials due to the steep pitch present.

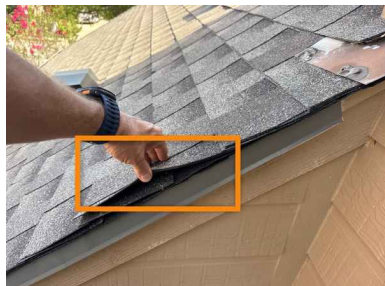
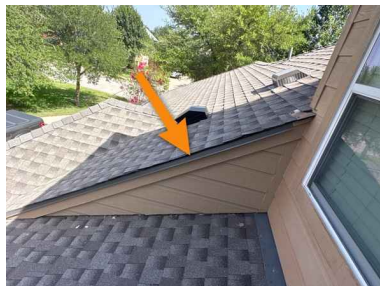
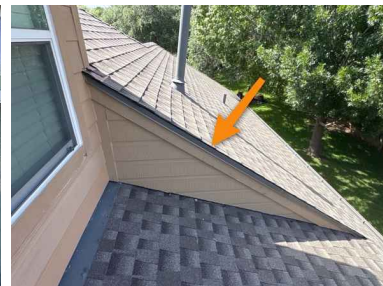
The first row of shingles was not properly sealed and appeared to be double layered at the upper right side of the home. Recommend further evaluation by a roofing professional to check all areas of the roof

Recommendation: Contact a qualified roofing professional.

Pyka: LoveRain inspected on 7-1-2026 and noted the starter course is present and is correctly installed along the eaves and rakes.

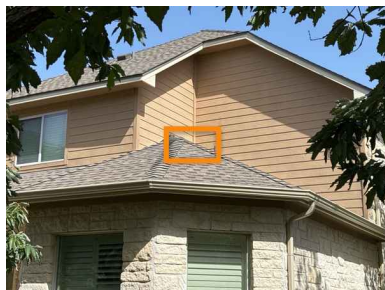
Back left corner

Insufficient ventilation was present for the roof covering at the back left corner and front left corners of the home. Ventilation is an essential component in maintaining attic temperature as well as ensuring the maximum life of the roofing materials.

Recommendation: Contact a qualified roofing professional.

Pyka: LoveRain inspected on 7-1-2026 and noted the vents were replaced in accordance with the original build as it was adequate and there were no signs of issues.

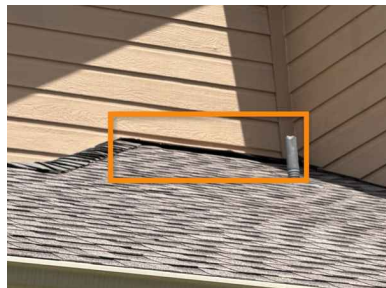
Flashing was not properly secured at the back left corner roof covering. This can allow water penetration under flashing, which should be flush with roof covering.

Recommendation: Contact a qualified roofing professional.

Pyka: Lifted flashing was sealed with screws by LoveRain on 7-6-2026.

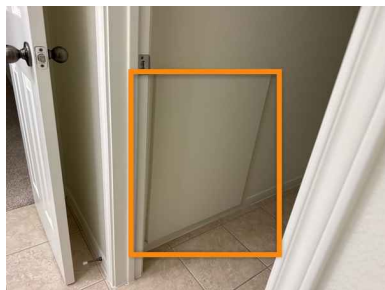
The framed-in attic access in the upstairs back guest bathroom was not removed at the time of the inspection. This attic enclosure could not be viewed.

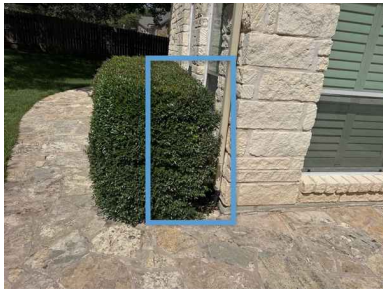
Trees/vegetation were observed in direct contact with siding materials at the back side of the home. Live vegetation should be trimmed back at least 12" to prevent damage to siding materials and avoid pest intrusion.

Recommendation: Recommended DIY Project

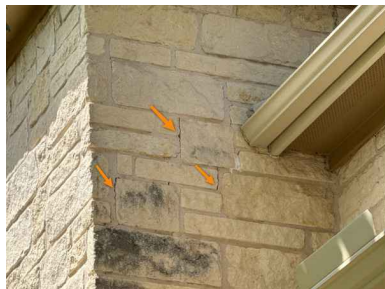
Left side of the home

Cracking was observed in the mortar joints. This is common with weathering/settling over time.

Pyka: Contractor, Joe Gonzales, addressed cracking on 7-6-2026.

Recommendation: Contact a qualified professional.

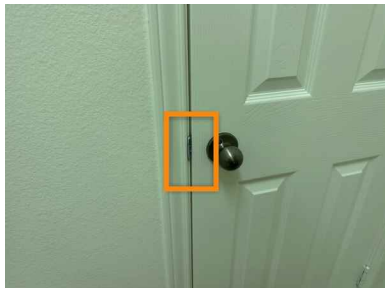
Primary bathroom closet

**3: Door Latch To Strike Plate**

Recommendation: Contact a qualified professional.

Pyka: Homeowner addressed on 7-9-2026.

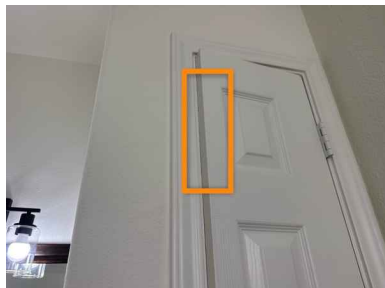
Primary bathroom

**4: Sides of the Door Rubs**

Recommendation: Contact a qualified professional.

Pyka: Homeowner addressed on 7-9-2026.

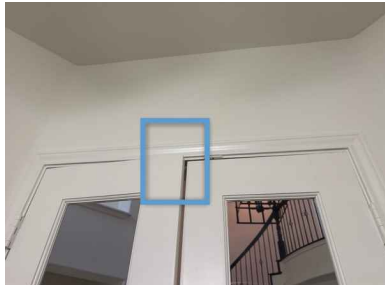
Downstairs front office

**5: Top Latch Defective**

Recommendation: Contact a qualified professional.

Pyka: Homeowner addressed on 7-3-2026.

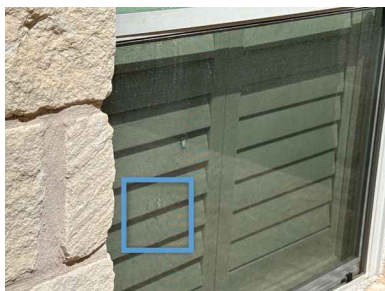
**1: Damaged Screens**

Damaged/missing window screen(s) were observed.

Recommendation: Contact a qualified professional.

Pyka: After careful consideration, property owner elects to not proceed with recommendation.

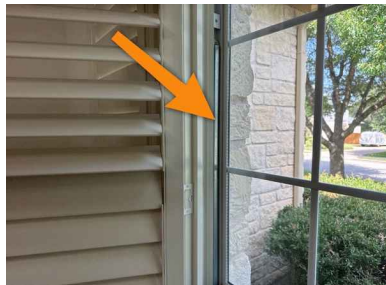
Downstairs front office

**2: Track****Recommendation**

The window tracks were damaged at the downstairs front office

Recommendation: Contact a qualified window repair/installation contractor.

Pyka: After careful consideration, property owner elects to not proceed with recommendation as window is operational.

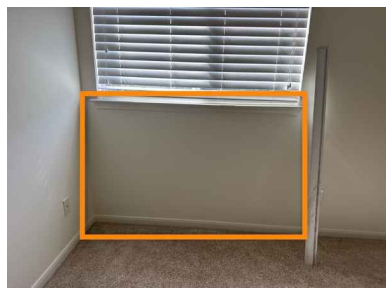
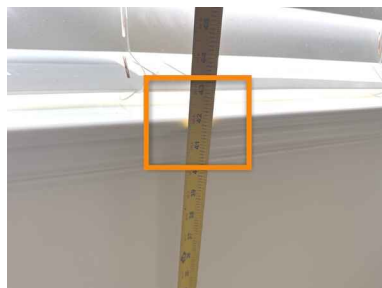
**3: Egress height****Recommendation**

The windows for the upstairs back middle guest bedroom exceeded height restrictions for emergency egress. Per current standards, the window sill should not exceed 44" in height above the floor

Pyka: The window height was in compliance when the home was built in 2003. Property owner elects to not proceed with recommendation.

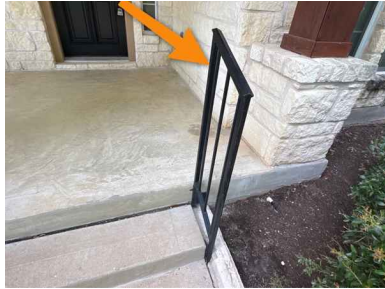
## 2: Loose Guard Rail/Hand Rail

Loose guard rail/hand rail observed at the front porch steps. Recommend repairing to prevent damage or personal injury

Recommendation: Contact a qualified carpenter.

Pyka: Contractor,  
Joe Gonzales,  
addressed on  
7-8-2026.

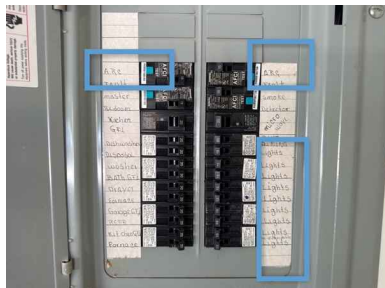
The breakers at the subfeed panel were not fully/properly labeled.

Pyka: ATX Electrical Services performed work at the house on 7/6/2026 and noted that the breakers are not specifically labeled but have general labels.

Recommendation: Recommended DIY Project

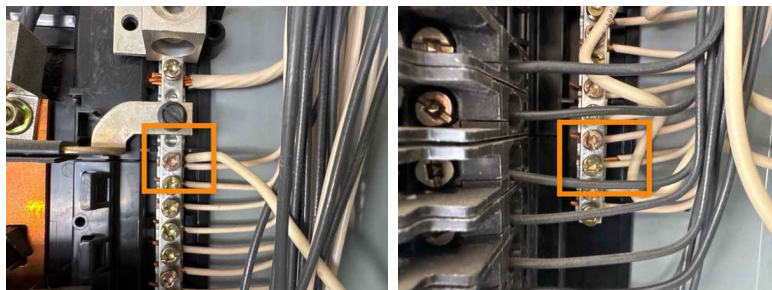
Double taps were observed to the neutral bus at the subpanel. This configuration is improper, as it can cause electrical arcing or overheating. Recommend further evaluation by a licensed electrician.

Recommendation: Contact a qualified electrical contractor.

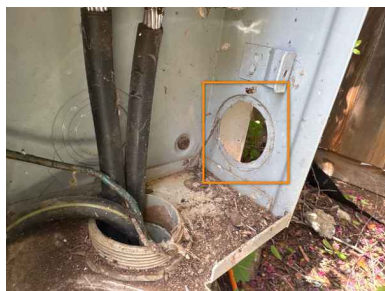
## 3: Open Knockouts - Side Of Panel

Open knockout hole was present at the right side of the main service panel in the back yard. Recommend sealant to prevent pest intrusion.

Pyka: Completed by ATX Electrical Services on 7/6/2026 with notation KO seal placed on 1 1/2 opening on main panel service.

Recommendation: Contact a qualified electrical contractor.

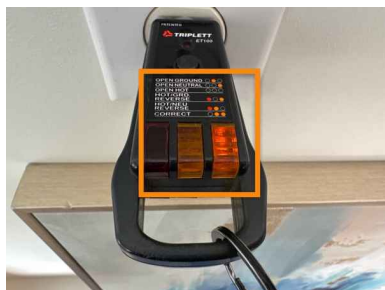
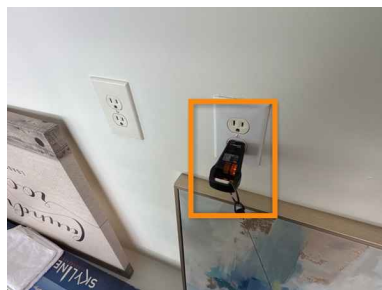
**7: Open Neutral Outlet****Recommendation**

The wall outlet in the center garage was observed to have an open neutral (improperly wired).

Recommendation: Contact a qualified electrical contractor.

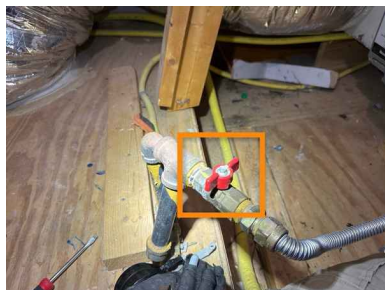
Downstairs unit

Limitation: Gas service was not active at the downstairs furnace at the time of the inspection. Unable to test heating equipment functionality.

Pyka: Hank's AC and Heating reconnected the flow pipe on 7/3/2026 and turned the gas on.

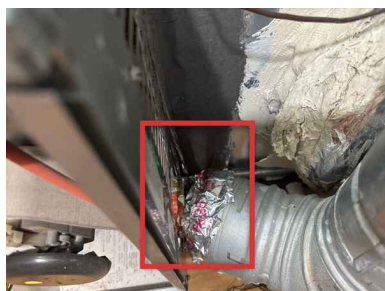
Downstairs unit

**1: Furnace flow not connected****▲Major Deficiency or Safety Hazard**

The furnace flow at the downstairs furnace in the attic was not properly connected. Recommend further evaluation by an HVAC professional to prevent damage or personal injury due to dangerous gases.

Recommendation: Contact a qualified HVAC professional.

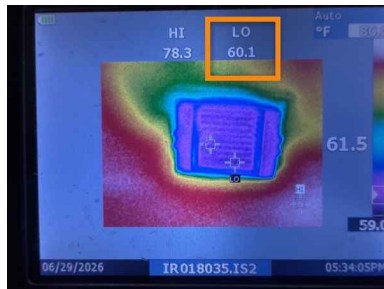
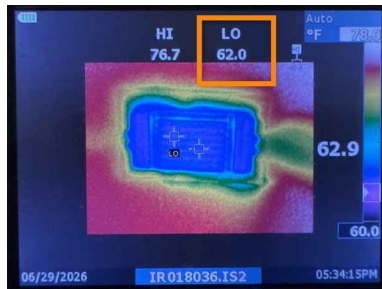
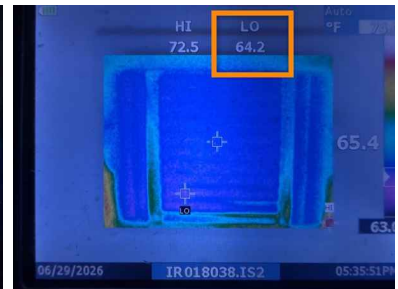
*Comments:***1: Inadequate/Inconsistent Temperature****➡Recommendation**

Inadequate/incon cool air was present throughout the primary bedroom/bathroom and upstairs of the home. With the thermostat set to 65 degrees, cool air was detected between 60-64 degrees through the registers. (Standard variance is 15-22 degrees between the supplies and the return.) Recommend further evaluation by a licensed HVAC professional. Both thermostats were set and verified on the same setting.

60-64 degrees

Recommendation: Contact a qualified HVAC professional.

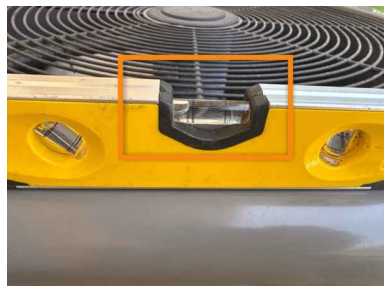
Downstairs unit

**2: Condenser Unlevel****➡Recommendation**

The exterior downstairs condenser unit appeared to be unlevel at the time of the inspection.

Recommendation: Contact a qualified HVAC professional.

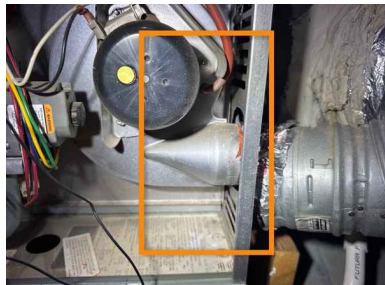
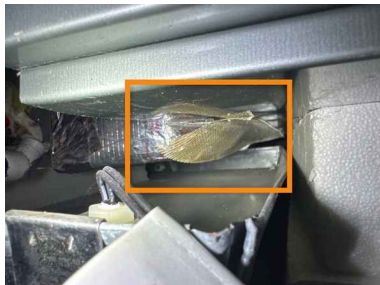
**3: Air Leak****➡Recommendation**

Air loss was detected at the air handlers. Recommend sealing the system to ensure maximum performance.

Recommendation: Contact a qualified HVAC professional.

Pyka: The air leak was sealed with mastic foil tape by Hank's AC & Heating on 7-3-2026.

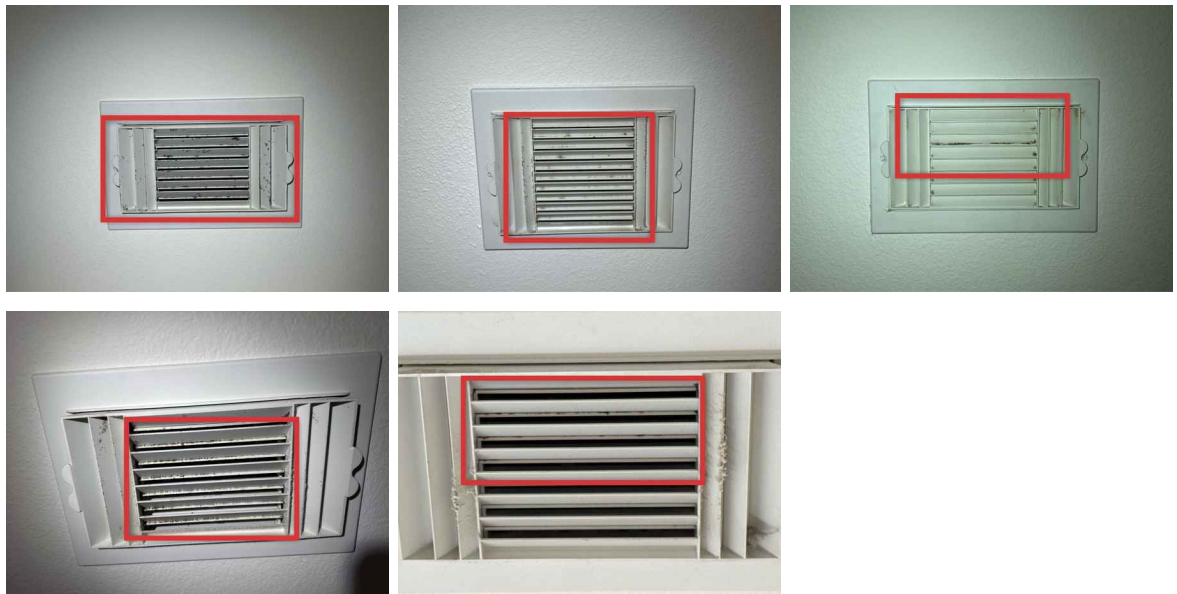
Possible microbial growth was observed at multiple air supply vents throughout the home. Recommend further evaluation by a licensed mold professional.

Pyka: Coit cleaned the HVAC supply lines on 7-2-2026. All vent covers were replaced.

Recommendation: Contact a qualified HVAC professional.

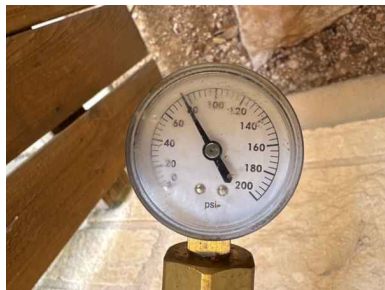
Static water pressure reading: 78 PSI PSI

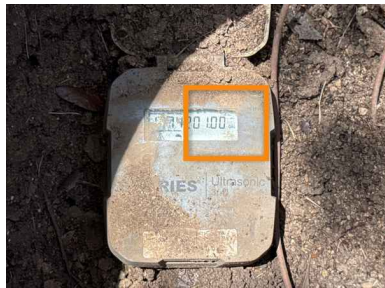
Observed activity at the micro-meter of the water meter in the front yard. This could be an indication of a possible water leak at an exterior hose bib, faucet inside the home, or a toilet tank could be constantly filling. Recommend further evaluation by a licensed plumber

Recommendation: Contact a qualified plumbing contractor.

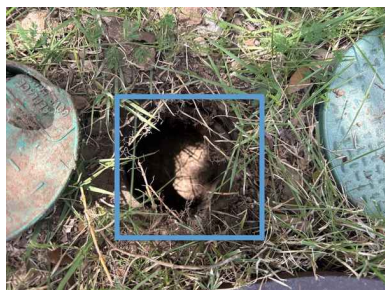
### 2: Main Shut Off Valve Buried

The main shut-off valve was buried under soil/debris at the time of the inspection. This fixture should be kept clear of soil and debris to allow ease of access in the event of a water leak.

Pyka: This was unburied during PRV replacement by The Good Plumber on 7-2-2026.

Recommendation: Contact a handyman or DIY project

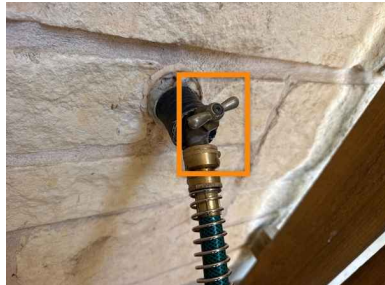
Right side of the home

**3: Hose Bib Leak**

The exterior hose bib leaks during operation at the right side of the home

Pyka: Repaired by The Good Plumber on 7-1-2026.

Recommendation: Contact a qualified plumbing contractor.

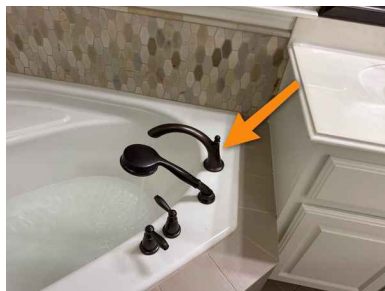
**4: Fixtures Loose**

The plumbing fixture(s) was noted as loose or not properly secured at the primary bathroom tub. Recommend repairs by a licensed plumber to prevent leaks.

Pyka: Repaired by The Good Plumber on 7-2-2026.

Recommendation: Contact a qualified plumbing contractor.

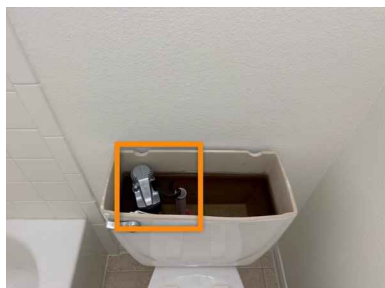
Upstairs backside guest bathroom toilet

**5: Running Toilet**

The water supply was observed to be constantly running at the toilet in the upstairs back guest bathroom. This may indicate a problem with the refill system.

Pyka: The Good Plumber repaired the toilet on 7-2-2026.

Recommendation: Contact a qualified professional.

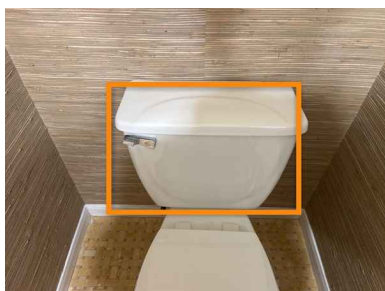
Downstairs guest half bathroom toilet

**1: Toilet Tank Loose**

The toilet tank was not properly secured at the downstairs guest half bathroom. Repairs by a licensed plumber are advised to prevent leaks/damage.

Recommendation: Contact a qualified plumbing contractor.

Pyka: The Good  
Plumber  
addressed on 7-1-2026.

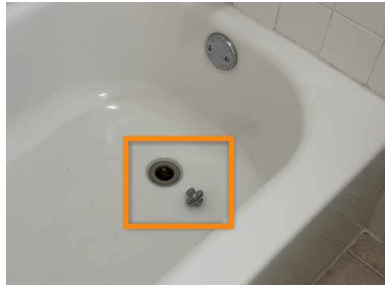
Upstairs, backside, guest bathroom tub

**2: Drain Stop Missing****Recommendation**

Missing drain stop was noted at the upstairs backside guest bathroom tub

Pyka: The Good Plumber repaired on 7-2-2026.

Recommendation: Contact a qualified plumbing contractor.

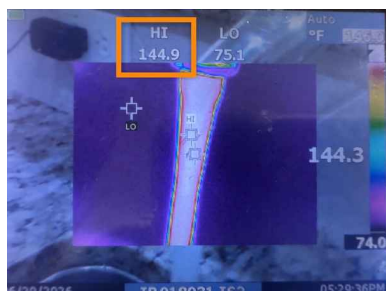
145 degrees

**1: Excessive Temperature****🔴Recommendation**

Excessive hot water temperatures (over 120 degrees) were observed throughout the home at 145 degrees. Excessive temperature increases scalding risk. Recommend further evaluation.

Recommendation: Contact a qualified plumbing contractor.

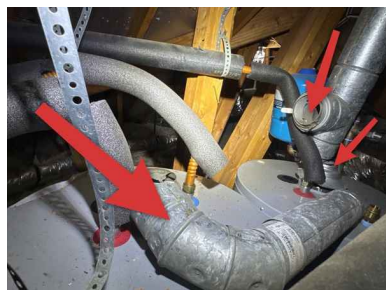
**2: Draft Hood Loose****🔴Major Deficiency or Safety Hazard**

The draft hoods at the top of the two water heaters for the exhaust vents were loose, not installed properly or not connected to the top of the water heaters. Recommend further evaluation by licensed plumber to ensure that all harmful gases are expunged properly to the exterior of the home.

Recommendation: Contact a qualified plumbing contractor.

Pyka: The Good Plumber reinstalled the venting on 7-2-2026.

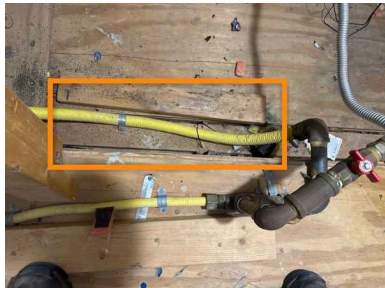
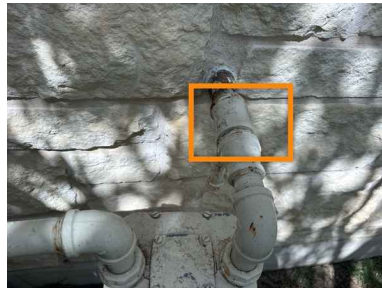
*Comments:***1: CSST w/ No Bonding****Recommendation**

The exterior gas meter does not appear to be bonded. Recommend further evaluation by a licensed electrician. The electrical bonding connection between the gas lines and the electrical system could not be verified/observed. Lack of electrical bonding may increase the potential for lightning strikes to cause electrical arcing at the CSST lines, resulting in gas leak or fire. For safety, it is recommended that this installation be further investigated by a licensed electrician. Please [www.CSSTSafety.com](http://www.CSSTSafety.com) for more information.

Pyka: ATX Electrical Services reviewed on 7/9/2026 and determined there is bonding. The Black Gas Pipe at the gas meter OHMS out to ground buss on the main electrical panel. It appears that the gas system is bonded to the cold water pipe due to ground clamp on cold water pipe.

Recommendation: Contact a qualified plumbing contractor.

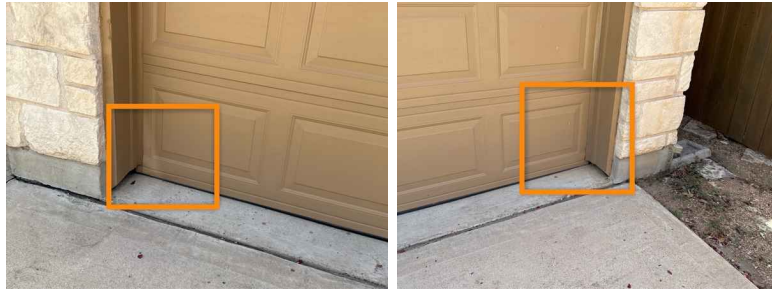
*Comments:***1: Panel Damage**

Damage was observed to the 8 foot garage door metal sectional panel.

Recommendation: Contact a qualified garage door contractor.

Pyka: James Edwards Garage Doors and Repairs inspected on 7-1-2026 and noted individual panel can not be purchased to match the existing panel. Homeowner declines to make the repair as the garage door is operational.

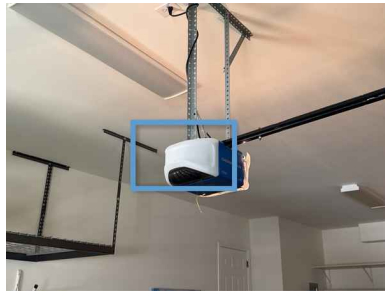
**2: Light Out**

The light fixture for the 16 foot overhead garage door opener was not functional at the time of the inspection. Possible burnt out bulb(s) noted.

Recommendation: Contact a handyman or DIY project

Pyka: Homeowner replaced the light fixture on 7-6-2026.

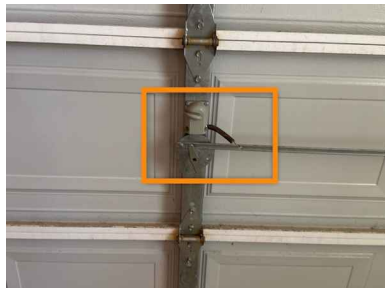
**3: Lock Present**

An operable lock was present to the two overhead garage doors and should be permanently locked open or removed to prevent damage to garage door components.

Recommendation: Contact a qualified garage door contractor.

Pyka: James Edwards Garage Doors and Repairs inspected on 7-1-2026 and noted both doors are already in the locked position.

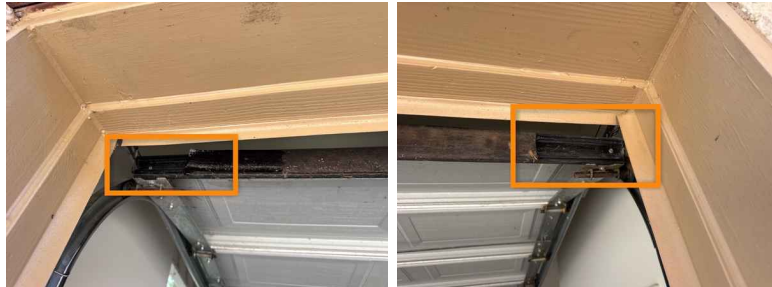
**4: Loose/damaged gaskets****🔴Recommendation**

The bottom gasket at the garage doors were loose/damaged at multiple locations.

Pyka: James Edwards Garage Doors and Repairs has been hired to replace both gaskets. He attempted the repair on 7-8-2026, but had the incorrect gasket. As of 7-9-2026 he is awaiting the new replacement gasket.

Recommendation: Contact a qualified garage door contractor.

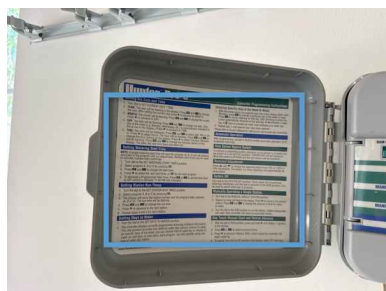
#### 1: Sitemap Missing

An irrigation layout map should be added for the sprinkler system.

Recommendation: Contact a qualified professional.

Pyka: Homeowner has documentation in the irrigation controller manual that provides the station layout map. The manual is located in garage cabinet. Addressed on 7-3-2026.

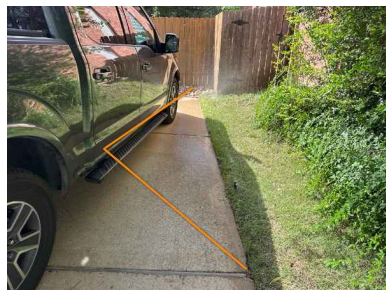
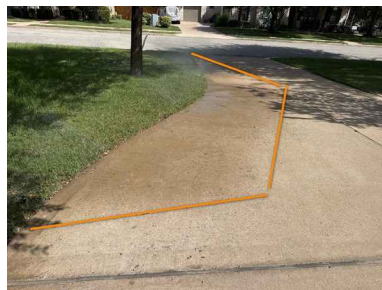
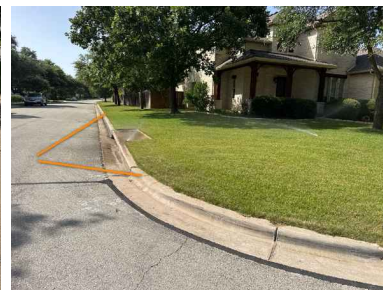
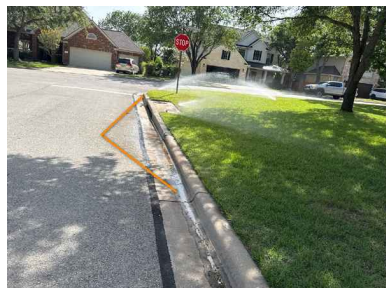
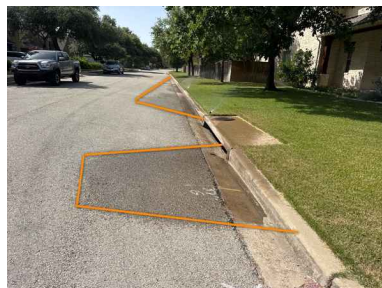
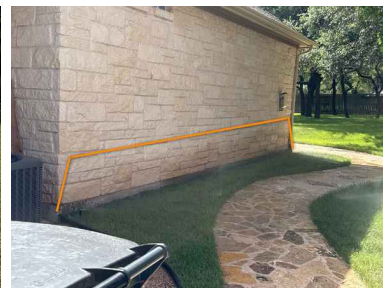
#### 2: Overspray

Significant over-spray was observed at multiple locations

Zone 1 in the front right yard

Zone 3 in the front yard

Zone 4 in the left side yard

Zone 12 In the right backyard

Recommendation: Contact a qualified professional.

Pyka: RaynMaker inspected the system on 6-30-2026 and adjusted the rotors in the front yard. Vendor noted there is really good/strong water flow/pressure in the system and some of the rotors will not adjust down any further. When adjusted down (distance), rotors will throw more water to the sides, so there is a fine balance between covering the turfgrass and not getting water in the street. Plus, with such strong pressure, there is a small amount of "misting" that will occur. It is within acceptable limits. Replaced 2 rotors in the front yard. Overspray in the backyard: It's apparent the sidewalk was put in long after the sprinkler system. Redesign of the system in that area is not cost effective or practical. Any runoff from the sidewalk merely goes into the surrounding turfgrass and topsoil.

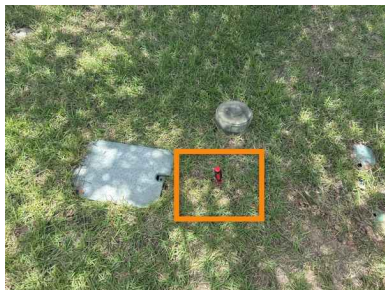
The main shut-off valve for the irrigation system was either not present or buried under soil at the time of the inspection. This fixture is required and should be kept clear of soil and debris to allow ease of access in the event of a water leak.

Recommendation: Contact a qualified landscaping contractor
