SELLER'S DISCLOSURE NOTICE

CONCERNING THE PROPERTY AT 1006 Shelley Avenue, Austin, Texas 78703

1006 Shelley – Engineering Foundation Evaluation Provided by Seller

1006 Shelley – Foundation Inspection Pages Provided by Buyer 1

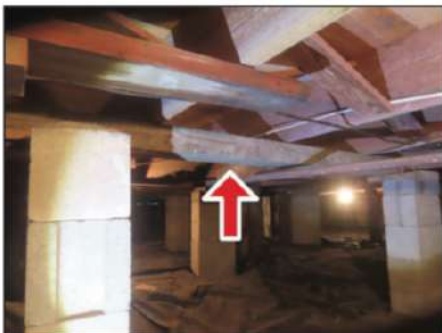
It appears a beam has been added for additional support-beam may have been positioned incorrectly(layed flat- 4" dimension supporting joist). Have a foundation contractor review for any recommended repair or improvement.
