5 POINT HOME INSPECTIONS

RESIDENTIAL INSPECTION

12935 Brigham Dr
Austin, TX 78732

PROPERTY INSPECTION REPORT FORM

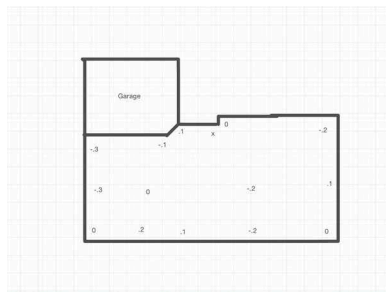
Our team utilized a Zip Level to take foundation elevation measurements on the first floor, which have been presented in the image below. It is important to note that while these measurements are useful in assessing foundation performance, they do not always accurately represent the true state of the foundation due to variations in floor covering styles and craftsmanship.

After conducting a limited visual inspection, it is my professional opinion that the foundation is performing its intended purpose and providing adequate support to the structure above. Our team understands the importance of a strong and stable foundation, and we take great care in assessing all aspects of its performance.

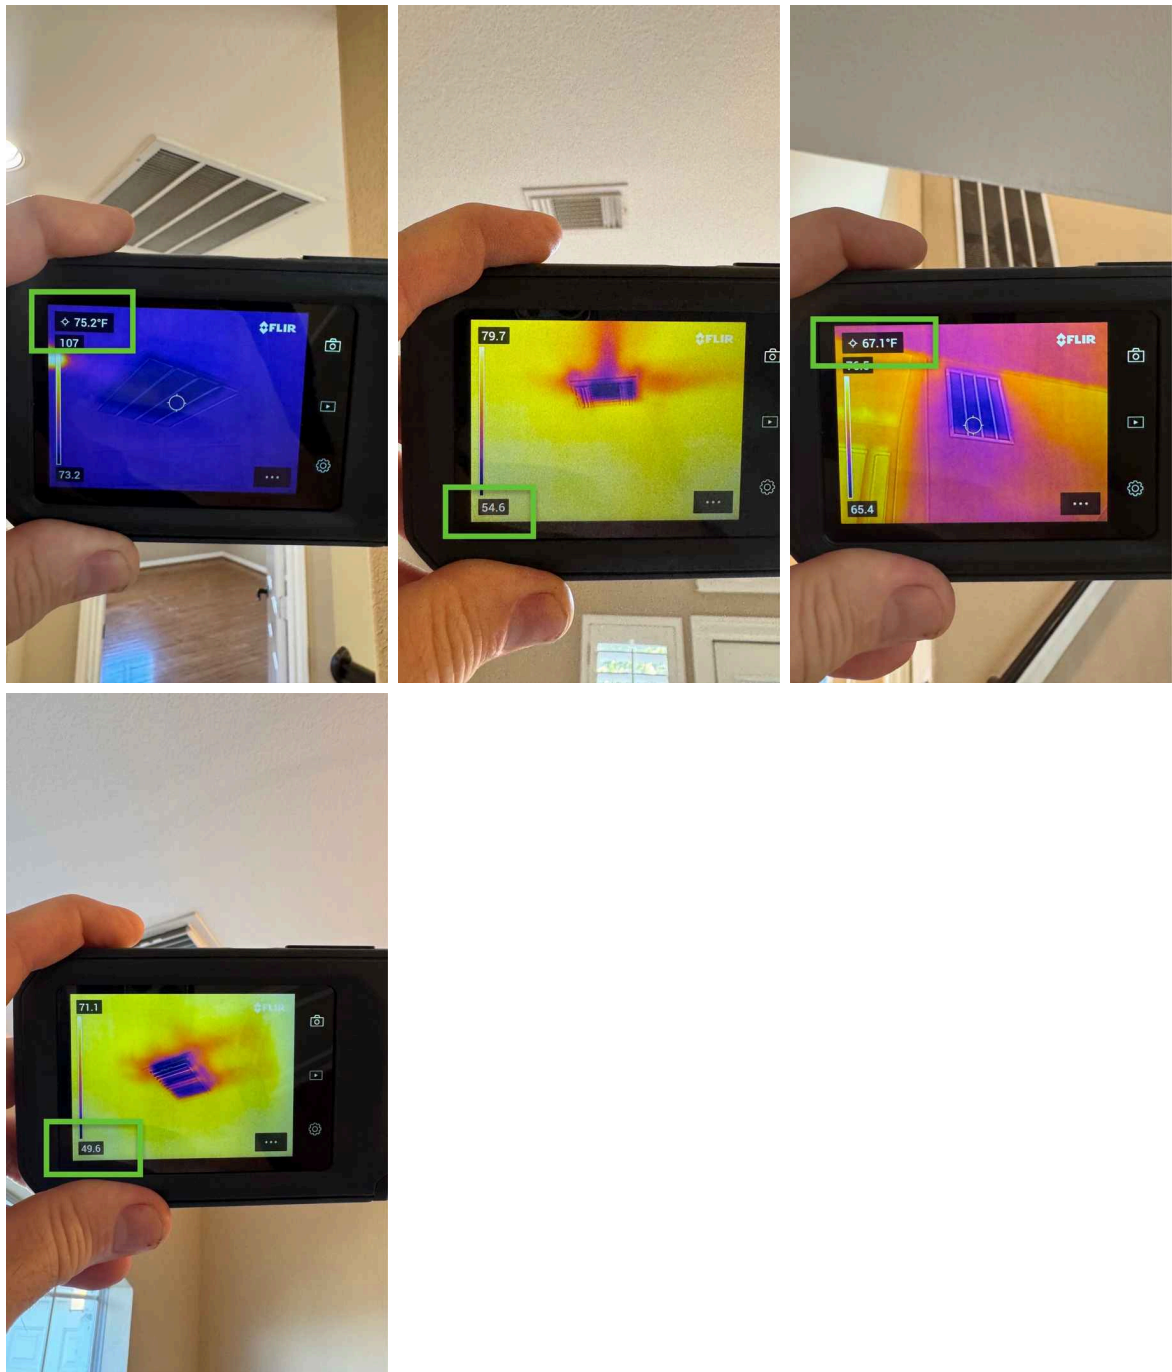
system. The average acceptable range is considered to be between 15-22° Fahrenheit measured between the return air and conditioned supply air. Today's measurements fell within that range, indicating that the cooling system is operating efficiently and effectively.
