RESIDENTIAL INSPECTION

3700 Clawson Rd 401 Austin, TX 78704

Jaret Kanarek	03/18/2024 2:00 pm
Name of Client	Date of Inspection
3700 Clawson Rd 401, Austin, TX 78704	
Address of Inspected Property	
Chris Walsh	25159
Name of Inspector	TREC License #
Name of Sponsor (if applicable)	TREC License #

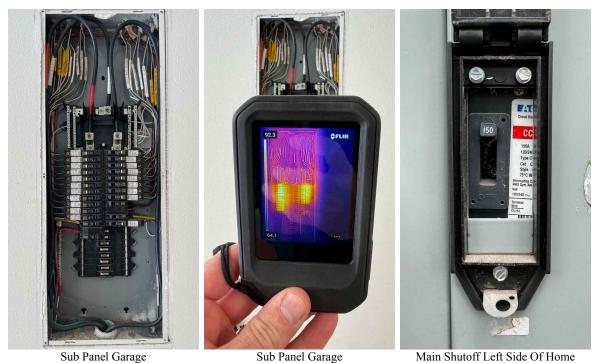
A. Service Entrance and Panels *Photos Of Panels:*

Box Rating and/or Main Disconnect Rating: 150 amps -

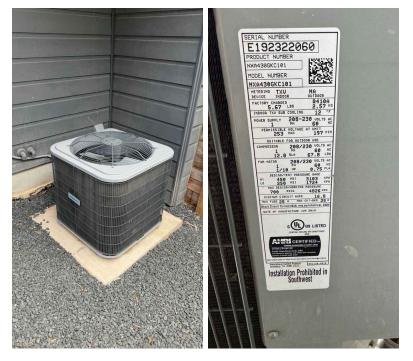
Photo Of Unit And Data Plate:

Manufacturer: Comfortmaker Year of Manufacture: 2019 Type of Systems: Central Air Conditioner Temperature Differential Within Range: The cooling equipment was inspected according to Texas's standards of practice and was performing as intended at the time of inspection.

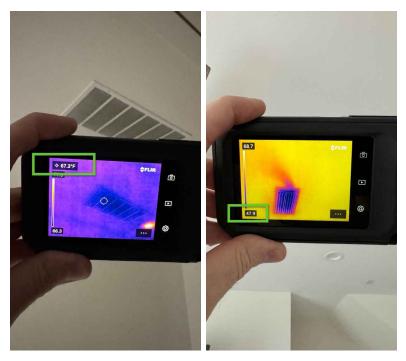
Temperature differential readings are the fundamental standard for testing the proper operation of the cooling system. The average acceptable range is considered to be between 15-22° Fahrenheit measured between the return air and conditioned supply air. Today's measurements fell within that range, indicating that the cooling system is operating efficiently and effectively.

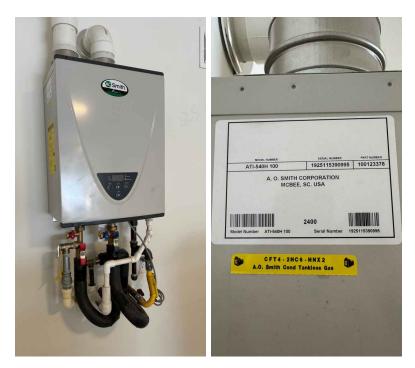
Manufacturer: AO Smith Year of Manufacture: 2019 Capacity: 0 Gallons Energy Sources: Gas Photo Of Water Temperature :
