5 POINT HOME INSPECTIONS 512-429-1091 cwalsh@5pointinspections.com https://5pointinspections.com

RESIDENTIAL INSPECTION

12935 Brigham Dr Austin, TX 78732

Jackie Hickithier	04/15/2024 9:00 am
Name of Client	Date of Inspection
12935 Brigham Dr, Austin, TX 78732	
Address of Inspected Property	
Chris Walsh	25159
Name of Inspector	TREC License #
Name of Sponsor (if applicable)	TREC License #

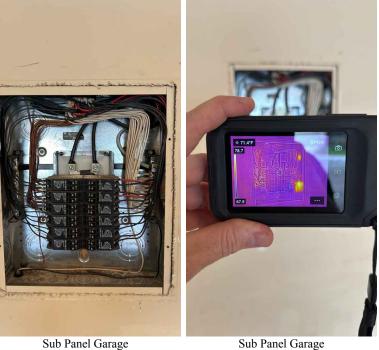
Box Rating and/or Main Disconnect Rating: 150 amps -

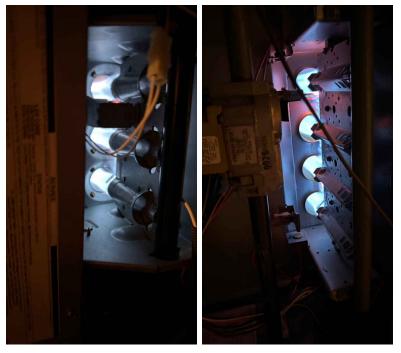
Manufacturer: Goodman, Rheem Year of Manufacture: 2017,1999 Type of Systems: Forced Air Energy Sources: Gas Photos of Heat:

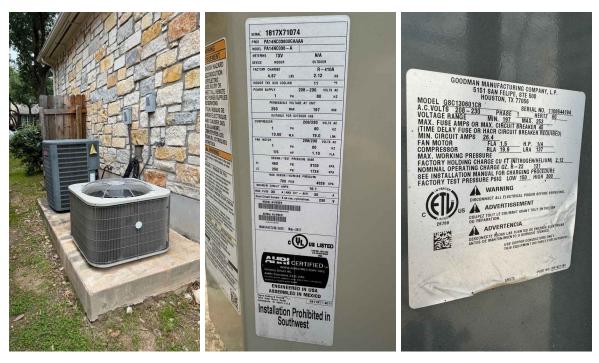
Manufacturer: Payne, Goodman Year of Manufacture: 2017,2011 Type of Systems: Central Air Conditioner HVAC Condensate Drain Info:

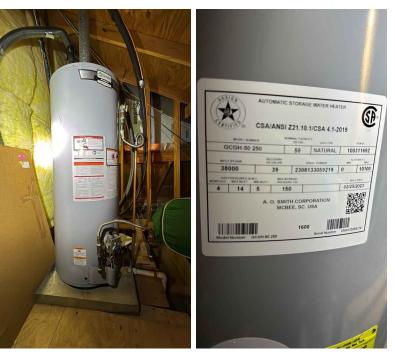
Photo of Unit And Serial Number:

Manufacturer: AO Smith Year of Manufacture: 2023 Capacity: 50 Gallons Energy Sources: Gas Photo Of Water Temperature :
