Building Envelope of Lot 4, Mirador Subdivision, Near Ranchos de Taos, Taos County, New Mexico

TOPOGRAPHIC SURVEY

Current owner: Steven and Marianna Sunderlin
Section 9, T 24 N, R 12 E, NMPM

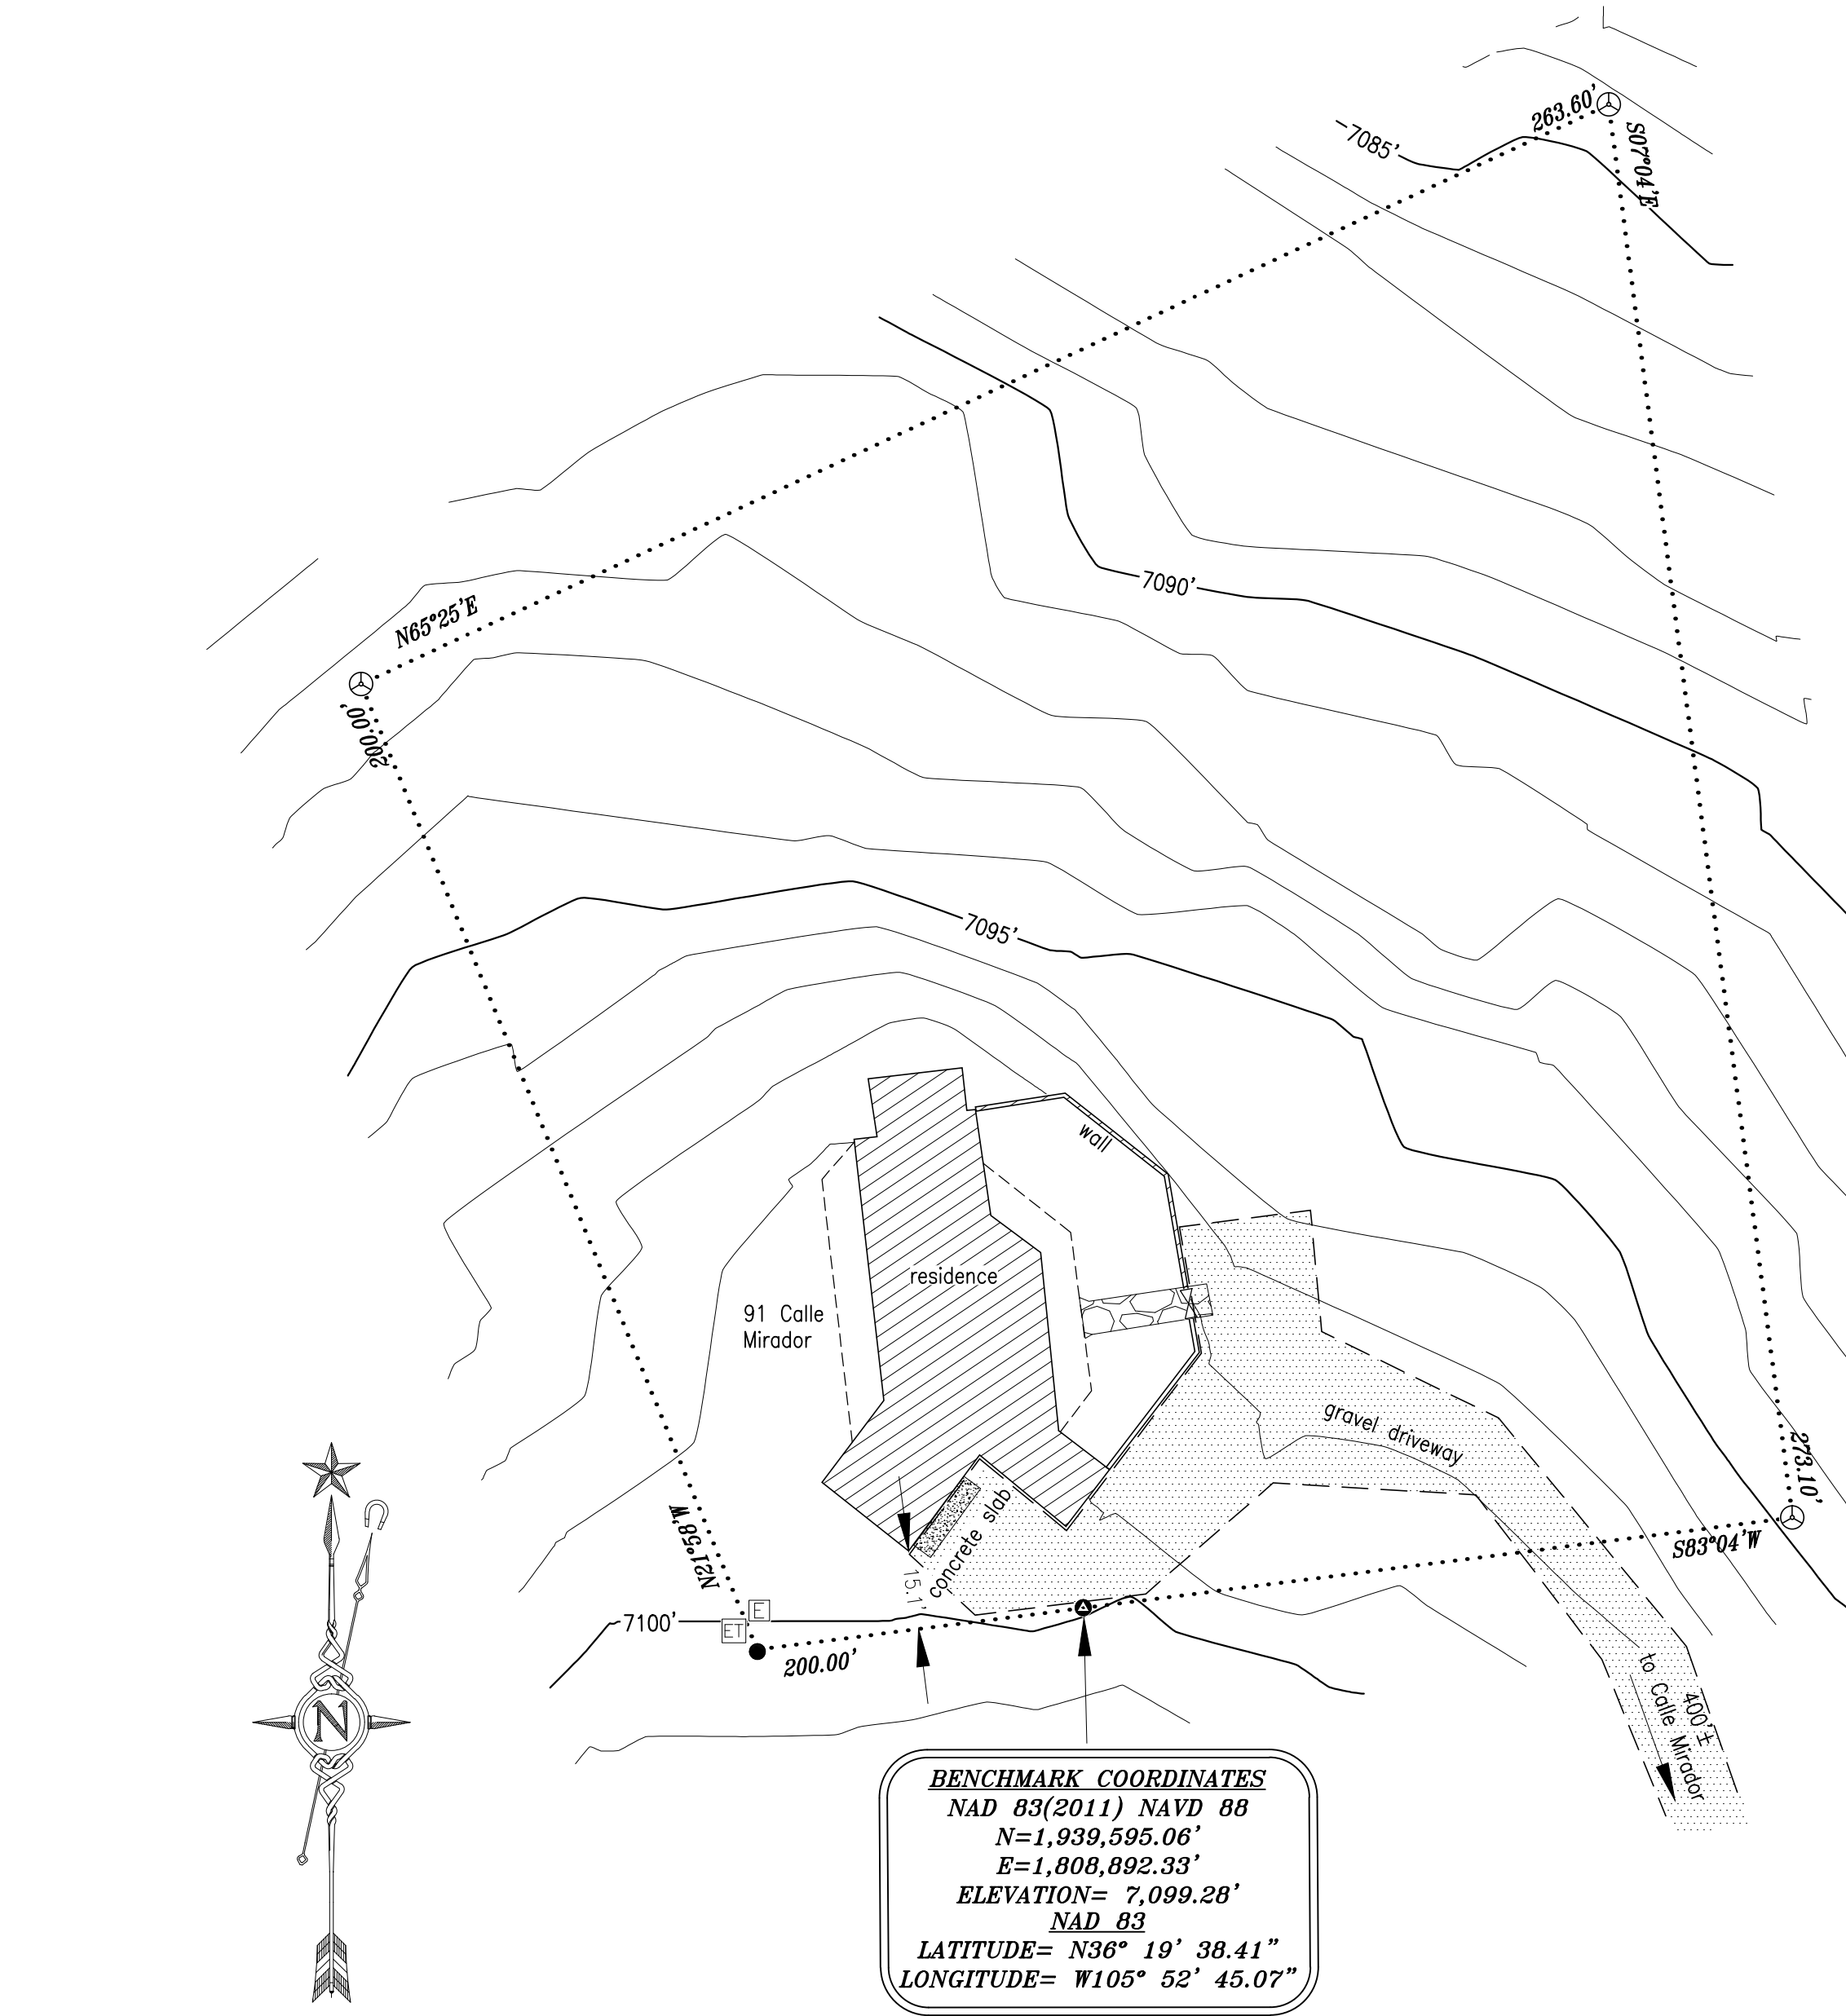
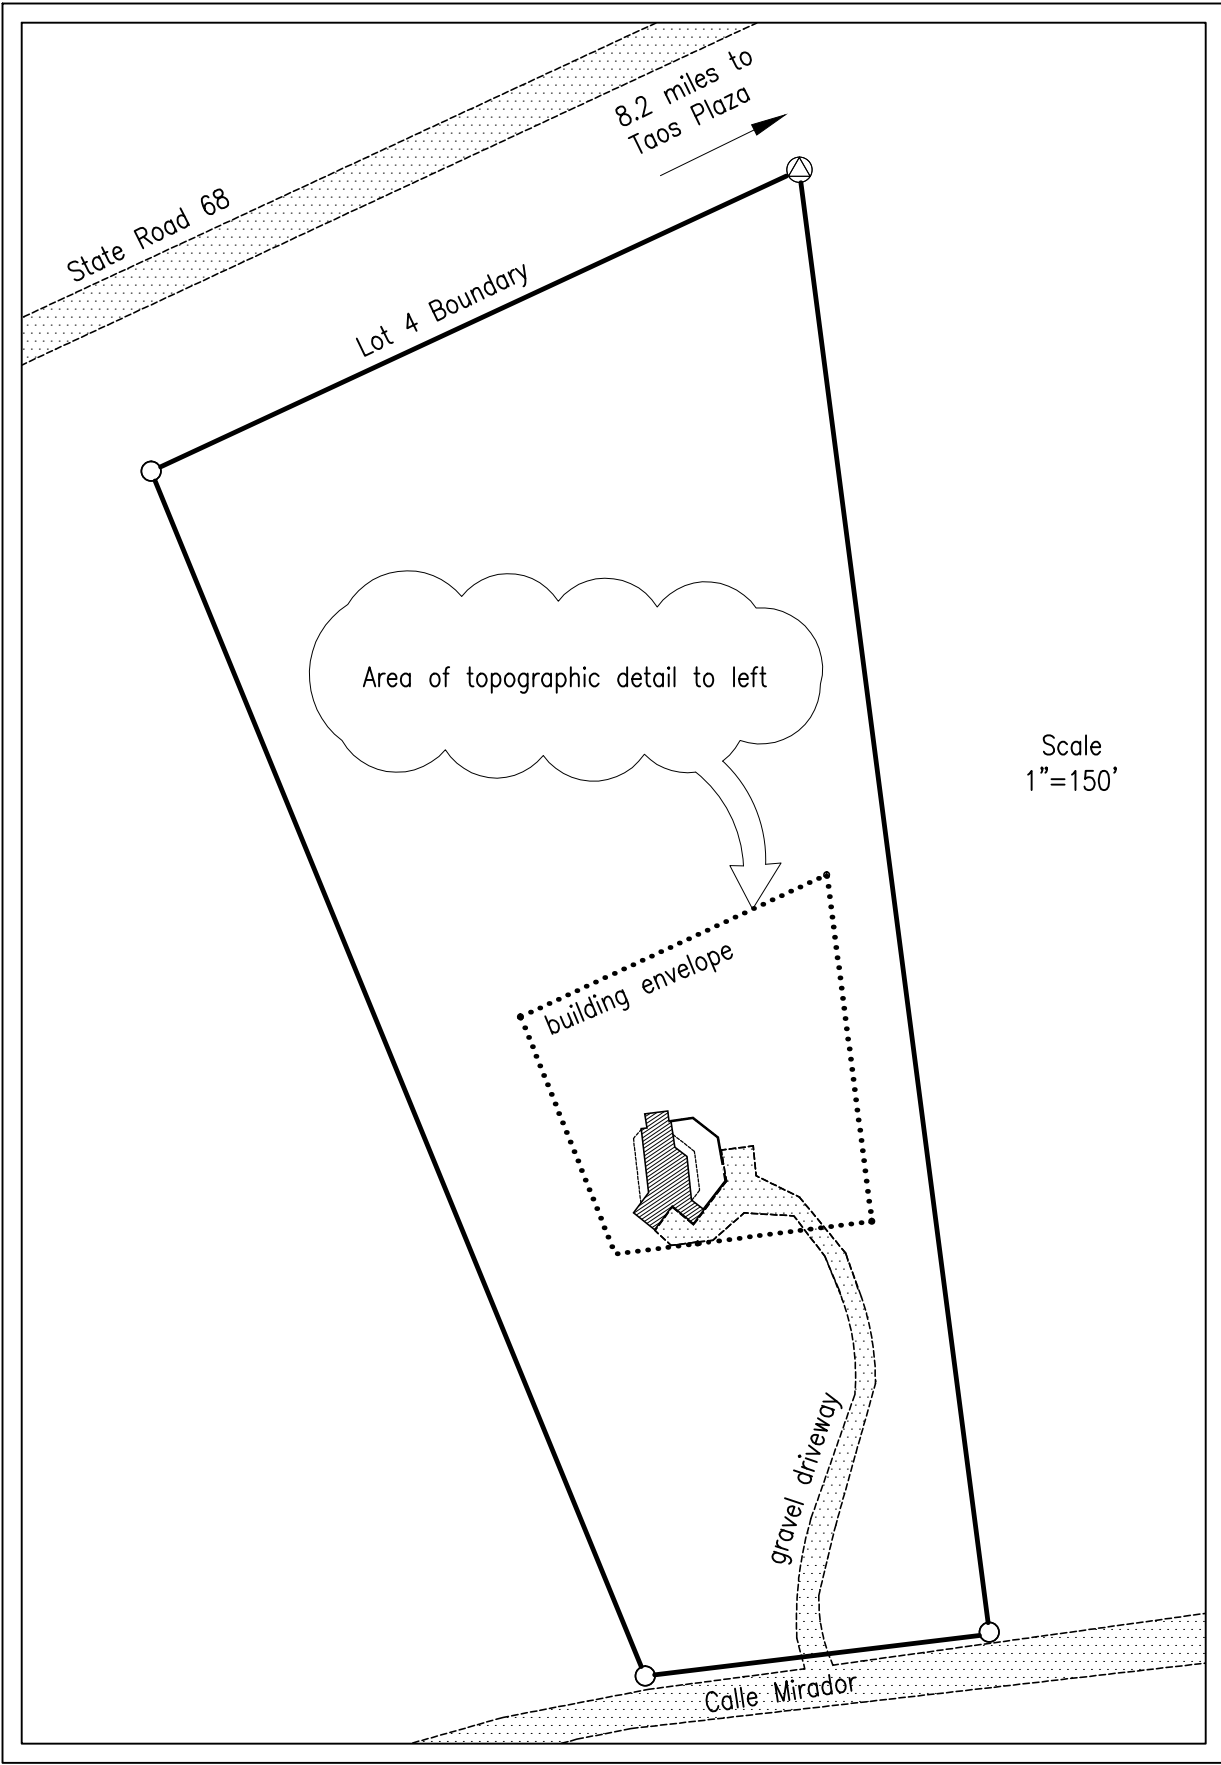
Bearings of this survey are based on information derived from ref. P1 as evidenced by monuments found in the field.

Vertical datum of this survey are based on measured geodetic control values post-processed through the National Geodetic Survey Online Position User Service (OPUS), and are indexed to the North American Vertical Datum (NAVD 88).
