THE STATE OF TEXAS  
THE COUNTY OF TRAVIS

The undersigned does hereby certify that a survey was this day made on the ground of the property legally described hereon and is accurate to the best of my abilities and that there are no boundary line conflicts, encroachments, shortages in area, overlapping of improvements, visible utility lines, or roads in place, except as shown hereon, and said property abuts a dedicated roadway. A portion of this property is within Zone A (100 Year Flood Plain) according to the Federal Emergency Management Agency Flood Insurance Rate Map Panel No. 48209C 0050 G, dated January 17, 2025.

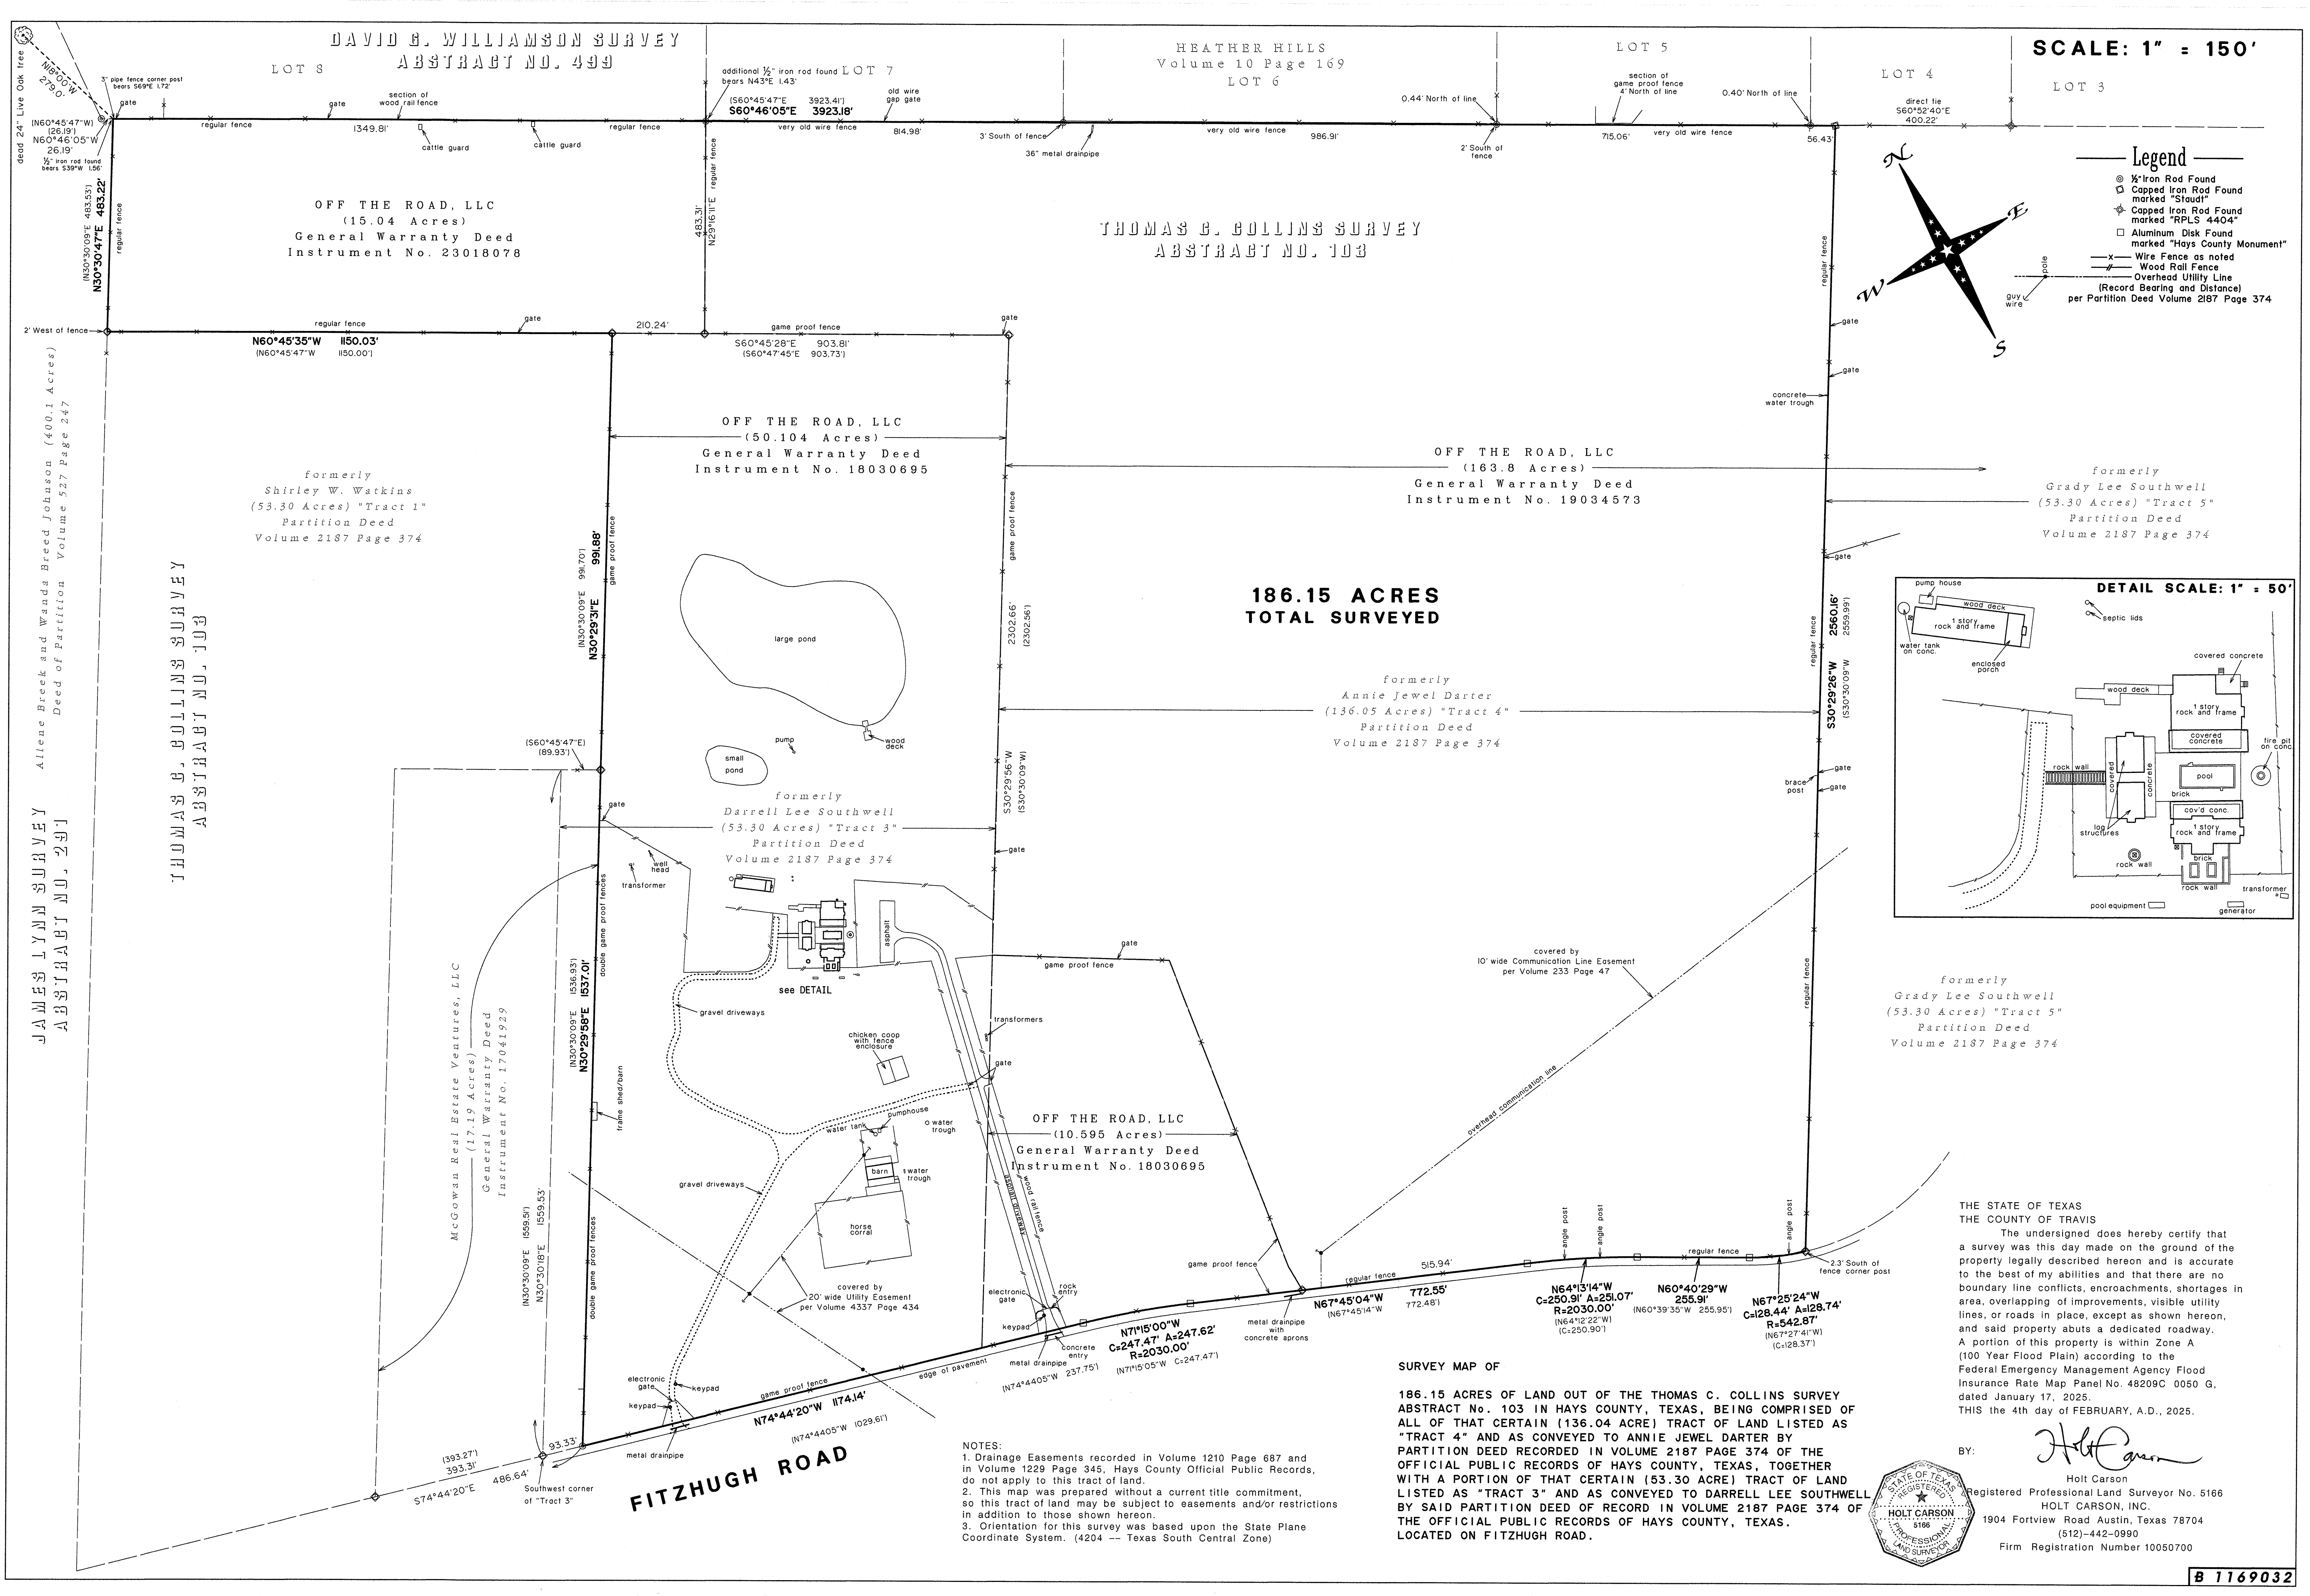
☉ ½" Iron Rod Found  
 ☐ Capped Iron Rod Found  
    marked "Staudi"  
 ☉ Capped Iron Rod Found  
    marked "RPLS 4404"  
 ☐ Aluminum Disk Found  
    marked "Hays County Monument"  
 — Wire Fence as noted  
 — Wood Rail Fence  
 — Overhead Utility Line  
 (Record Bearing and Distance)  
 Deed Volume 2187 Page 374

DETAIL SCALE: 1" = 10'
