# PROPERTY INSPECTION REPORT FORM

12318 Furrow Cove #A, Austin, TX 78753

09/06/2023 12:30 pm

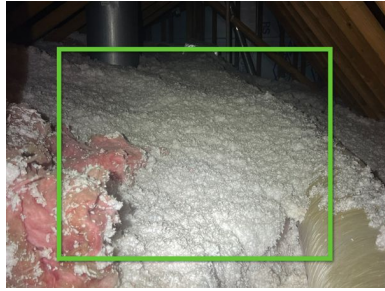
Blown in R38

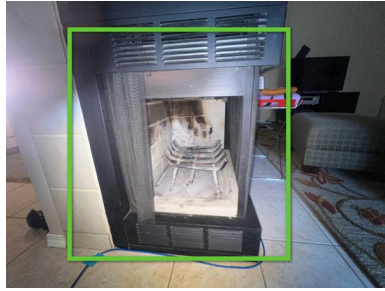
Living room fireplace - Working as Intended

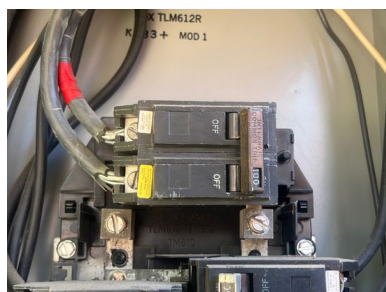
100 amp service, aluminum

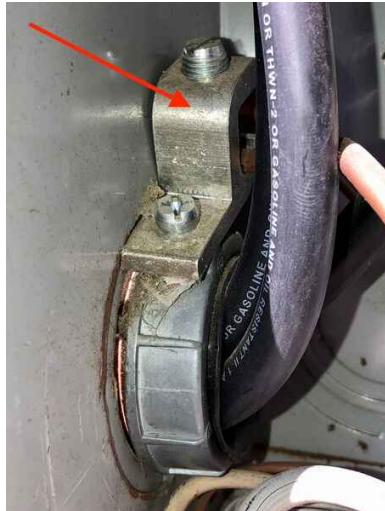
Raceway bonding clamp example

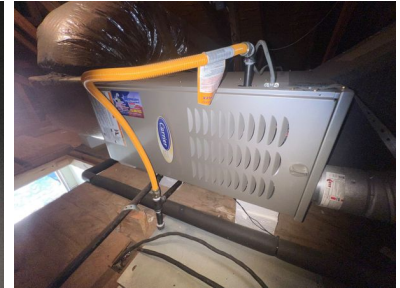
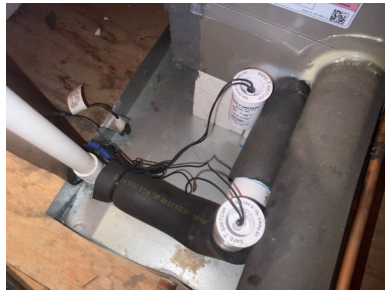
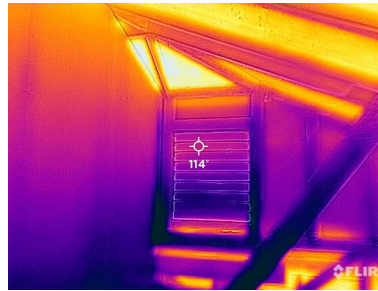
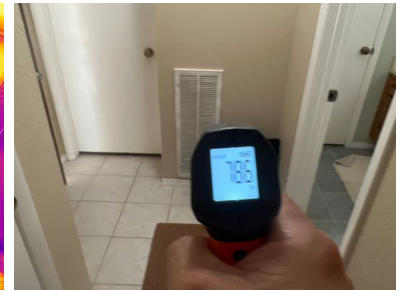
78° at return - 20° differential

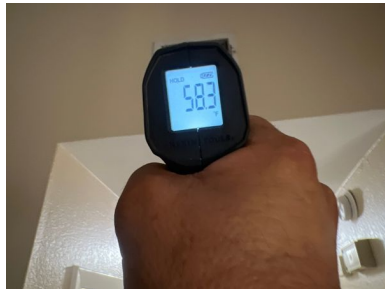
58° average at interior registers

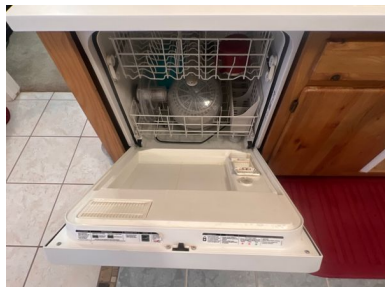
Dishwasher - Working as Intended

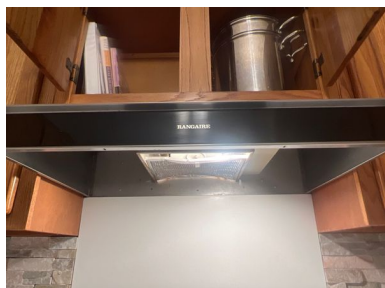
Range hood - Working as Intended

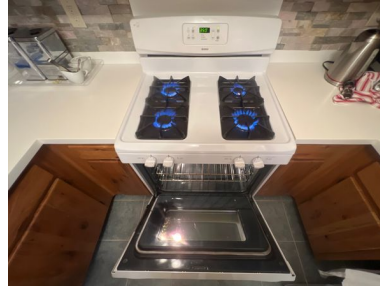
All burners working as intended

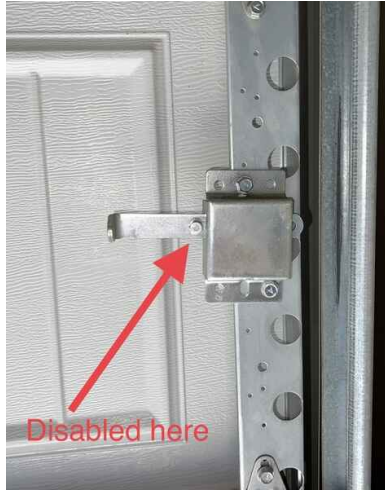
The overhead door lock should be disabled because there is an automatic garage door operator in place. This will help prevent accidentally activating the automatic opener when the door is locked, which may result in damage to the door and/or the automatic operator.

Disabled lock example
