Report #: 071025WO2.

Date of inspection: 07/10/2025.

Address of inspection: 211 Meadow Ridge Drive. , Tallahassee, FL 32312.

The following summary is provided as a courtesy for quick access to the information within the attached inspection report. It is not intended as a substitute for reading the entire inspection report.

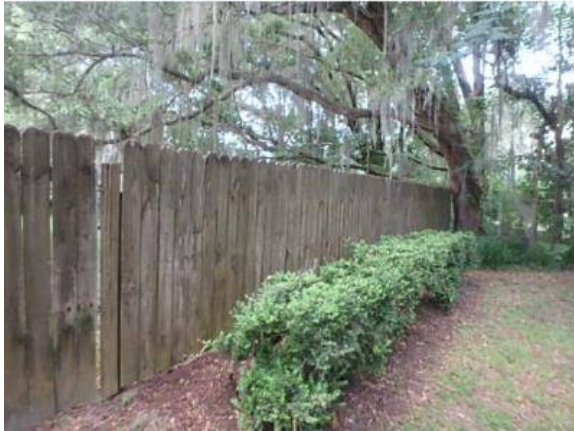
4. General deterioration and damage noted at the wood fencing and gates.

washed July 2025

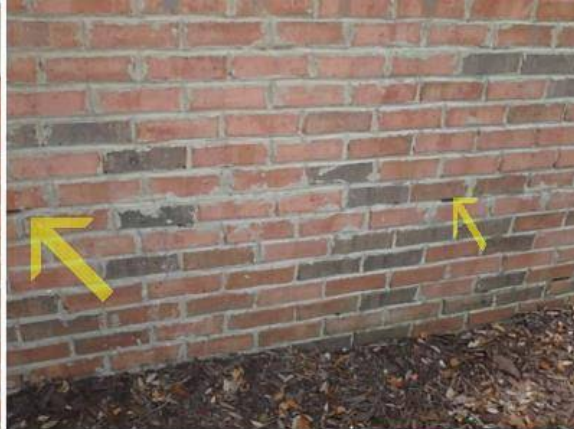
6. Separation and evidence of settlement noted at the right side exterior shed addition. Separation noted at the brick mortar at the transition to the house. Brick coursing does not appear level at the front facing wall.

Shimmed and Caulked August 2025

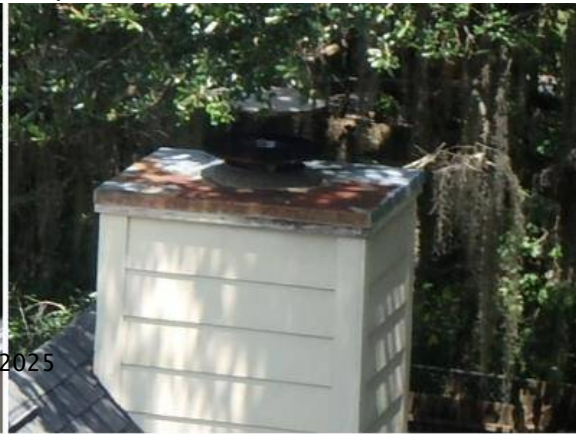
23. Rust damage noted at the chimney caps of both chimneys.

Painted August 2025

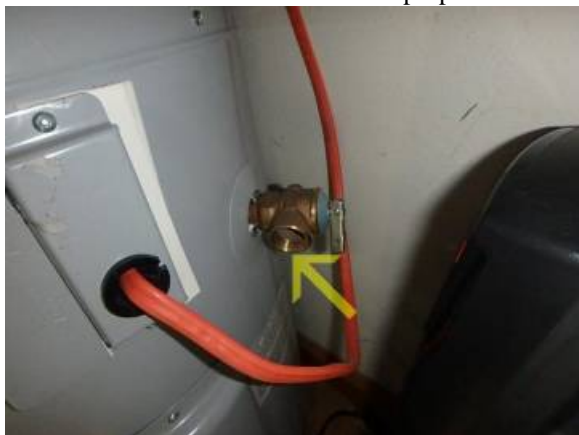
33. The water heater does not have a proper TRPV extension drain line.

Completed July 2025

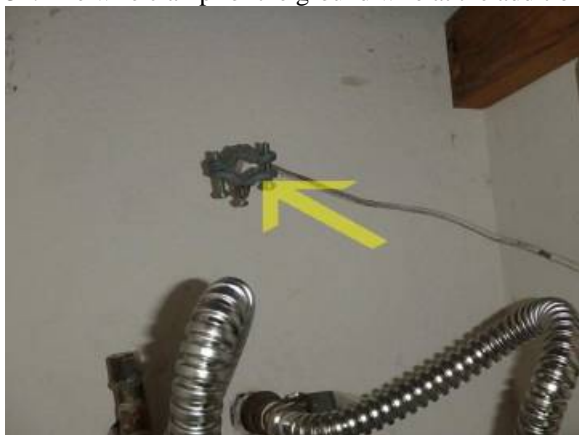
34. The wire clamp for the ground wire at the addition side water heater is disconnected.
