Inspection Report

G2 Home Inspections

Property Address 3063 S Dawes Pl Kennewick Wa

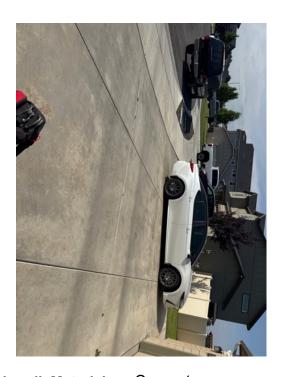
The driveway appeared to be in serviceable condition at the time of the inspection.

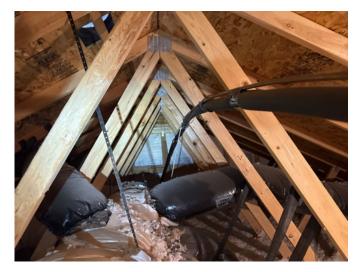
The visible and accessible portions of the attic appeared to be in serviceable condition at the time of the inspection.

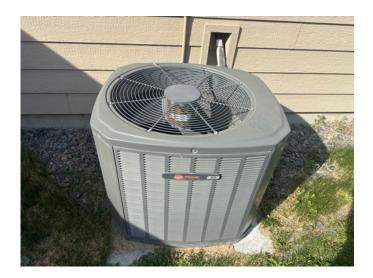
The AC unit was operational at the time of inspection. This is not an indication of future operation or condition.

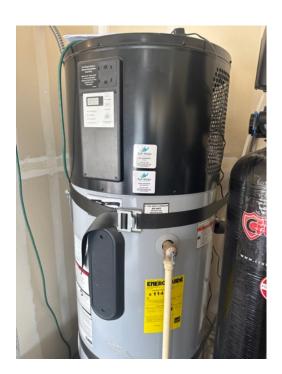
The water heater was operable at the time of inspection. This does not however guarantee future performance, operation, or condition.

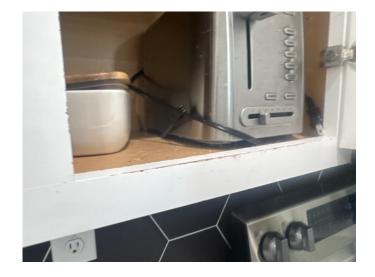
The kitchen cabinets appeared to be in serviceable condition at the time of inspection.

The kitchen cabinets showed evidence of minor wear.

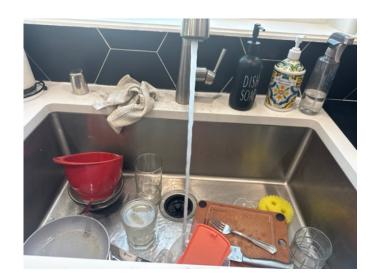
The kitchen sink appeared to be in serviceable condition at the time of the inspection. The faucet appeared to be in serviceable condition at the time of the inspection. The visible areas of the plumbing under the kitchen sink appeared to be in serviceable condition at the time of the inspection.

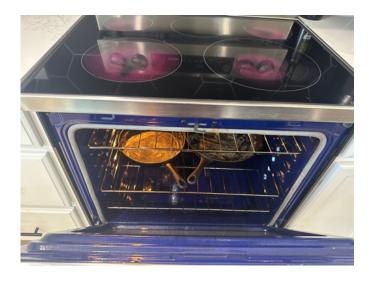
the electric range operated as intended at time of inspection

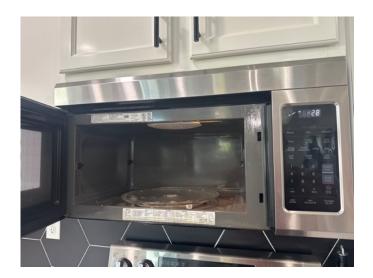
The above range microwave was operational at the time of inspection.

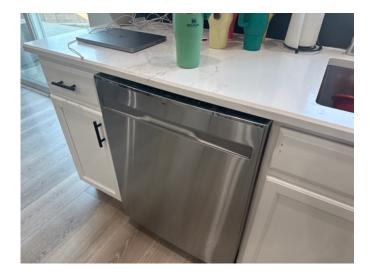
The dishwasher appeared to be in serviceable condition at the time of the inspection. This does not however guarantee future performance or conditions.

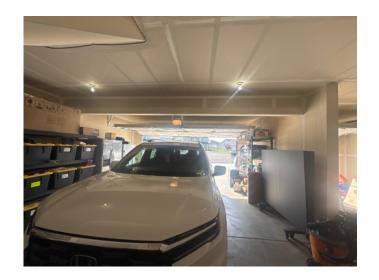
The general condition of the walls appeared to be in serviceable condition at the time of the inspection. Personal belongings and / or shelving prevented a full inspection of the entire wall. Moving or disturbing homeowner personal property is outside the scope of our inspection.

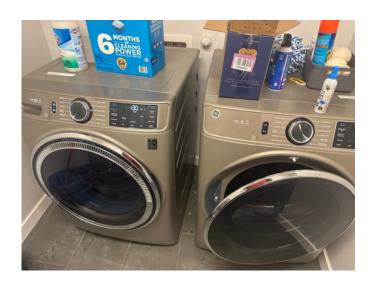
10.8) Laundry Room Conditions

The visible and accessible portions of the laundry plumbing components appeared to be in serviceable condition at the time of inspection.
