HOME INSPECTION REI 7-6

20808 Silverbell Ln
Pflugerville, TX 78660

PROPERTY INSPECTION REPORT FORM

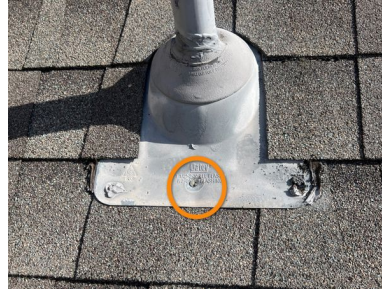
Flashing/Several Locations

Plumbing vent

Owners Notes: Covered exposed fasteners where accessible.

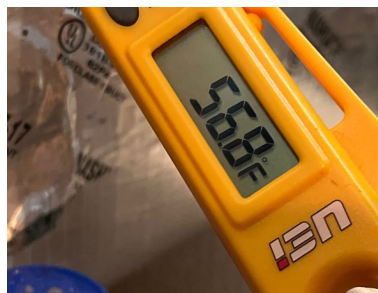
56° at the coil

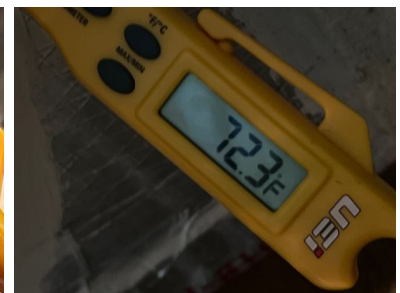
72° at the return/16° split

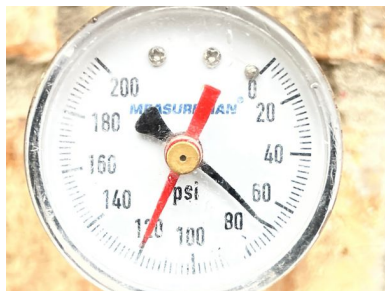
Approximately 70 psi

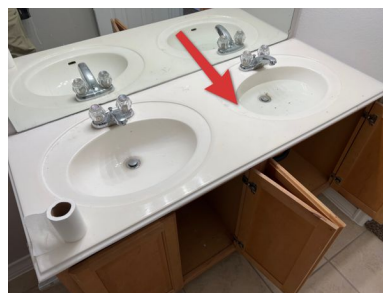
2nd Floor Bathroom

One or more sinks/tubs/showers drained slowly when tested. This may indicate a blockage or a more extensive problem. Further evaluation and/or repair by a licensed plumber is advised.

Owners Notes: Drains cleared.

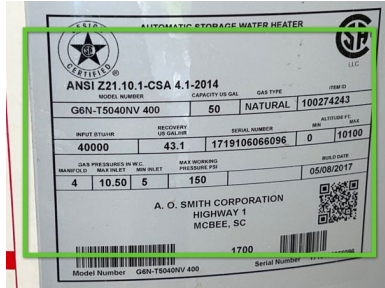
50 gallons/2017

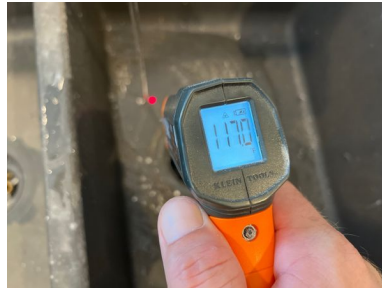
117° average

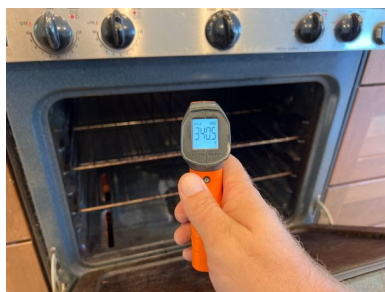
340°

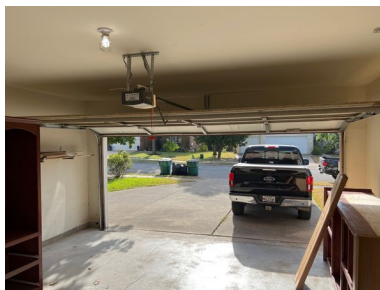
Working as Intended
