## Home Inspection Report

PROPERTY INSPECTED:  
1175 Forest Trail Place  
Oakville, ON L6M 3H7

Date of Inspection: 06/05/2026

Inspection No. 141168-1948

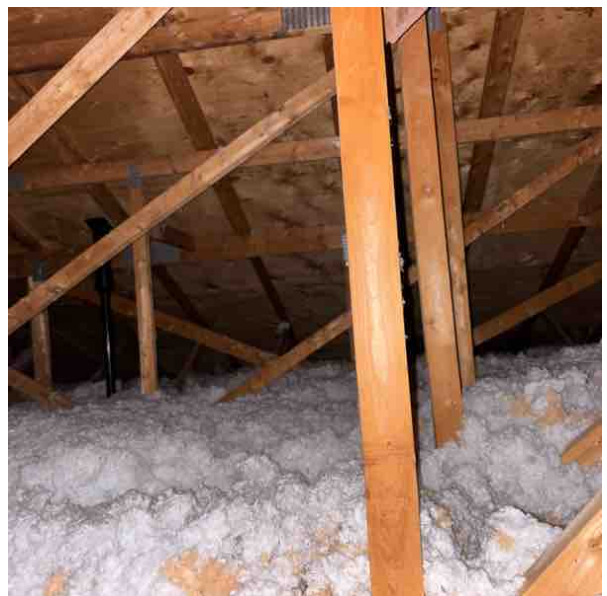
5.2.2 **Truss frames are solid, Sheathing was dry & without noticeable stains, insulation has decent levels with uniform coverage and the attic overall is in satisfactory condition.**

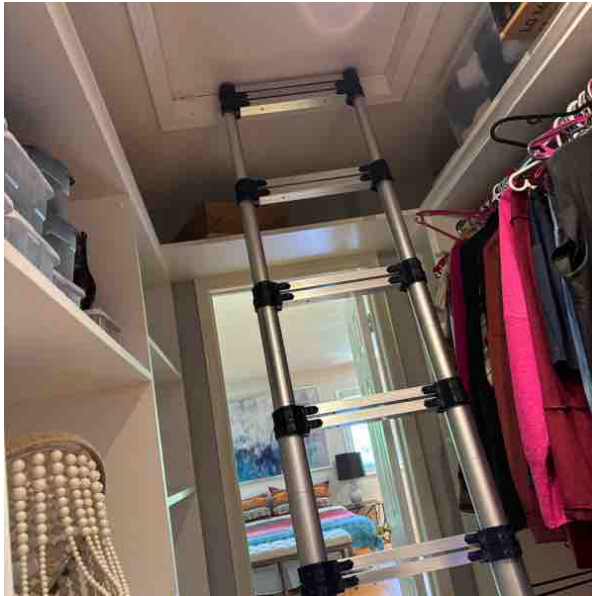
5.3.1 Attic access is via the ceiling hatch located in the bedroom closet.

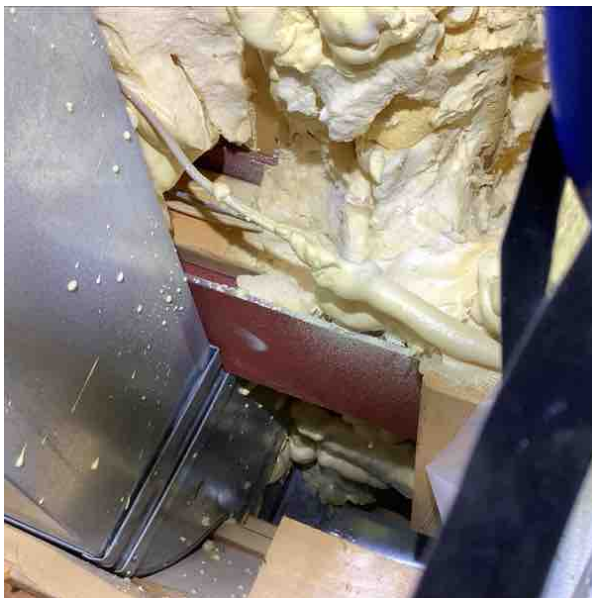
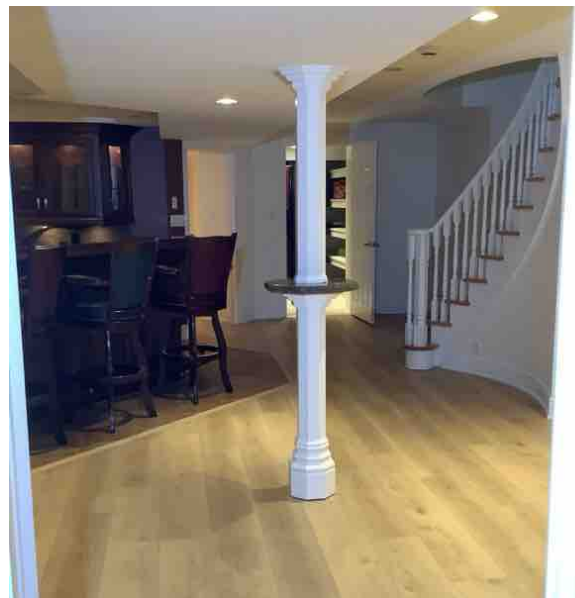
7.3.2 A steel beam was visible in the utility room and a post in the middle of the basement, but all other structure is concealed behind finish materials.

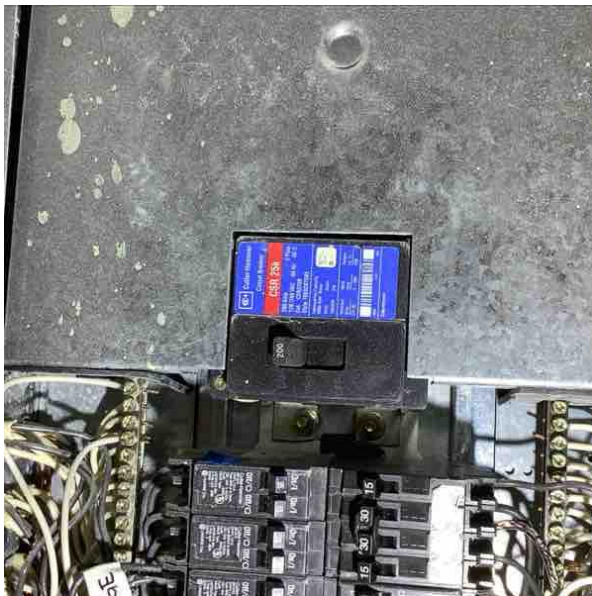
8.5.2 The main disconnect for the electricity going into the distribution panel, is the 200 amp breaker, located at the top of the panel.

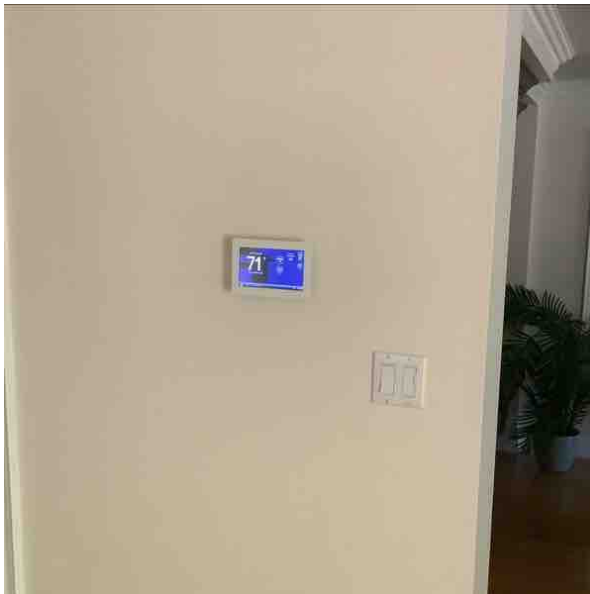
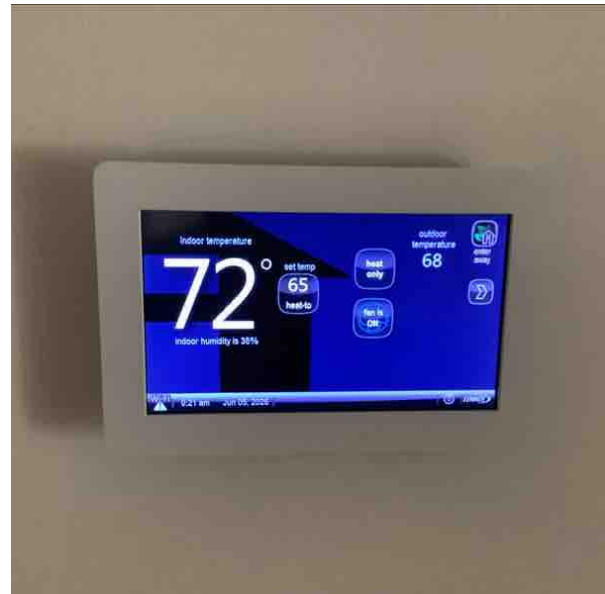
9.1.2 Programable thermostat is located on the main floor wall nearest the laundry room.

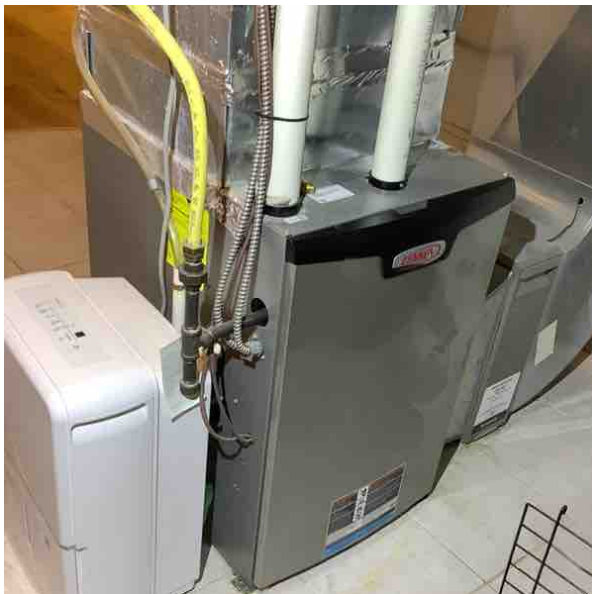
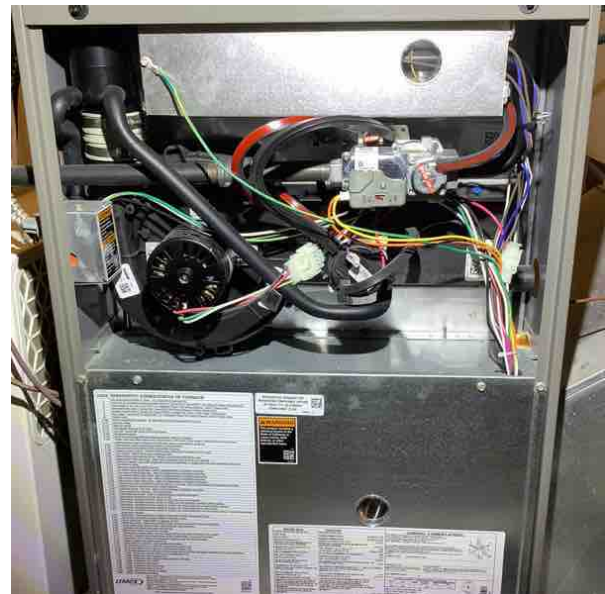
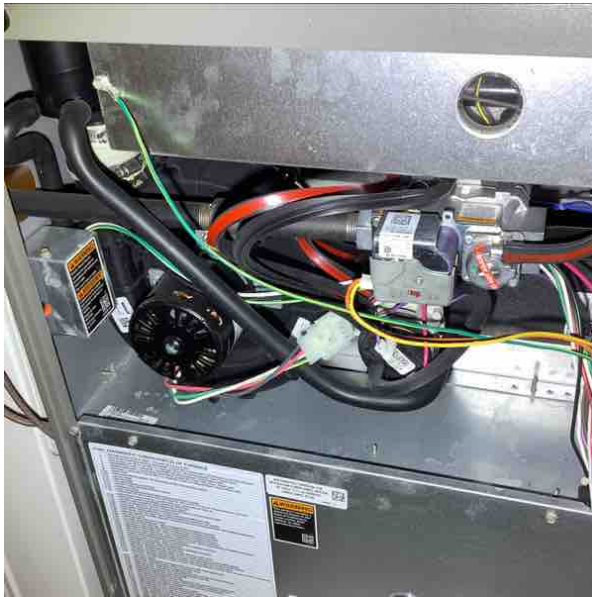
9.4.2 **Lennox Hi Eff furnace has 88,000 BTU / Hr Input, is 8 years old, middle of life cycle and was functioning at time of inspection.**

**Typical life expectancy is around 20 years.**

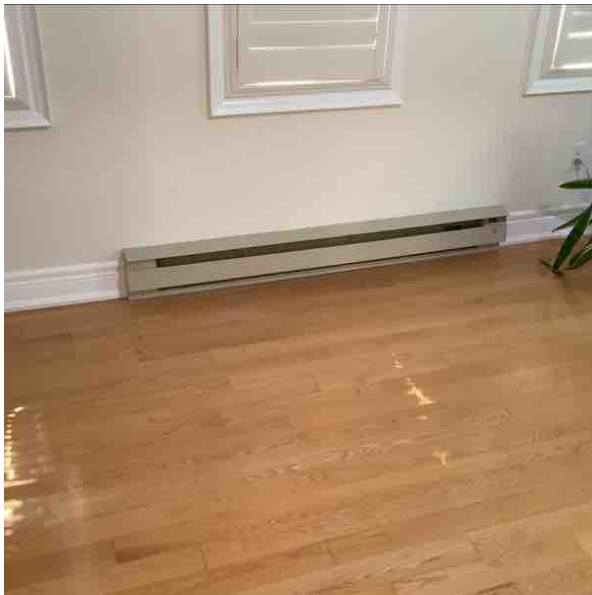
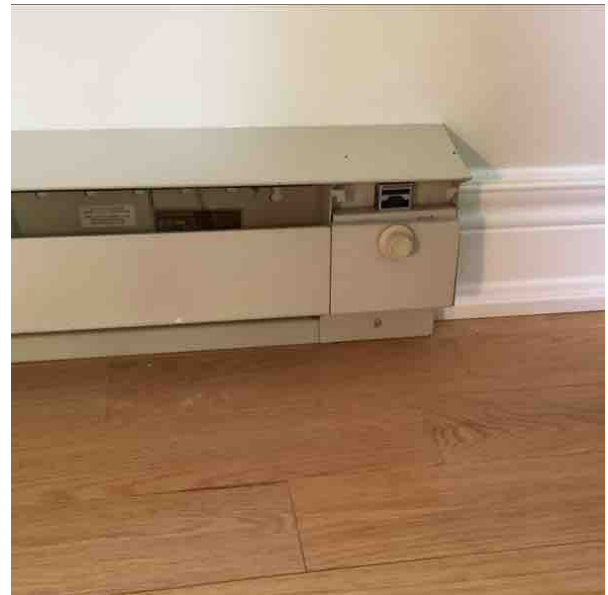
9.5.2 An electric baseboard heater was present in the south bedroom. As tested, the unit was functional.

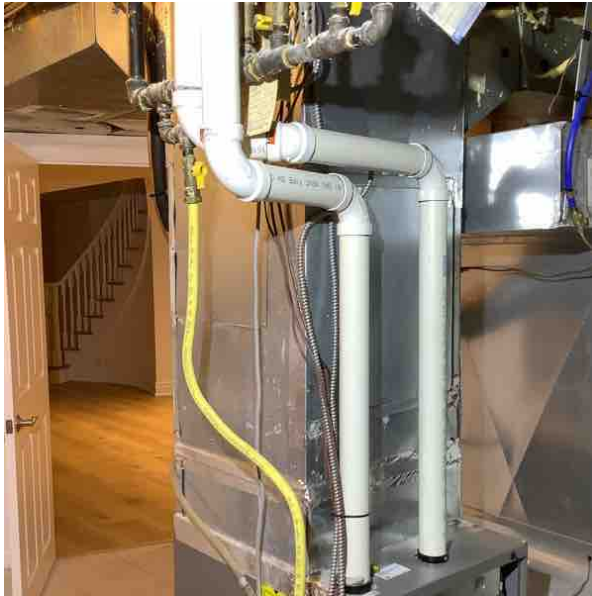
9.6.3 Gas vent piping (White) has the combustion air coming from the outside and the exhaust discharging to the exterior.

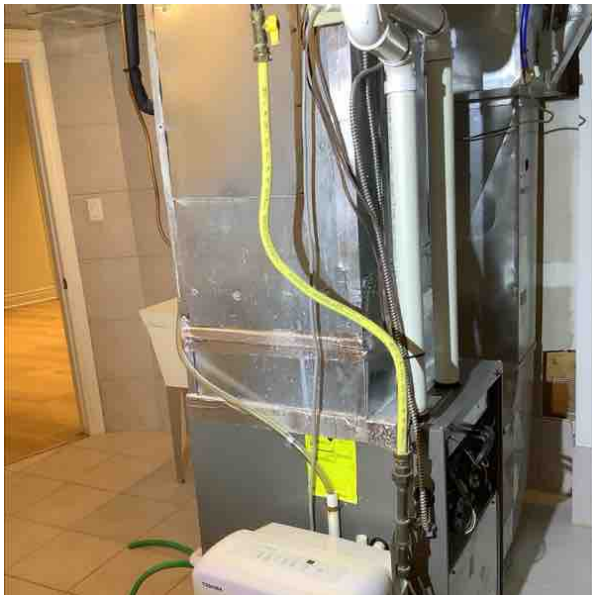
9.8.2 The flat yellow handle is the shut off for the natural gas going into the furnace.

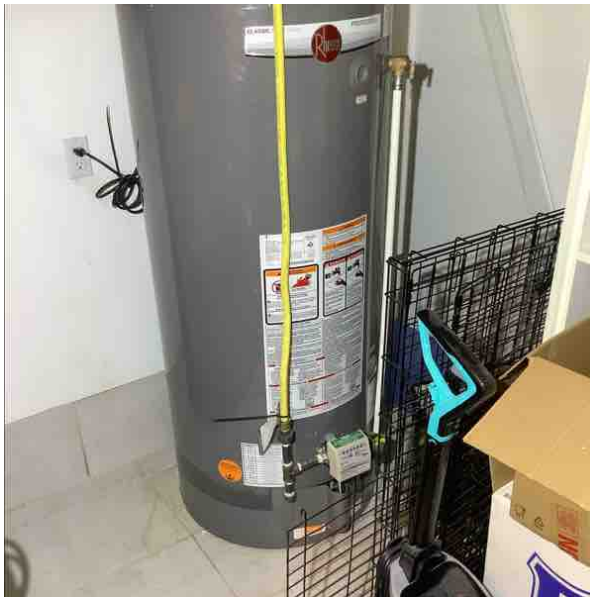
9.8.3 The flat yellow handle is the shut off for the natural gas going into the hot water tank.

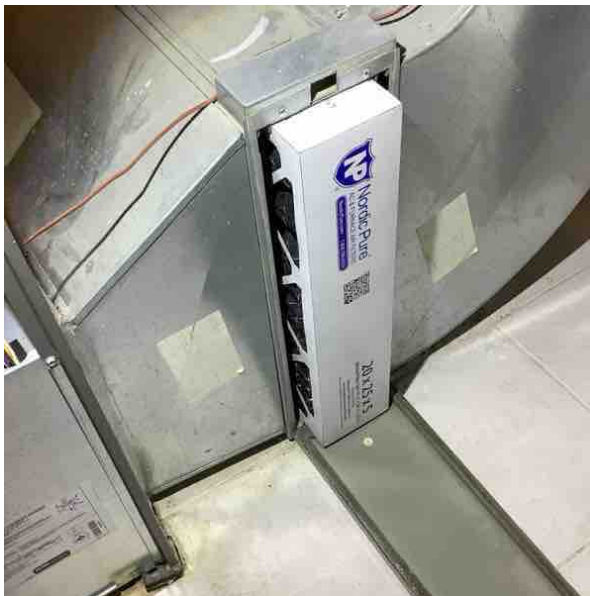
9.9.2 Disposable filter size is 20 x 25 x 5. Recommend to change once every 3 months or as per manufacture instructions.

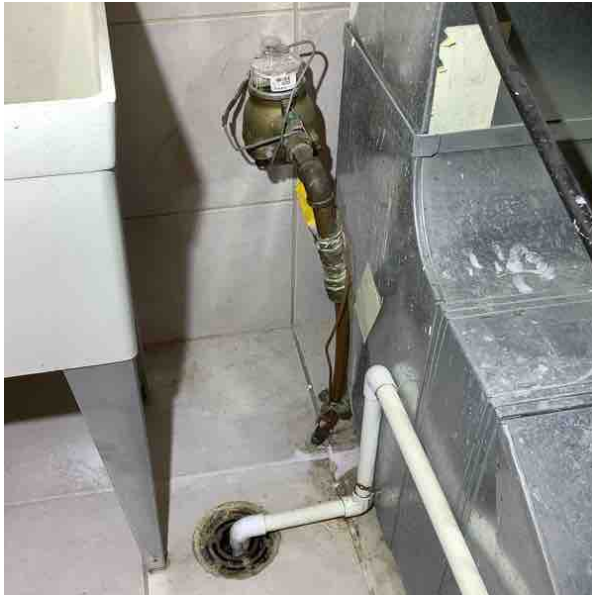
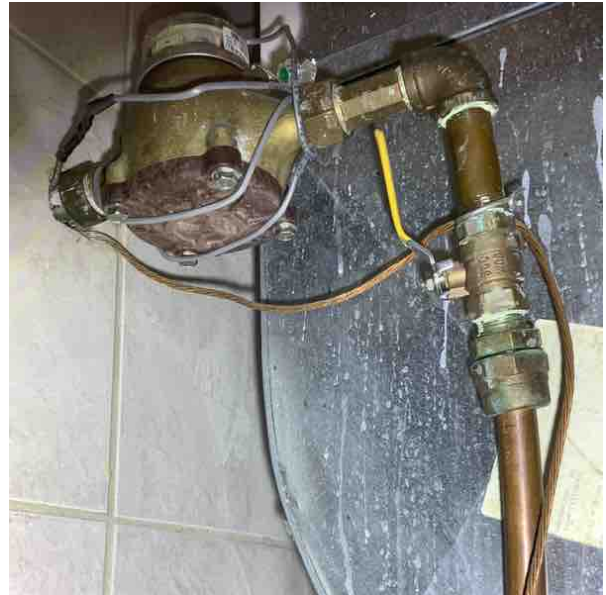
10.3.2 **Estimated 3/4" Copper supply line to the meter, is located in basement utility room.**

**\*Main shutoff for all water throughout the home is the flat yellow handle. Be sure to keep clear access in case of internal water emergencies.**

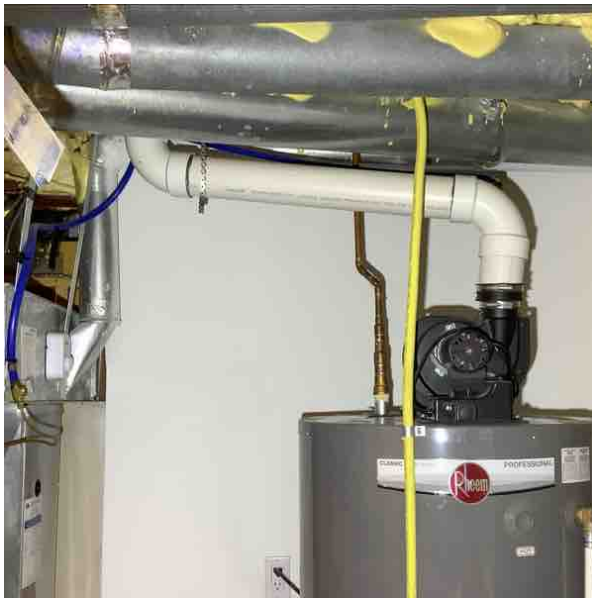
## 10.6.3 Power vented to the exterior.

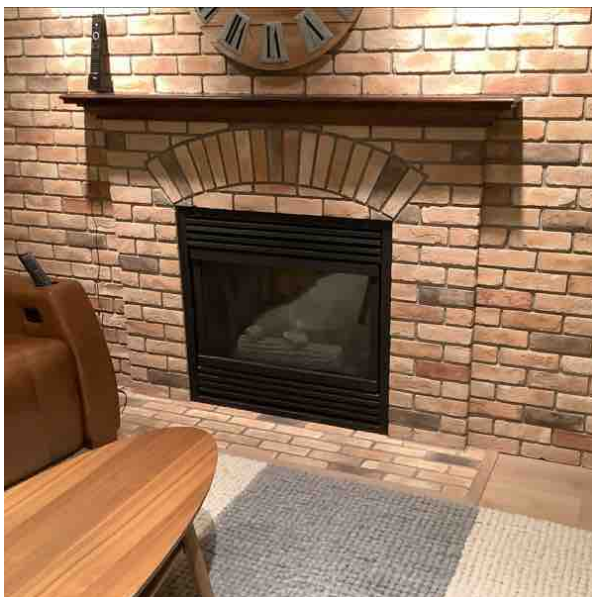
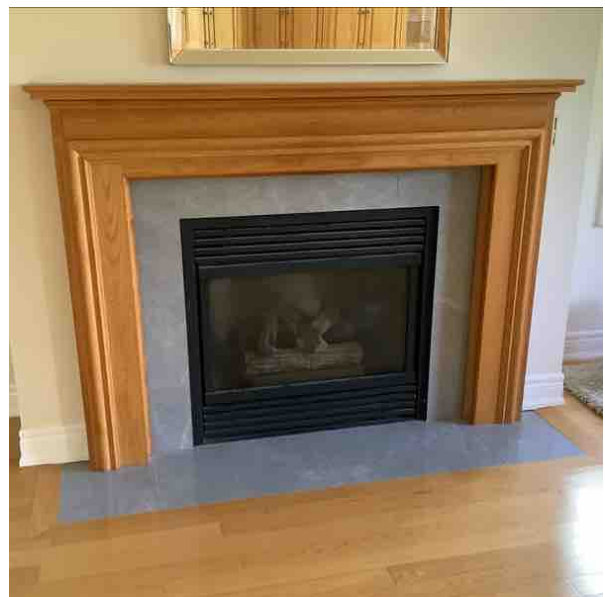
12.2.2 Gas fireplaces were present, however was not operated / tested and the functionality / safety was not determined. Recommend to verify function with the homeowner.

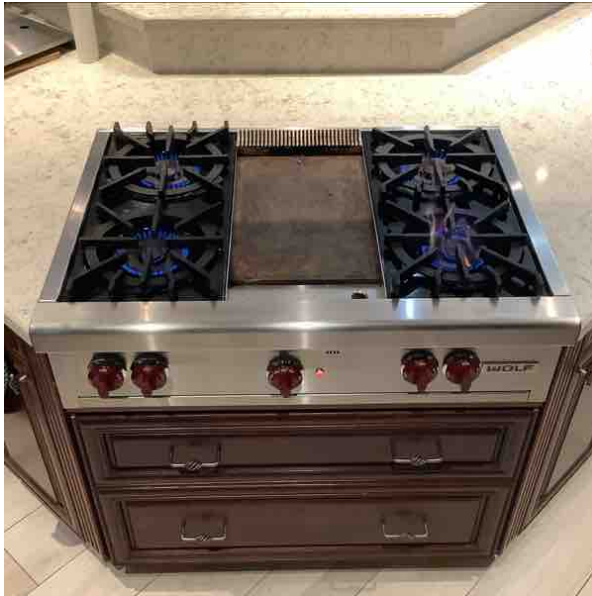
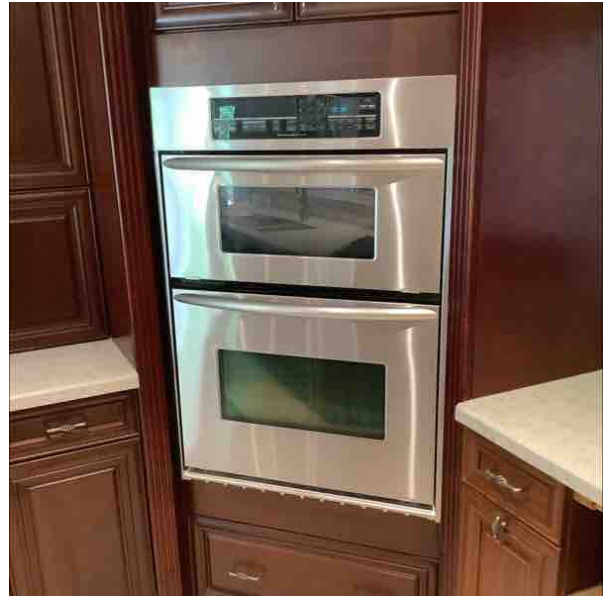
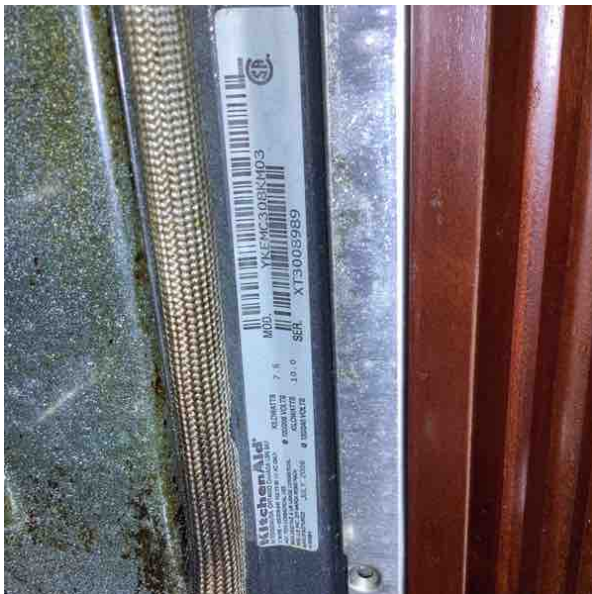
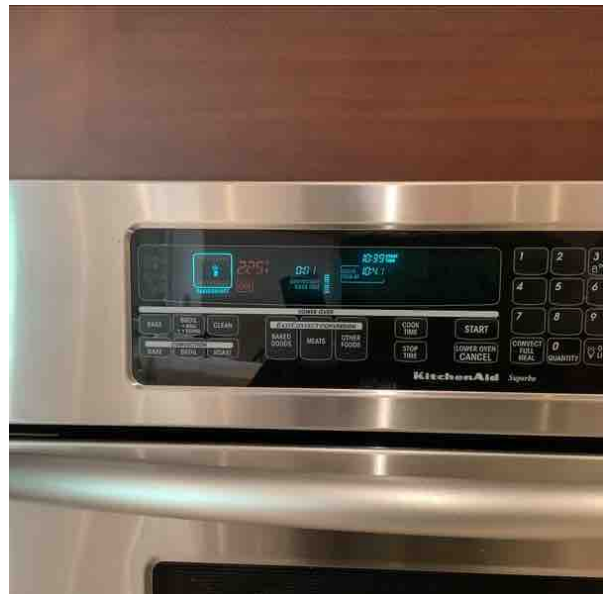
13.2.4 Wolf natural gas cooktop was tested and all 5 elements were functional. Oven was tested, and the heating coil was functional.

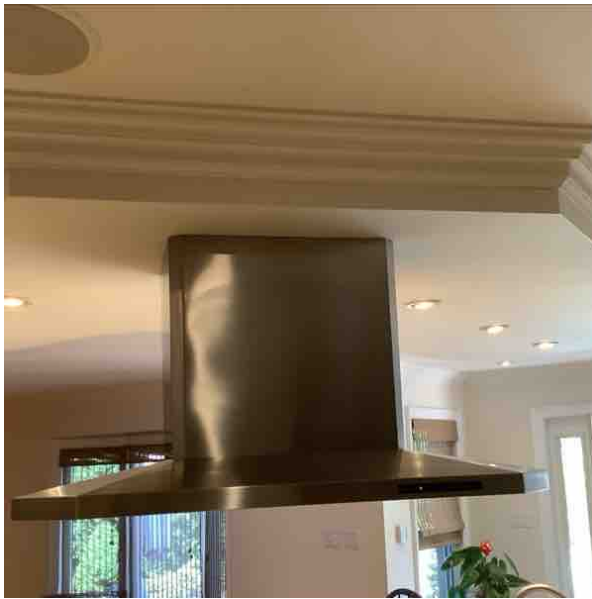
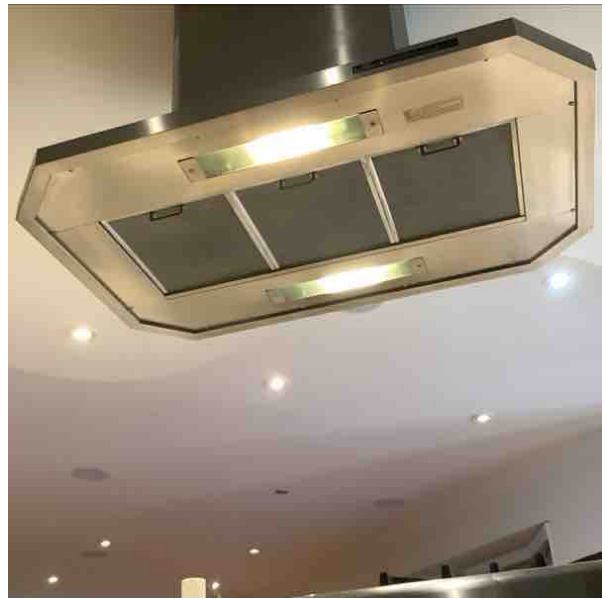
13.3.2 Thermador Range hood was tested and both fan and light features were functional.

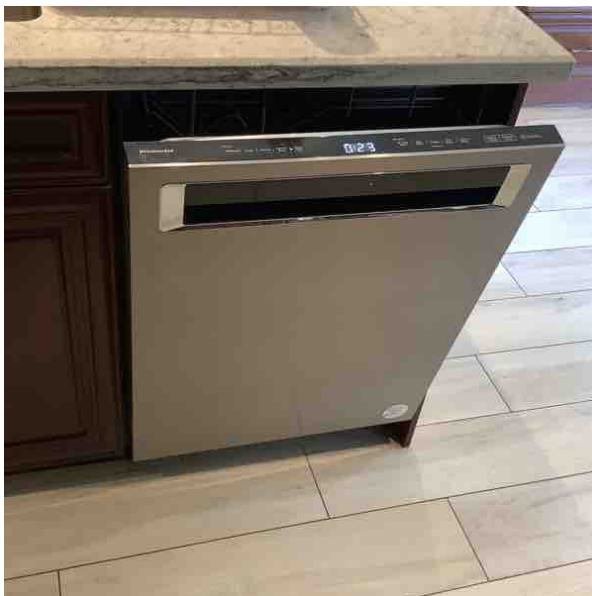
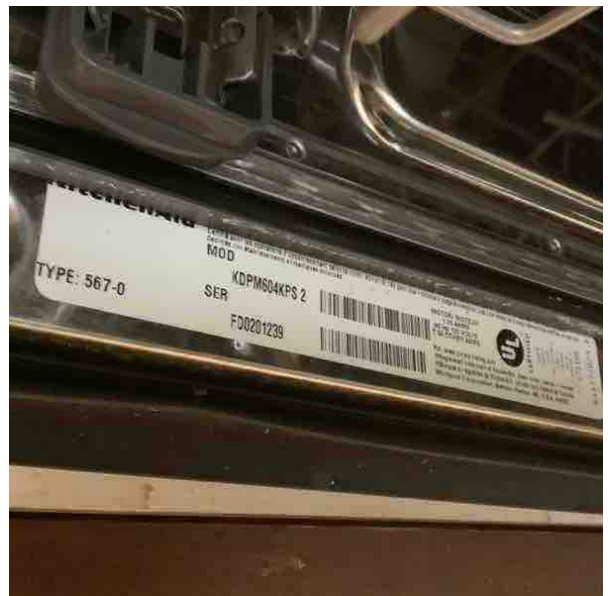
13.4.2 Kitchen Aid dishwasher was present, responded to operating controls but only tested on a rinse cycle.

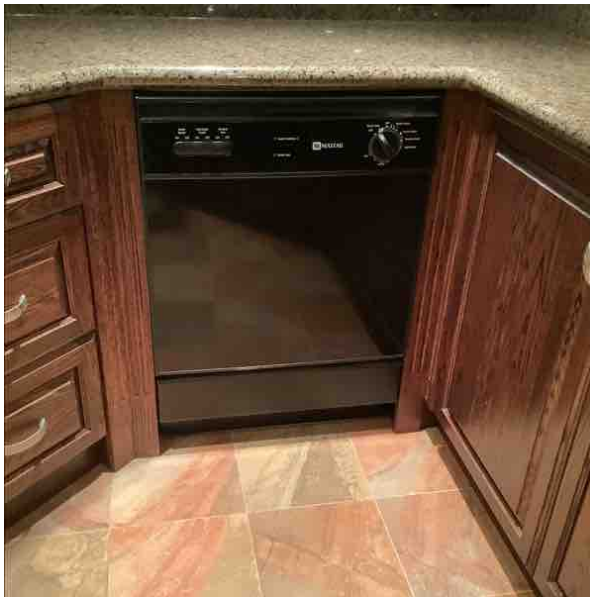
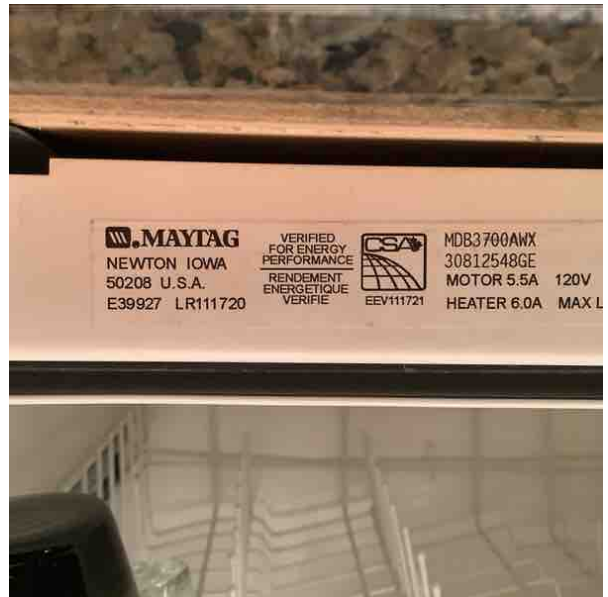
13.4.3 Basement Maytag dishwasher was present, responded to operating controls but not tested on a cycle.

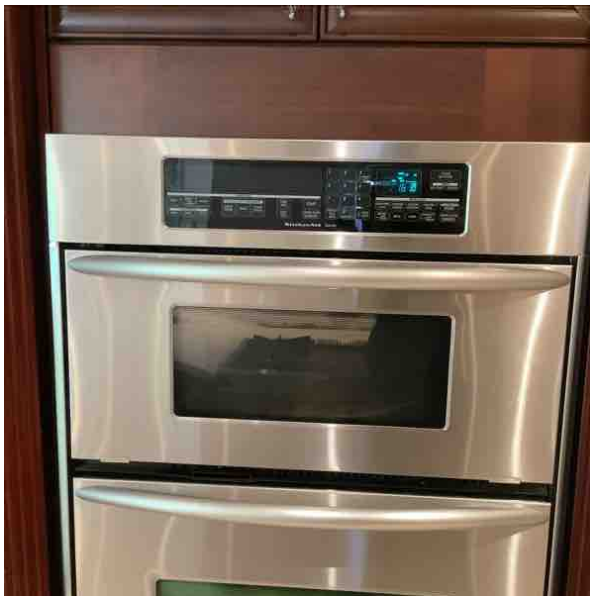
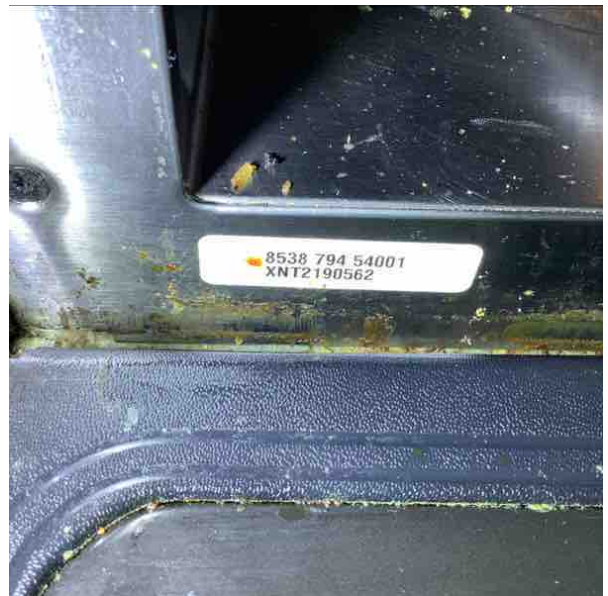
13.5.2 Kitchen Aid microwave was tested and found to be functional.

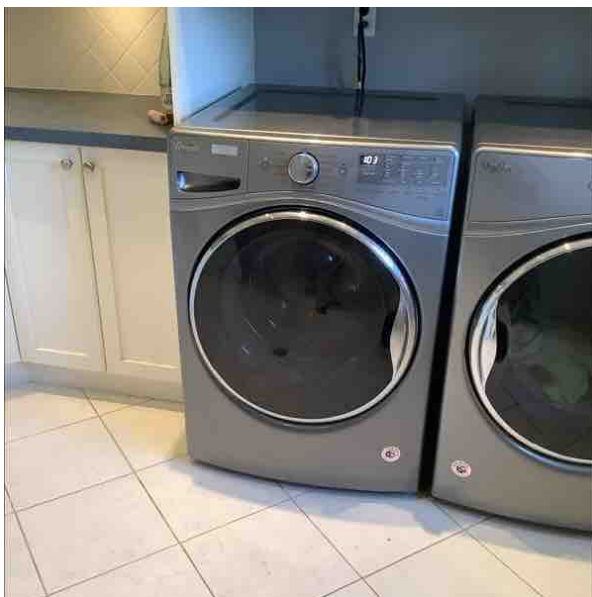
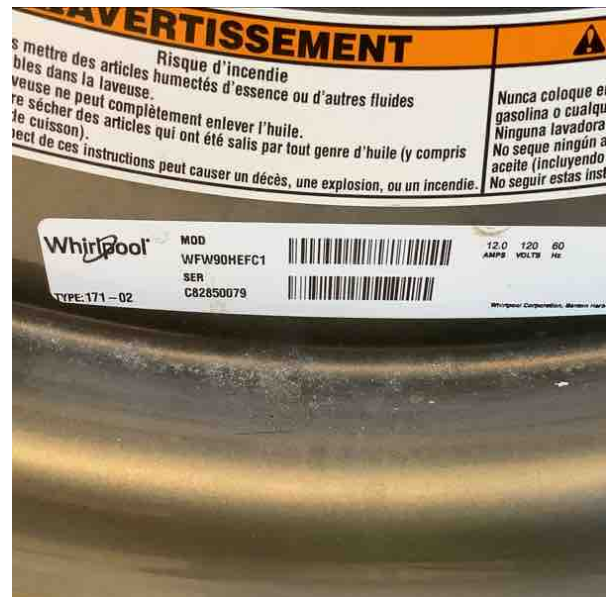
13.6.2 Whirlpool washer responded to operating controls but not tested on a cycle.

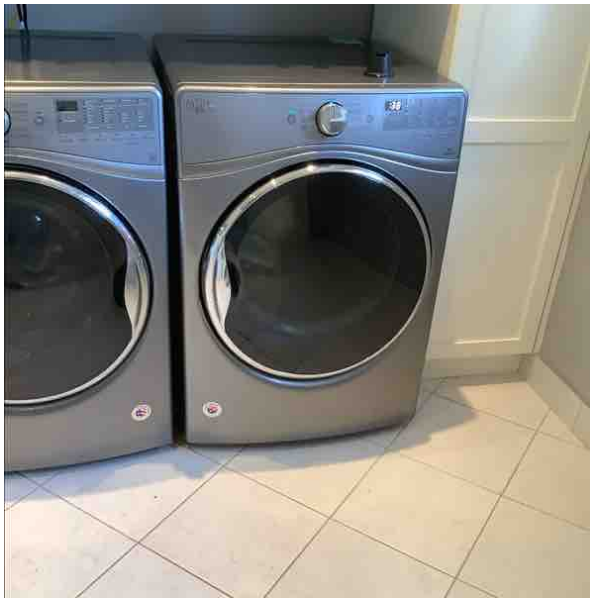
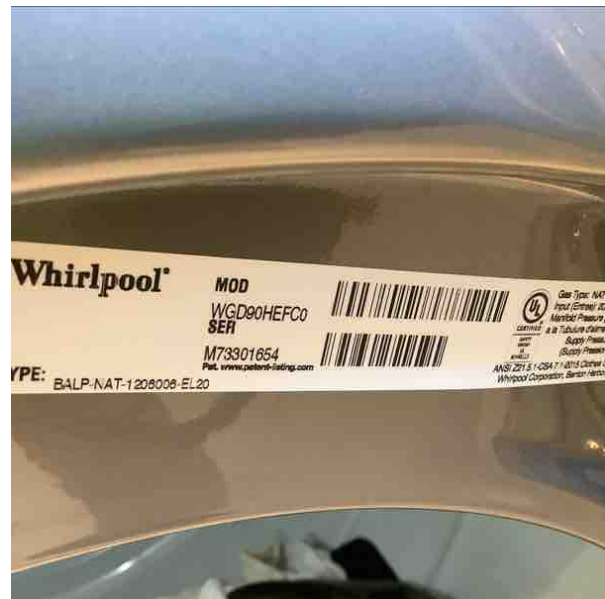
13.7.3 Whirlpool dryer responded to operating controls, was tested, and the heating coil was functional.
